PC 4.2

From: Lund, Brian [Brian.Lund@PacifiCorp.com]
Sent: Thursday, February 26, 2004 5:38 PM
To: Johnson, Janet
Subject: West Weber ComCast 400 S 4700 W Violation.doc

West Weber
ComCast 400 S 4700

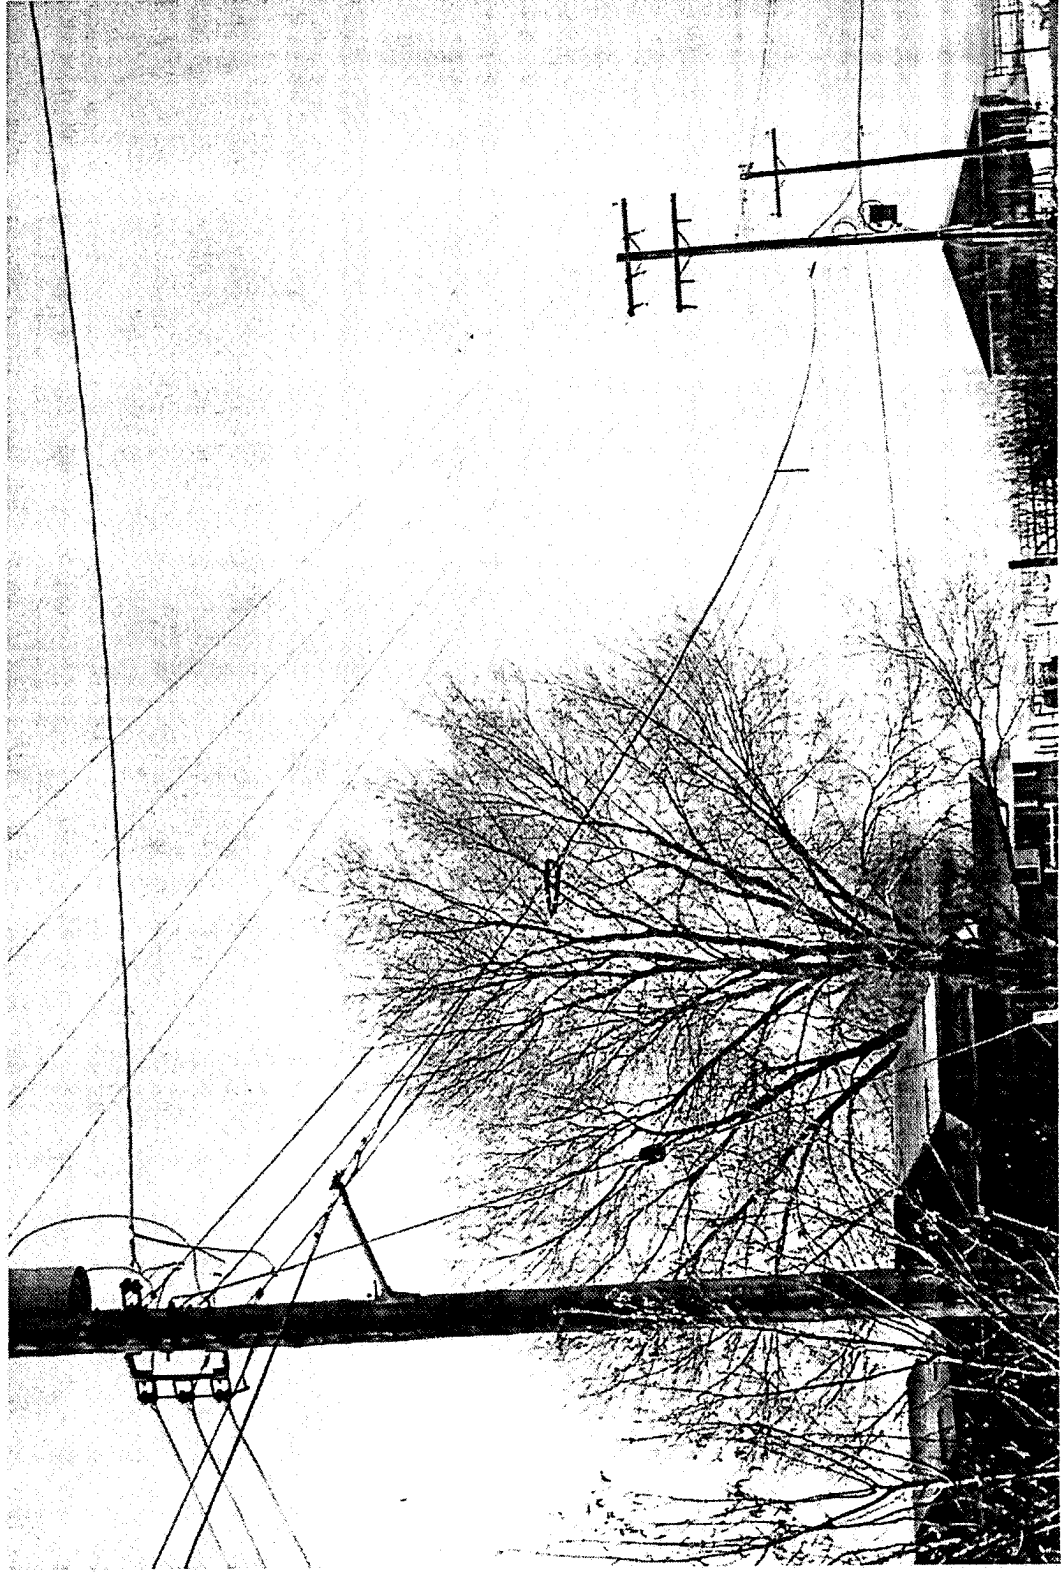
Pole # 11206002.0 175503 and 175505 on 02/25/2004. 400 S 4700 W, West Weber, UT

ComCast has placed strand and fiber in violation of NESC clearances and has created a very unsafe condition. A moderate wind will place ComCast in contact with PacifiCorp open wire secondary and energize the ComCast messenger. This eminent hazard will be corrected by PacifiCorp at ComCast expense.

The attached document has the information on an imminent hazard that we need to correct at ComCast Expense. Please get a charge number and then create a FLD order to "Replace open wire sec. with triplex for communications clearance."

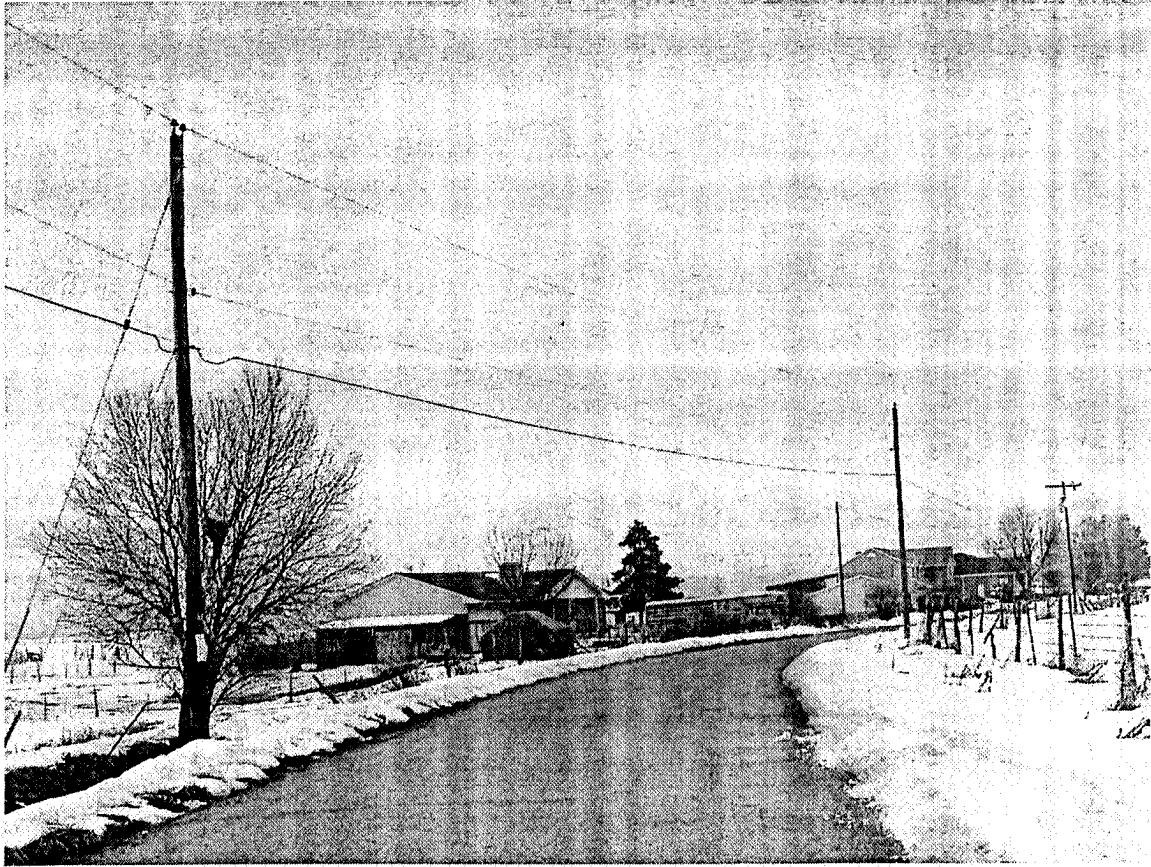
Pole 11206002.0 073803 and 073802 on 950 N @ 5650 W, clearance over roadway does not meet height requirements, 40" violations at both poles. No make ready requested by ComCast.

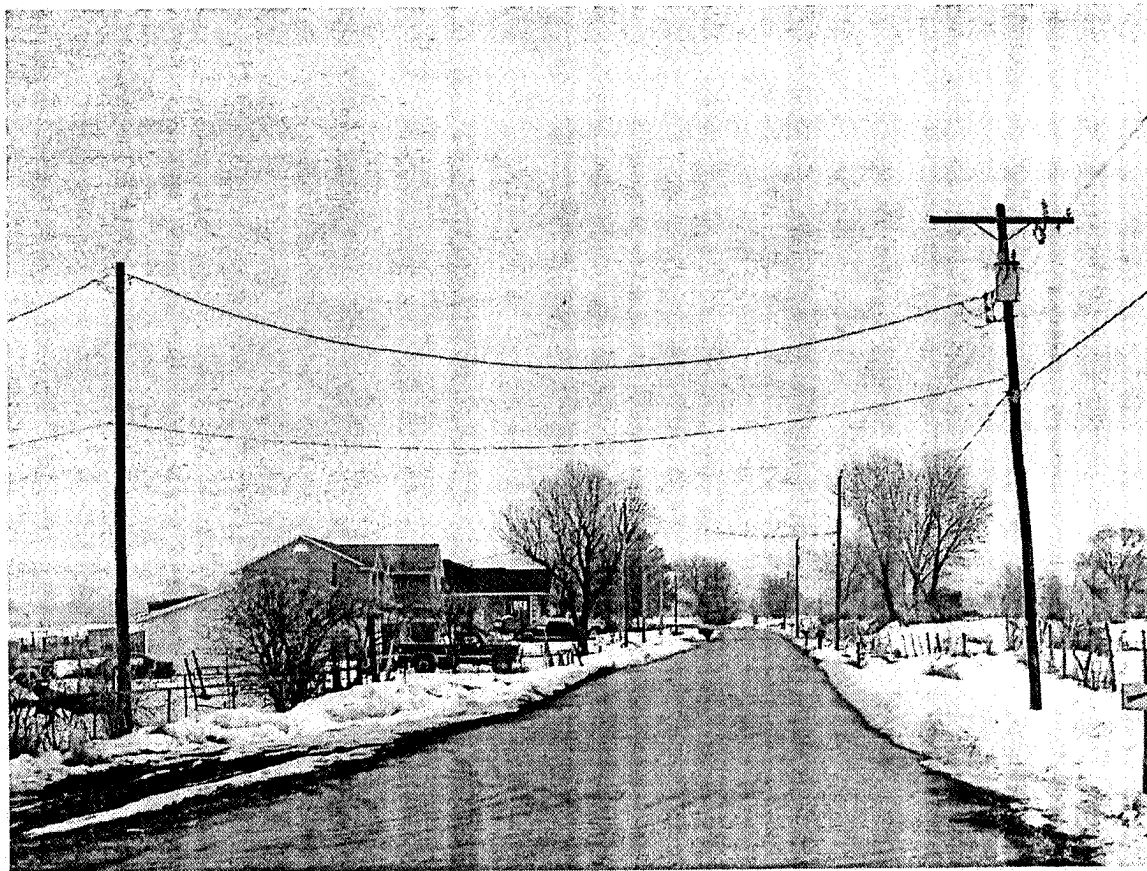
Pole 11206002.0 073801, 950 N @ 5600 W, clearance over roadway does not meet height requirements. No make ready requested. Cannot maintain height over roadway, mid-span clearance, and 40" at pole without make ready.

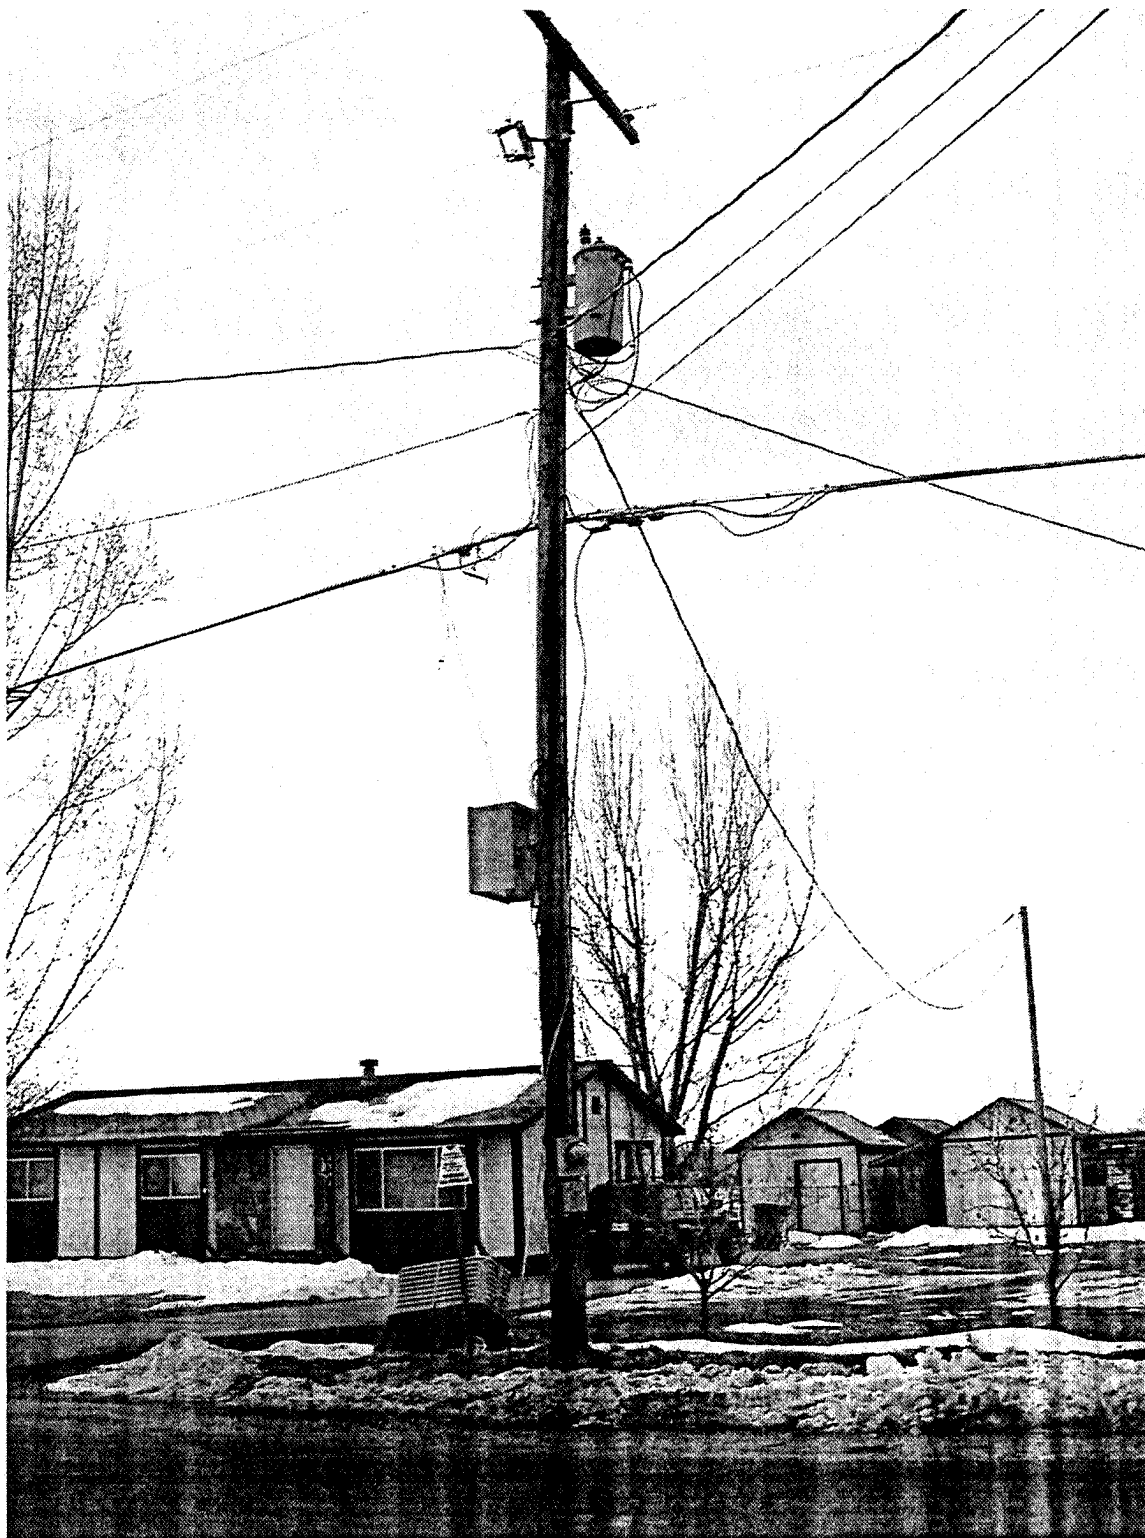
Pole 11206002.0 265405 on 2200 S., West Haven UT

Multiple 40" violations, unsecured cable down pole and laying on ground to ground mounted pedestal falling in ditch. Power supply does not meet minimum ground clearances. One service over road does not meet roadway clearances, and all three services create 40" violations on the service poles they contact.

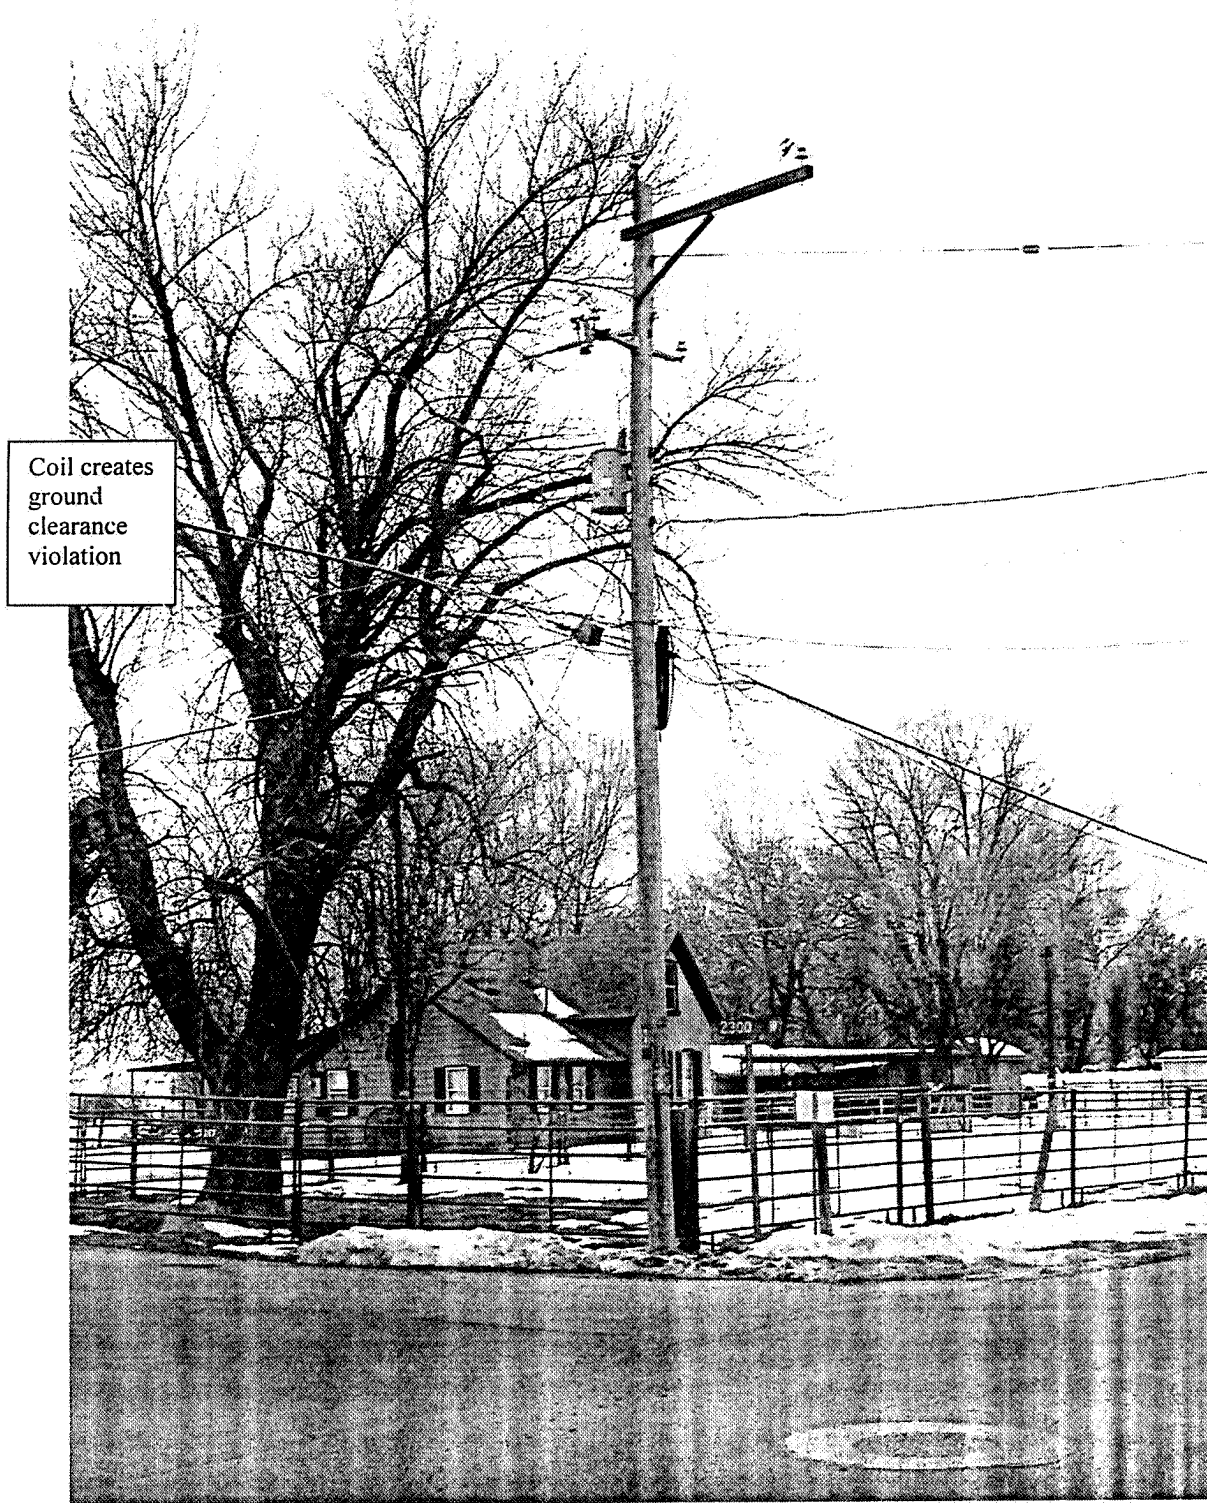
Pole 11206002.0 264405 2200 S and 2300 W, West Haven UT, temp coil creates ground clearance violation.

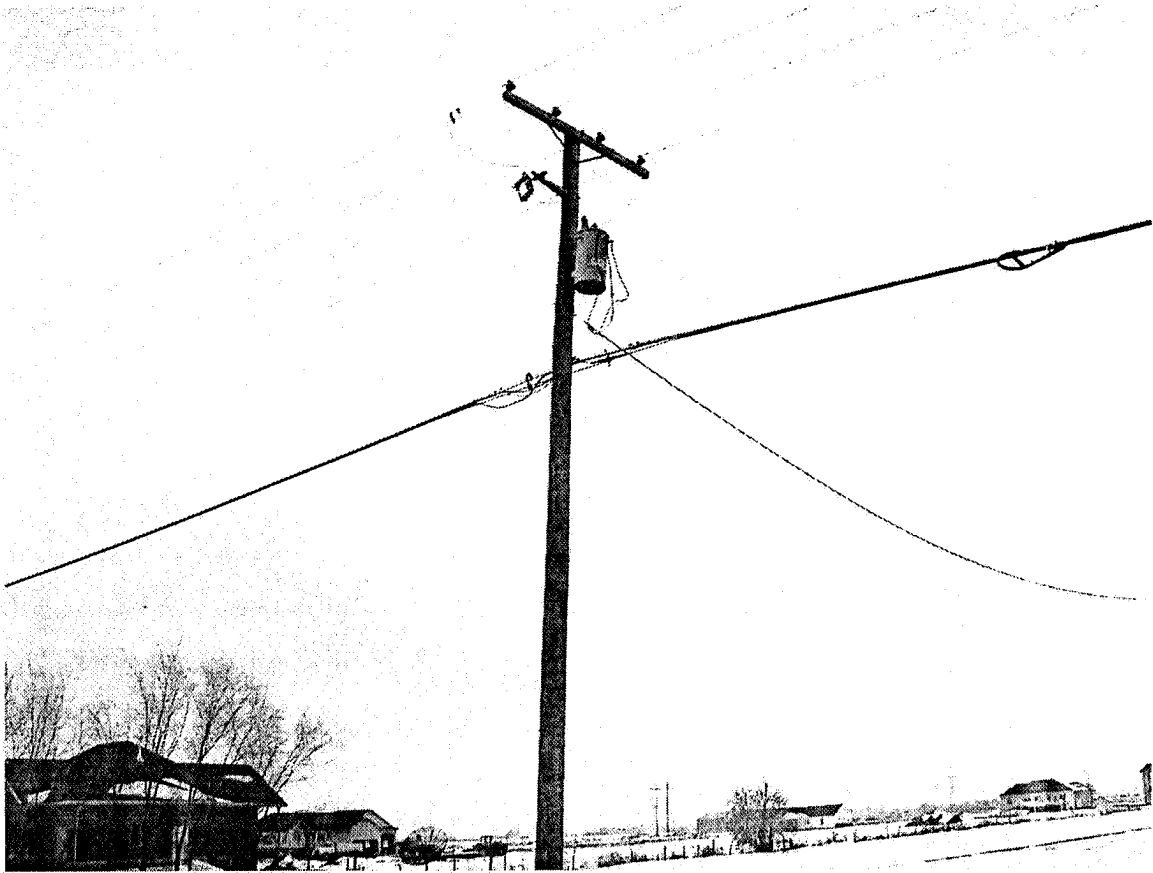
Pole 11206002.0 279502 40" violation, ComCast did not perform make ready when placing new cable.

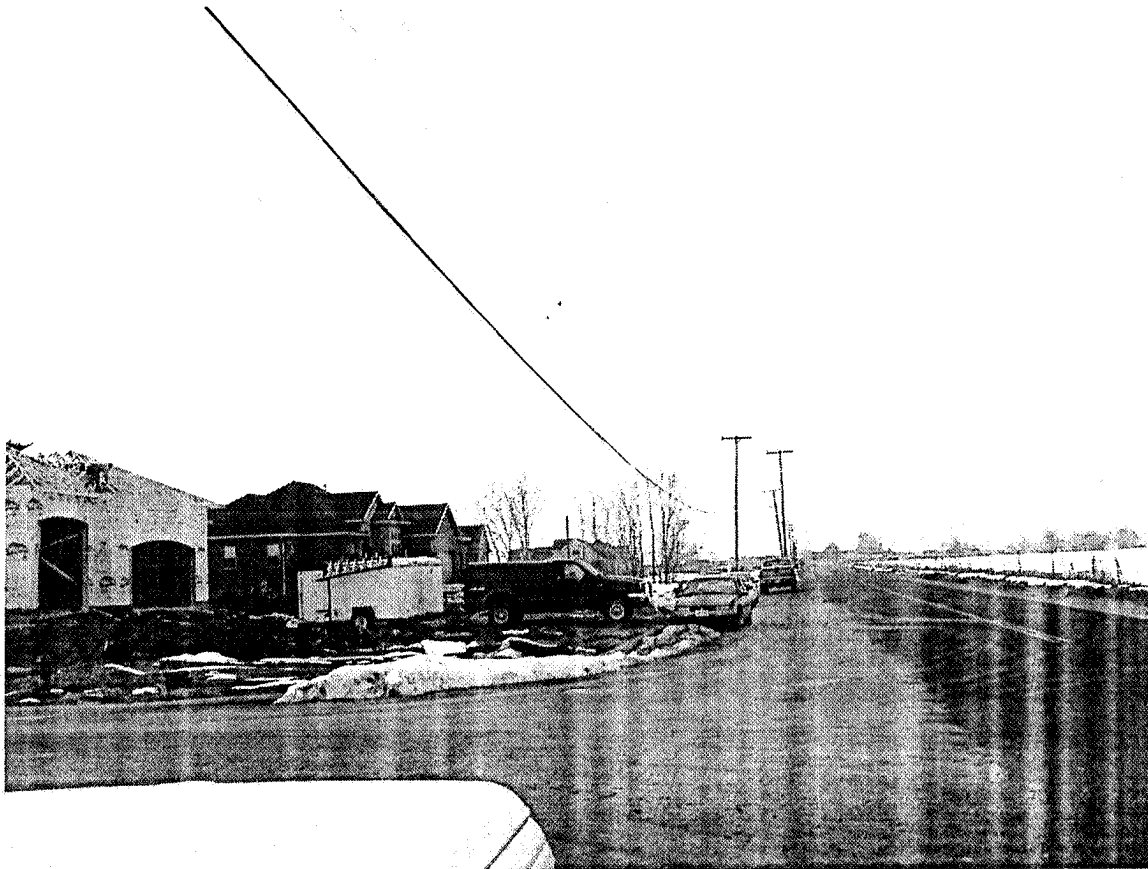
Pole 11206002.0 279506 to 279507 on 2700 W, ground clearance violation, ComCast did not perform make ready prior to lashing new cable.

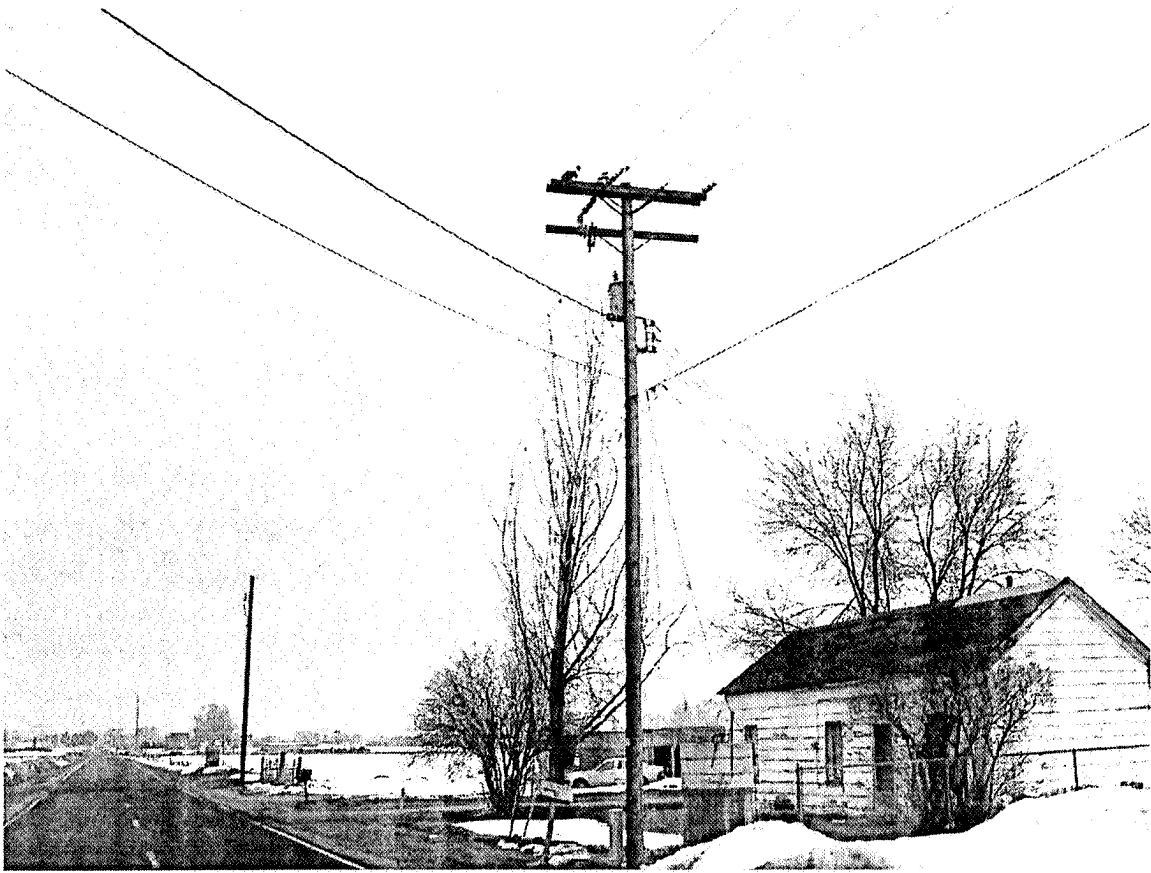
Pole 11206002.0 279200 on 2700 W, 40" violation not corrected when placing new cable, unsecured drops hanging down pole.

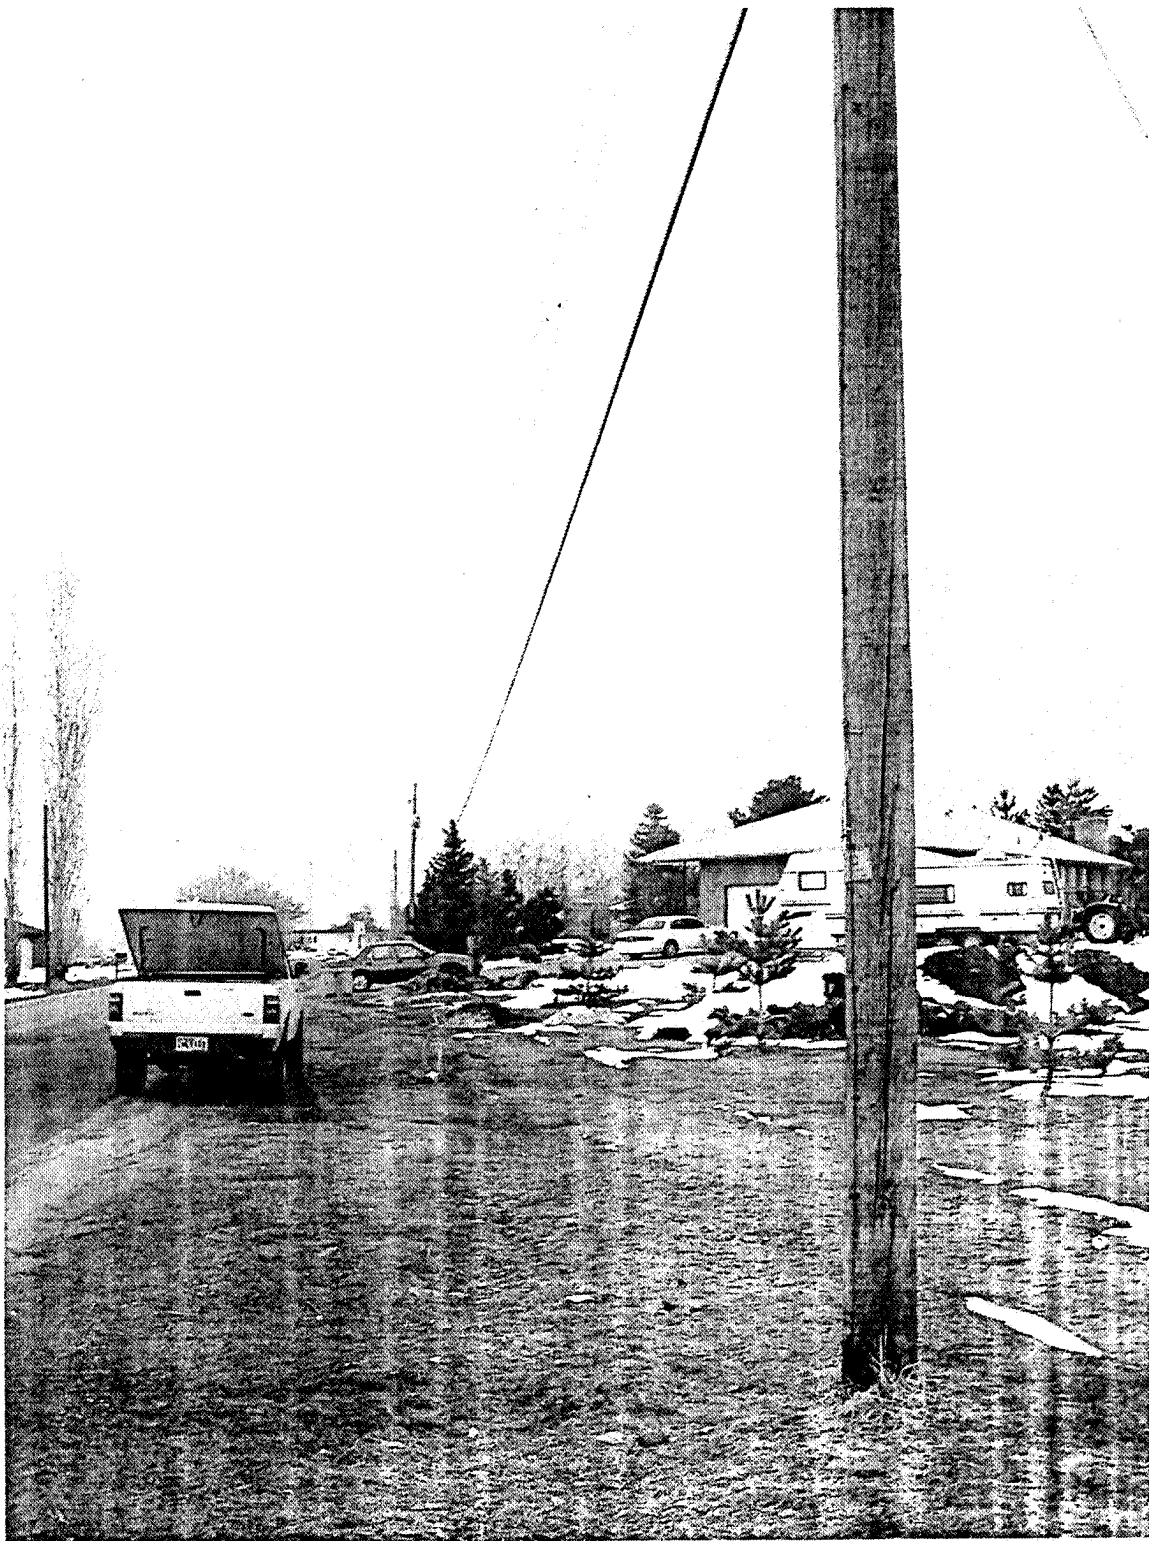
Pole 11206002.0 260500 to 260502 2200 S near 2700 W, low ground clearance (12' 4") not corrected when placing new cable. See next picture also.

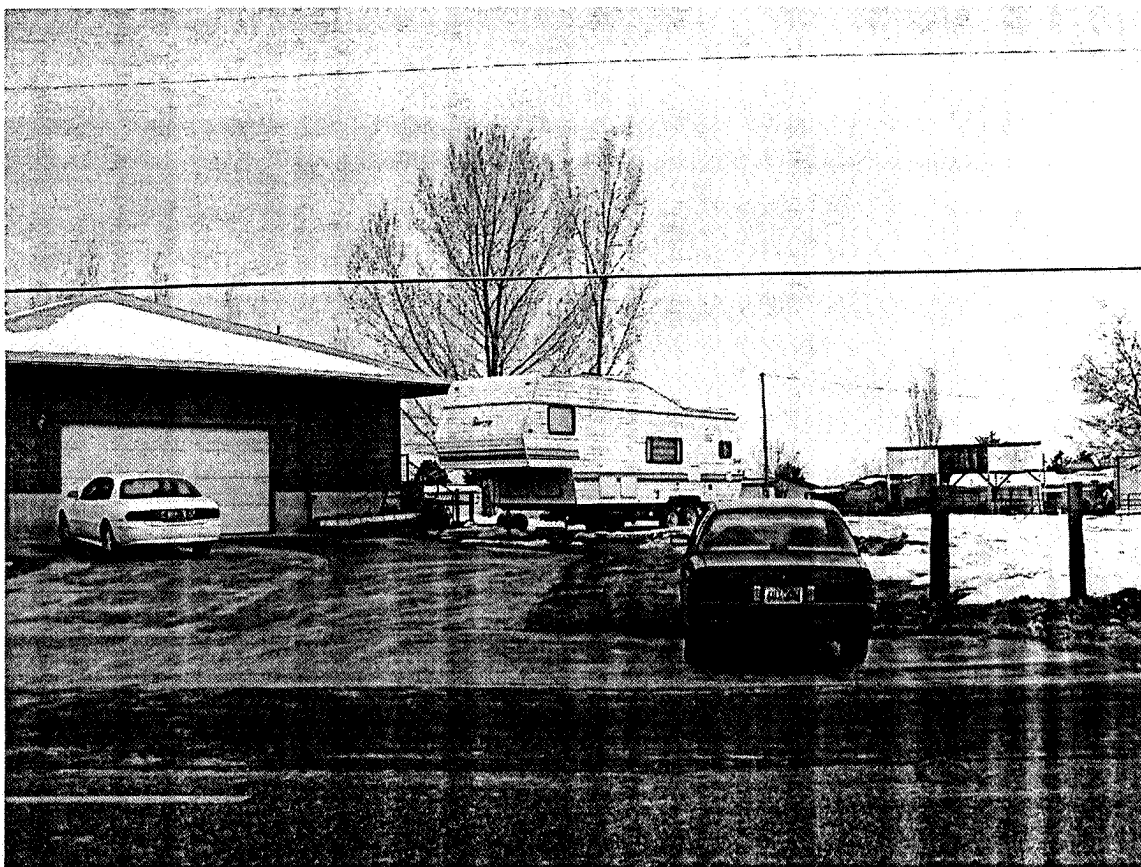
Pole 11206002.0 260500 to 260502, inadequate ground clearance., no make ready prior to placing additional cable.

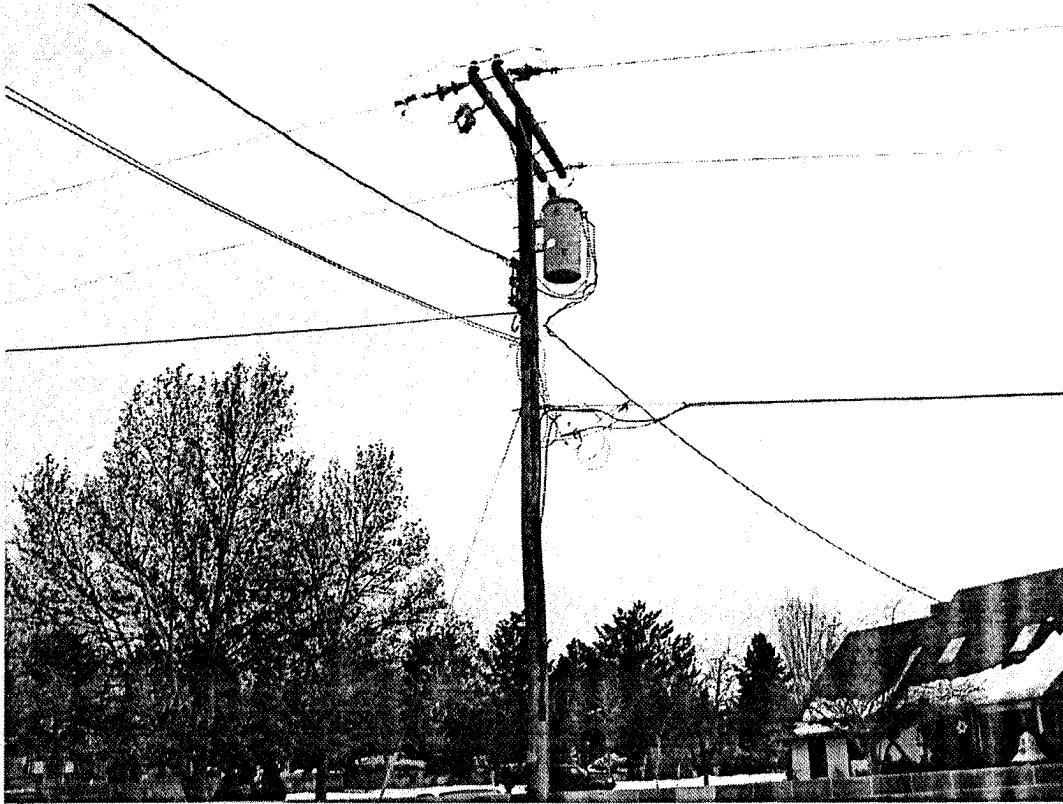
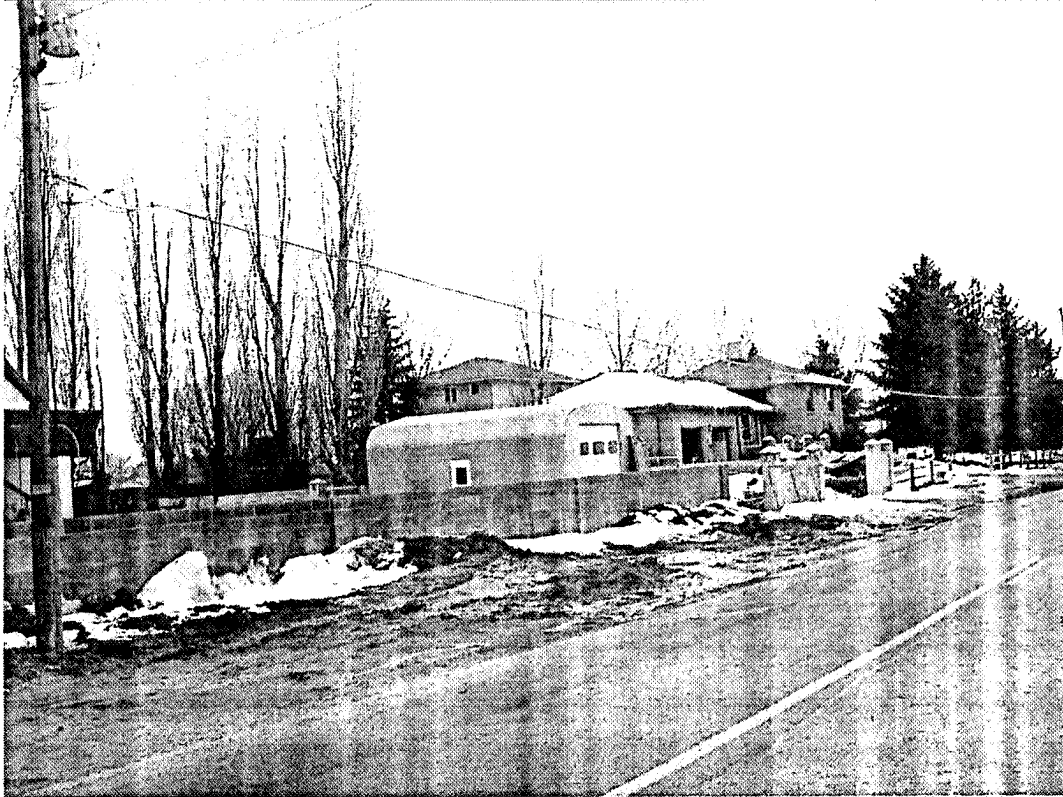
Pole 11206002.0 263403 on 2200 S. 40" violation, inadequate ground clearance to the west. Cannot maintain 40" and height of drops over roadway. No make ready requested or performed by ComCast.

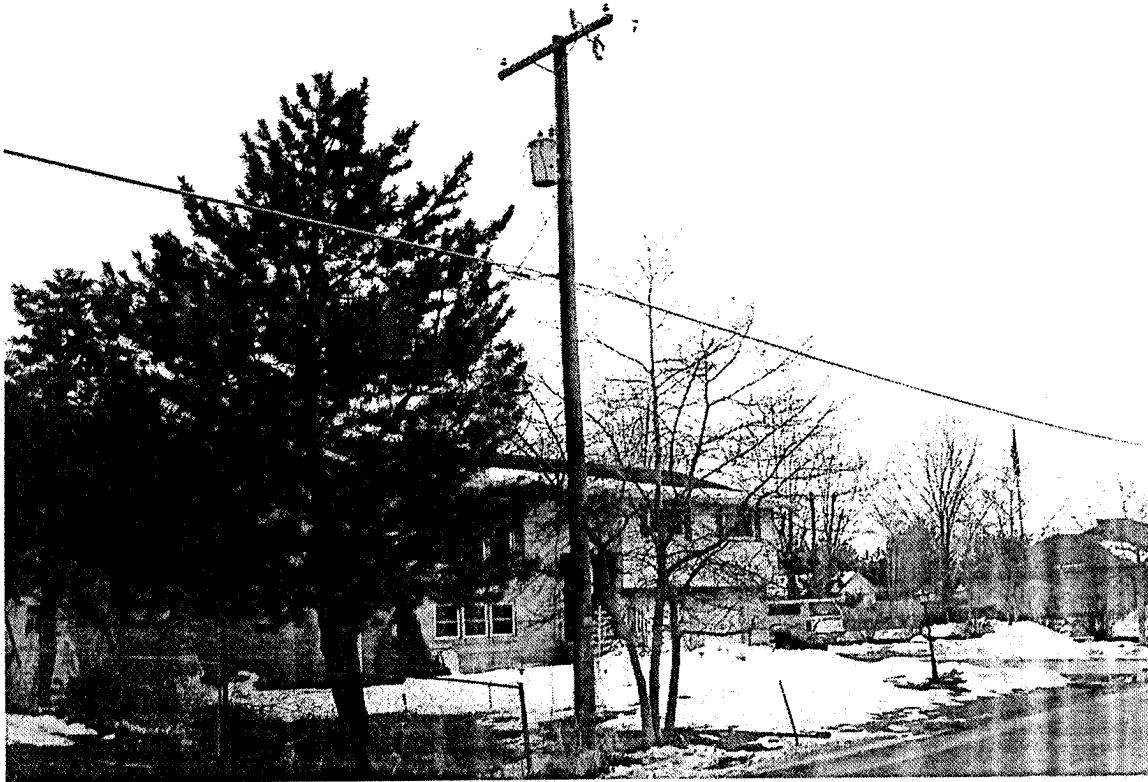
Pole 11206002.0 263400 on 2200 S, 40" violation, several drops hanging to ground unsecured down the pole.

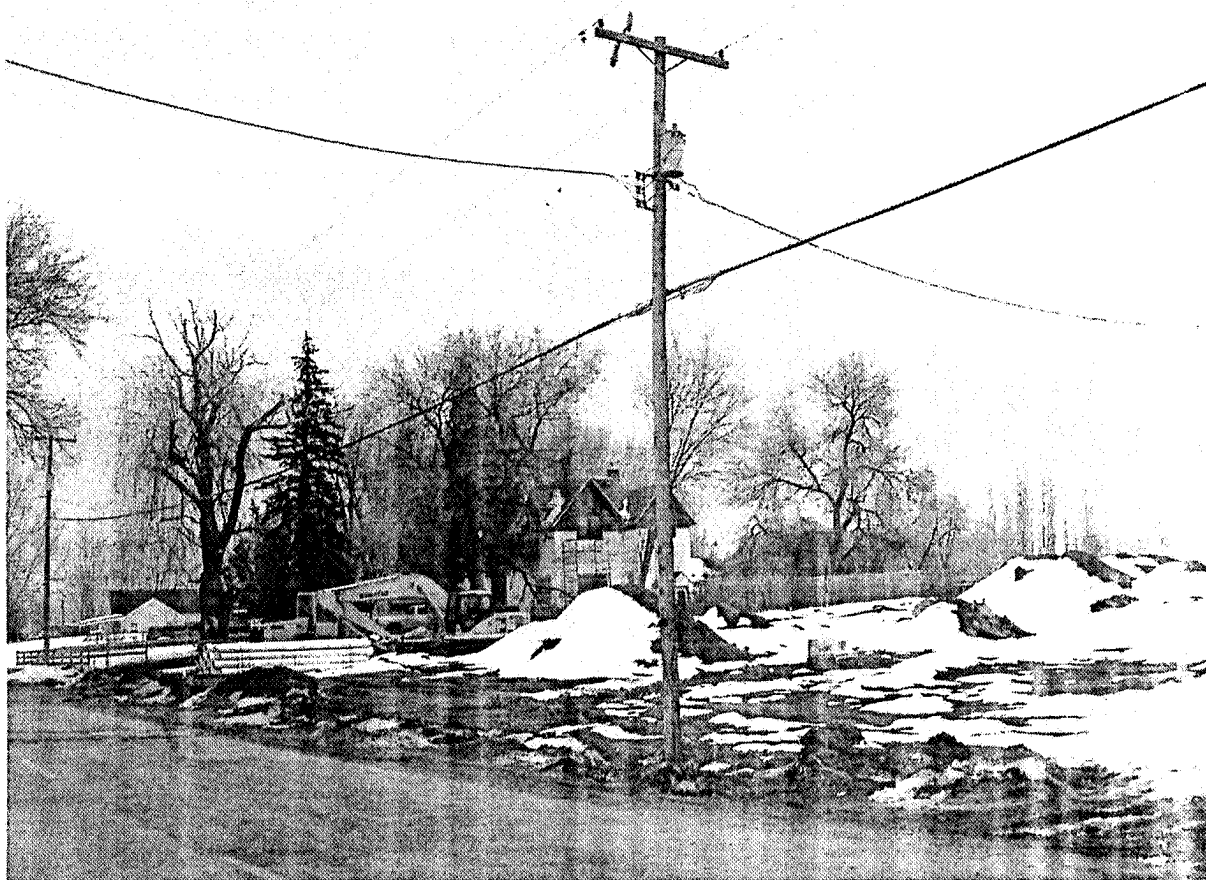
Pole 11206002.0 263406 on 2200 S, unsecured drops hanging down pole and laying on ground, hard to see in picture.

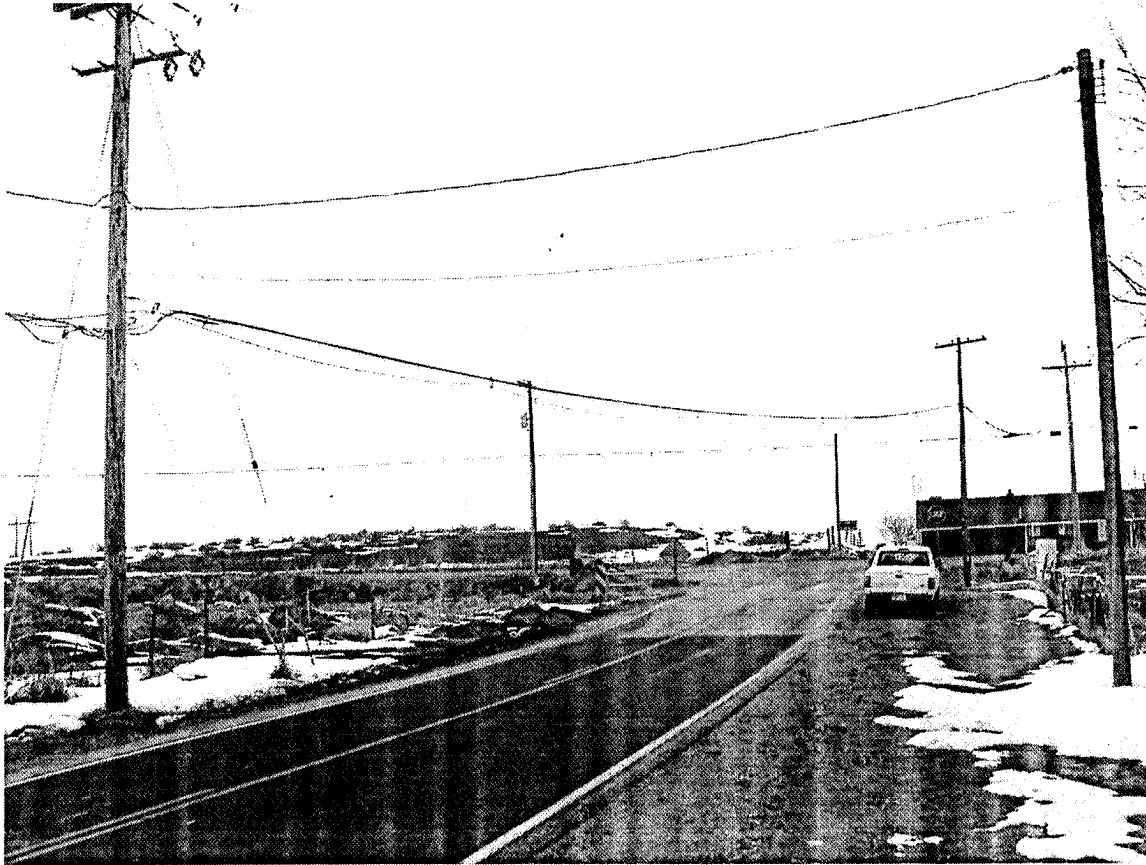
Pole 11206002.0 279904 to 260902 on 2700 W & 1800 S, New cable being placed without resolving existing road clearance violation. No make ready requested, secondary service needs to be raise so attachment can be raised for roadway clearance and maintain 40" clearance at pole. CATV also needs to place anchor and down-guy.

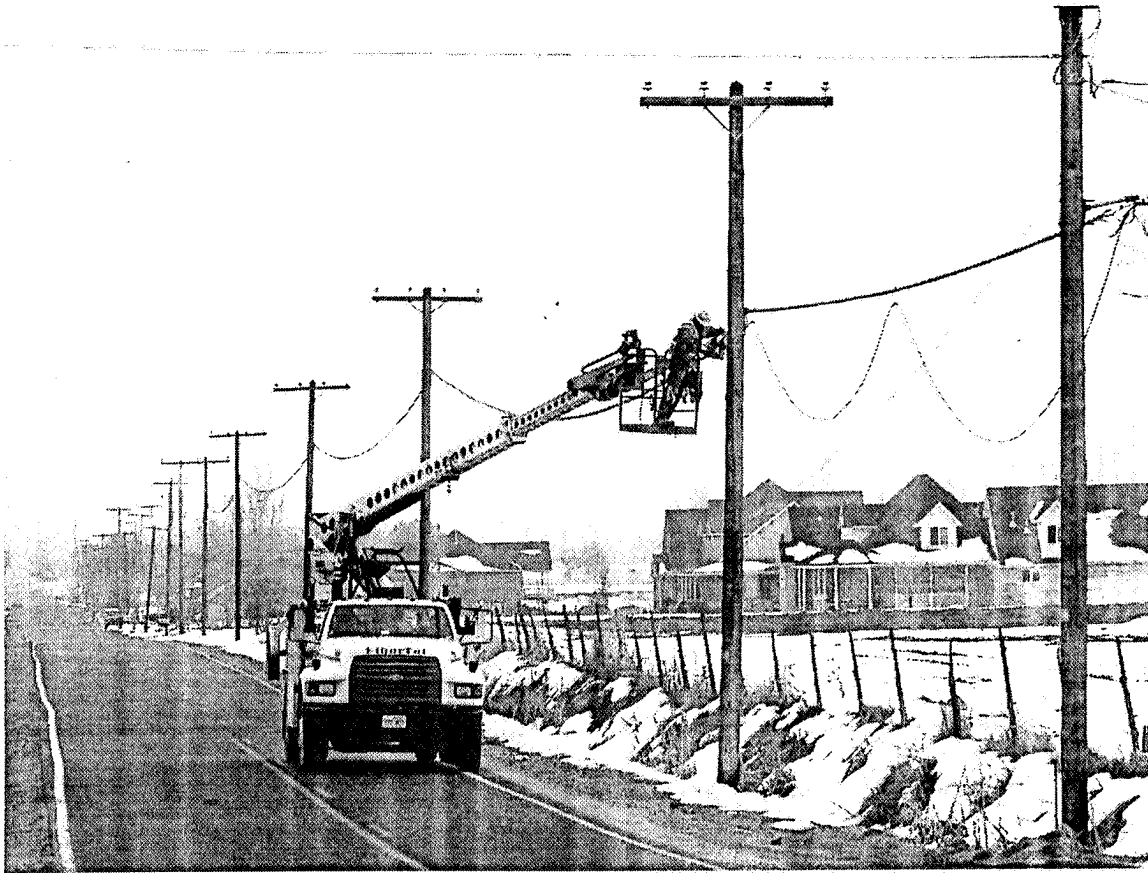
Communications work 2 spans south of Pole 11206002.0 279904, notice the stealth work area protection markers. Truck flashers were not in use either.

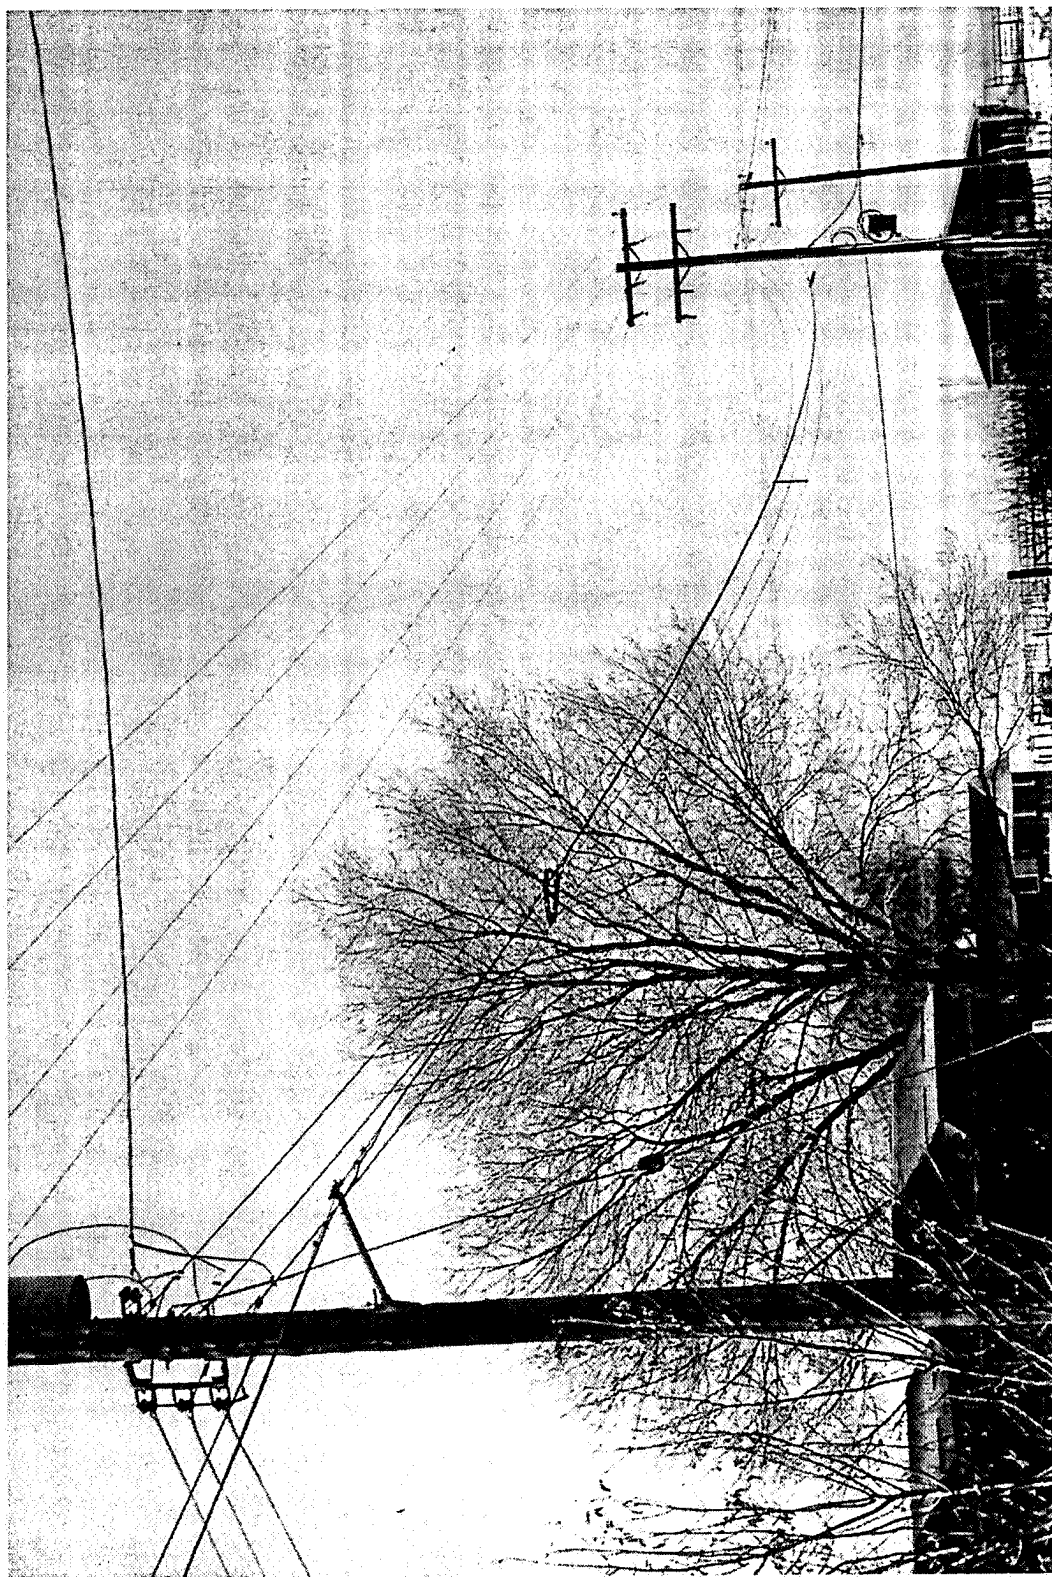
Pole # 11206002.0 175503 and 175505 on 02/25/2004. 400 S 4700 W, West Weber, UT

ComCast has placed strand and fiber in violation of NESC clearances and has created a very unsafe condition. A moderate wind will place ComCast in contact with PacifiCorp open wire secondary and energize the ComCast messenger. This eminent hazard will be corrected by PacifiCorp at ComCast expense.

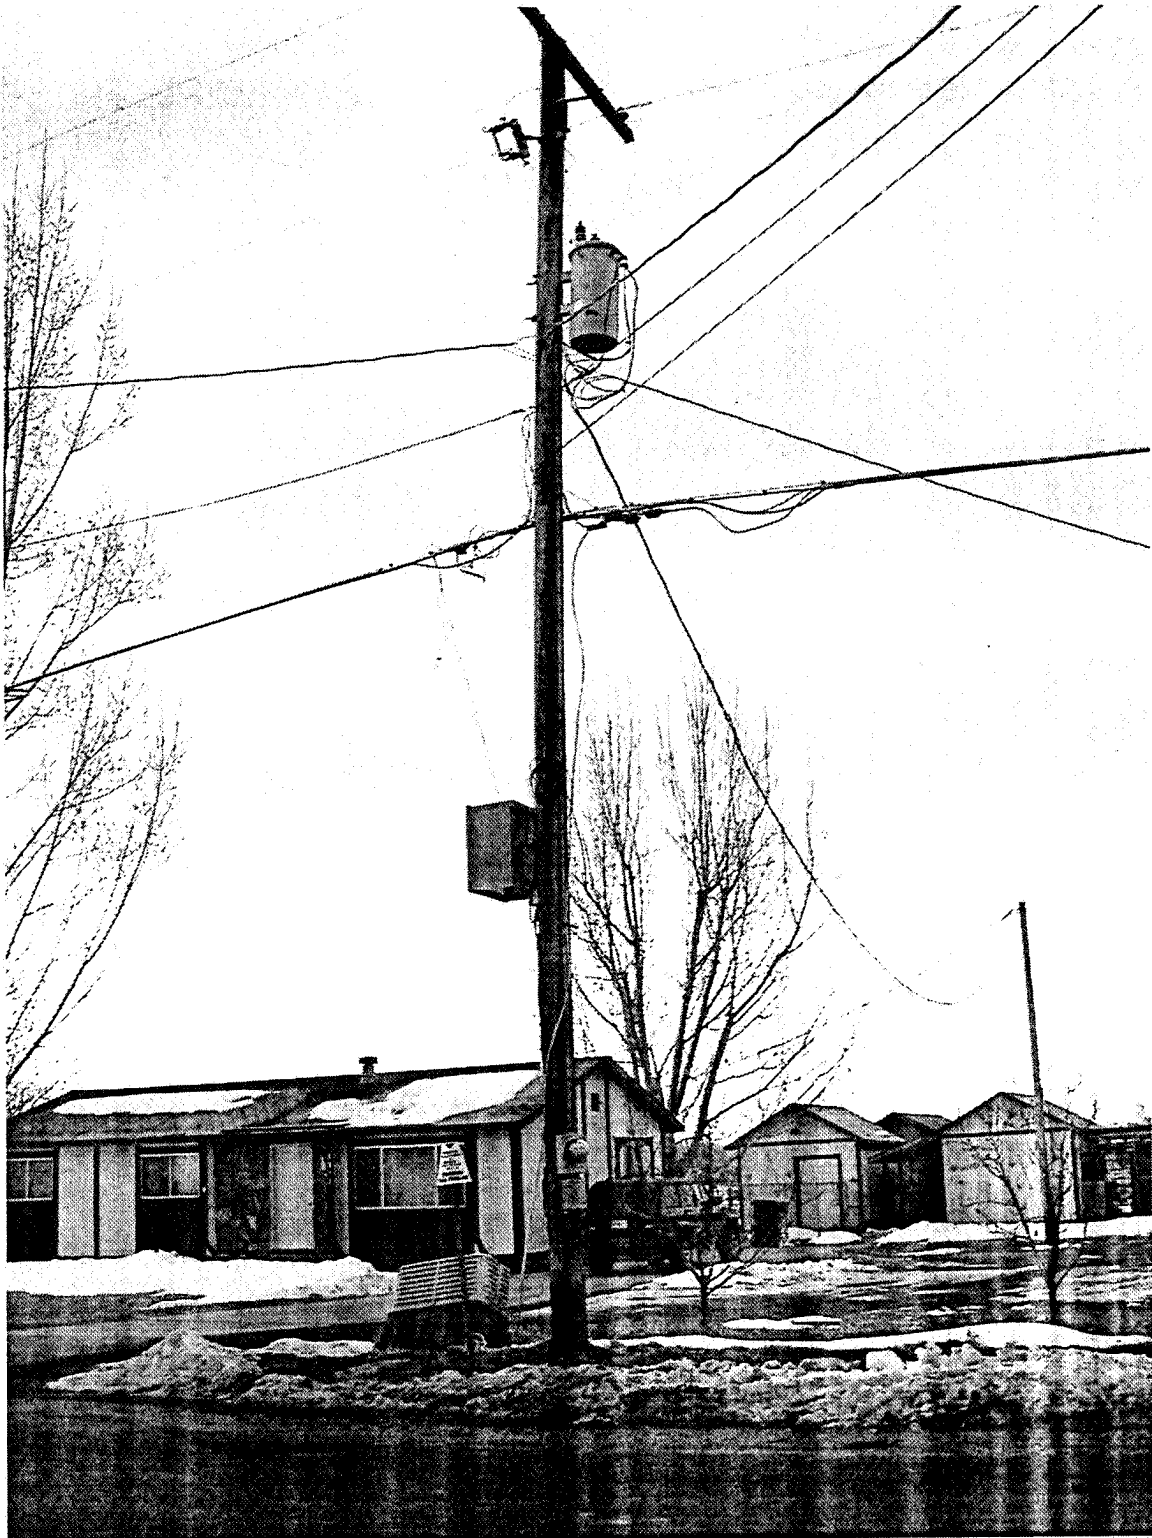
Pole 11206002.0 265405 on 2200 S., West Haven UT

Multiple 40" violations, unsecured cable down pole and laying on ground to ground mounted pedestal falling in ditch. Power supply does not meet minimum ground clearances. One service over road does not meet roadway clearances, and all three services create 40" violations on the service poles they contact.
