PC 4.2

From: Lund, Brian [Brian.Lund@PacifiCorp.com]
Sent: Thursday, February 26, 2004 5:38 PM
To: Johnson, Janet
Subject: West Weber ComCast 400 S 4700 W Violation.doc

West Weber
ComCast 400 S 4700

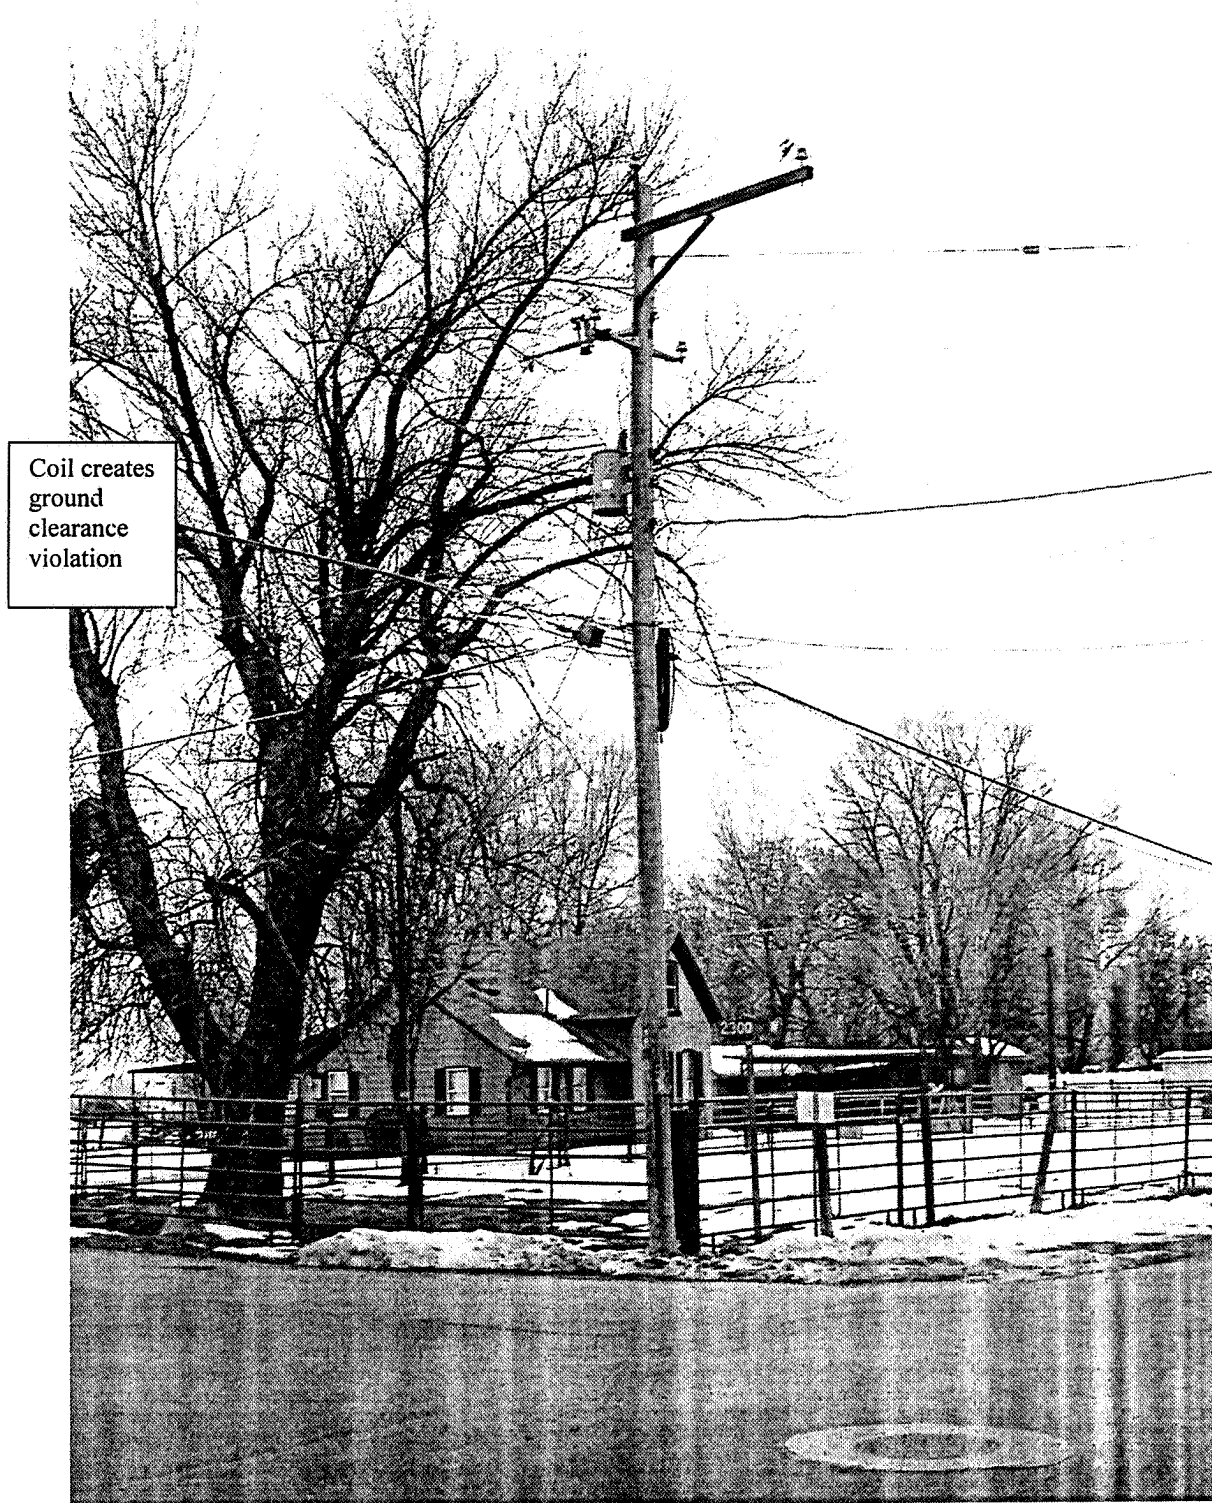
Pole 11206002.0 264405 2200 S and 2300 W, West Haven UT, temp coil creates ground clearance violation.

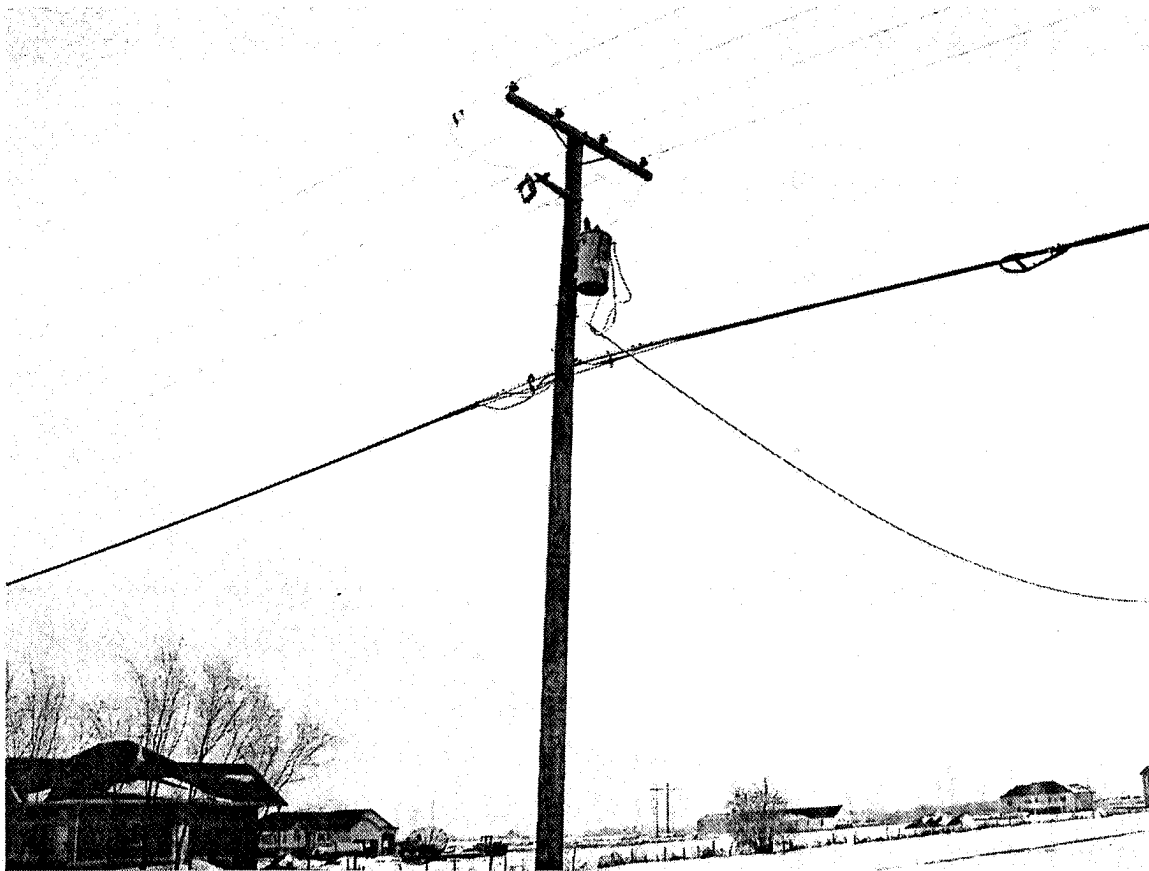
Pole 11206002.0 279502 40" violation, ComCast did not perform make ready when placing new cable.

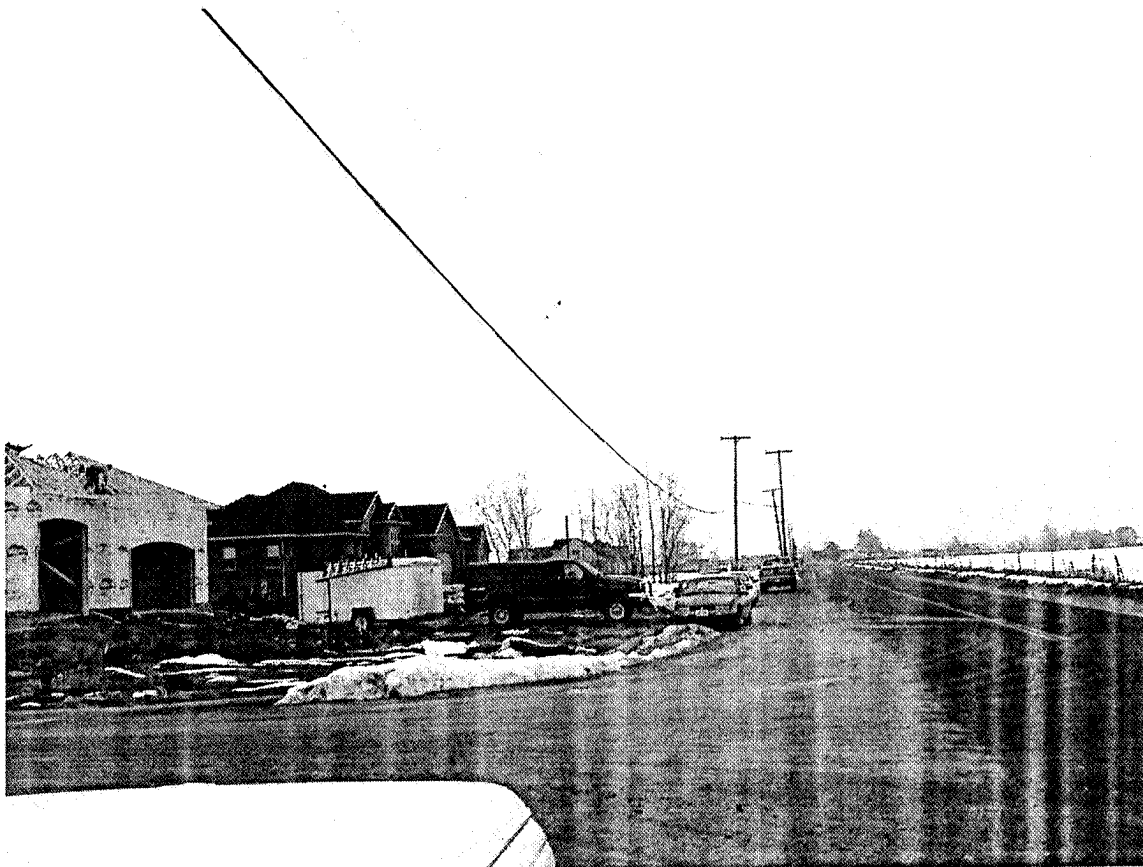
Pole 11206002.0 279506 to 279507 on 2700 W, ground clearance violation, ComCast did not perform make ready prior to lashing new cable.

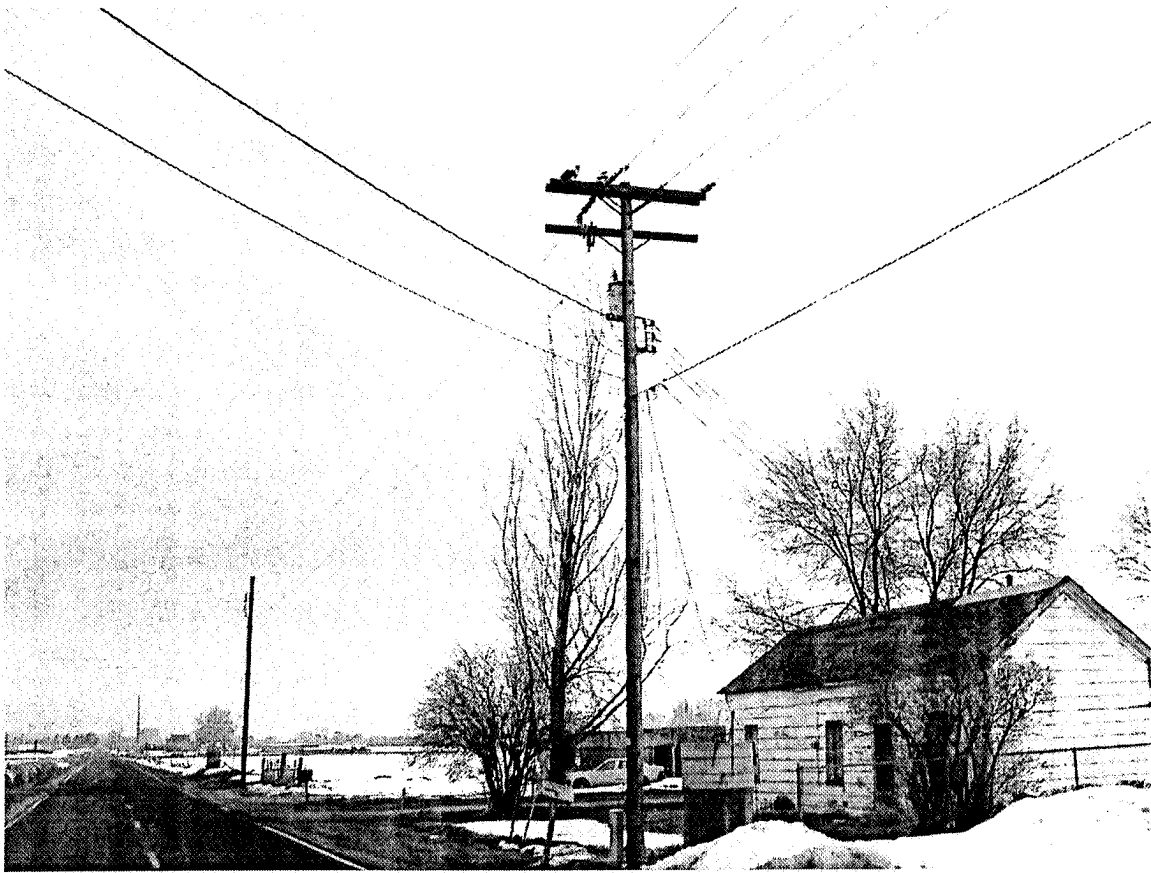
Pole 11206002.0 279200 on 2700 W, 40" violation not corrected when placing new cable, unsecured drops hanging down pole.

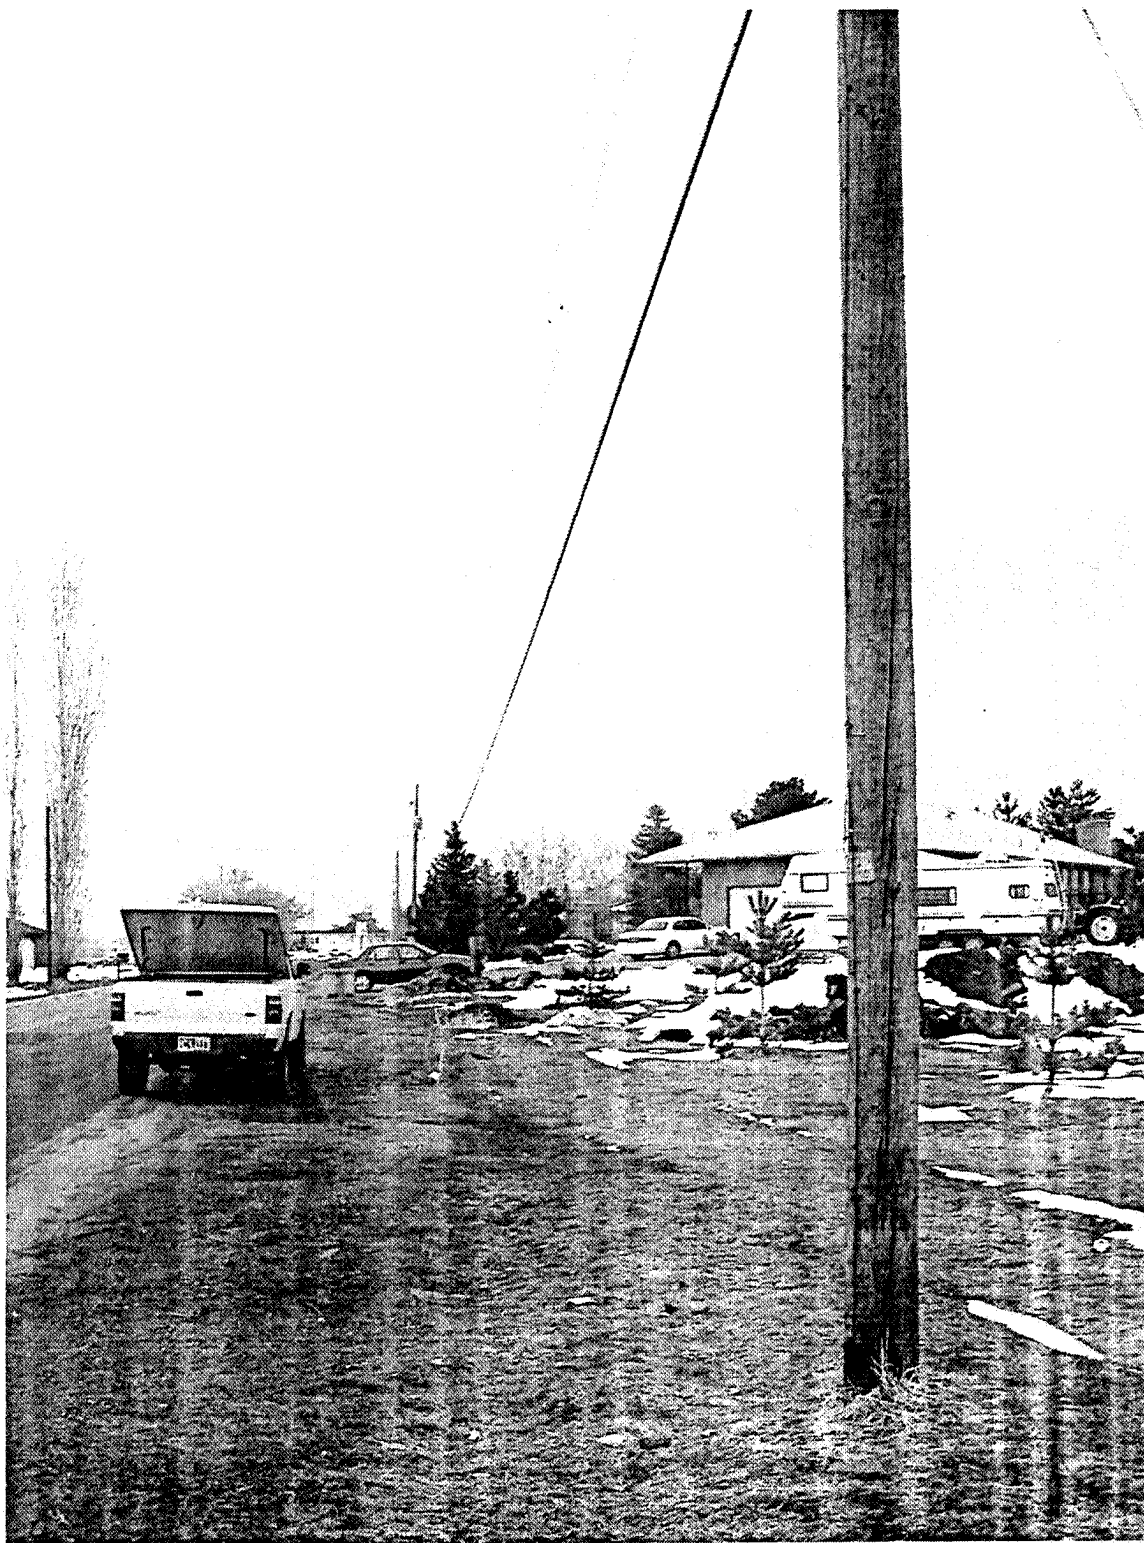
Pole 11206002.0 260500 to 260502 2200 S near 2700 W, low ground clearance (12' 4") not corrected when placing new cable. See next picture also.

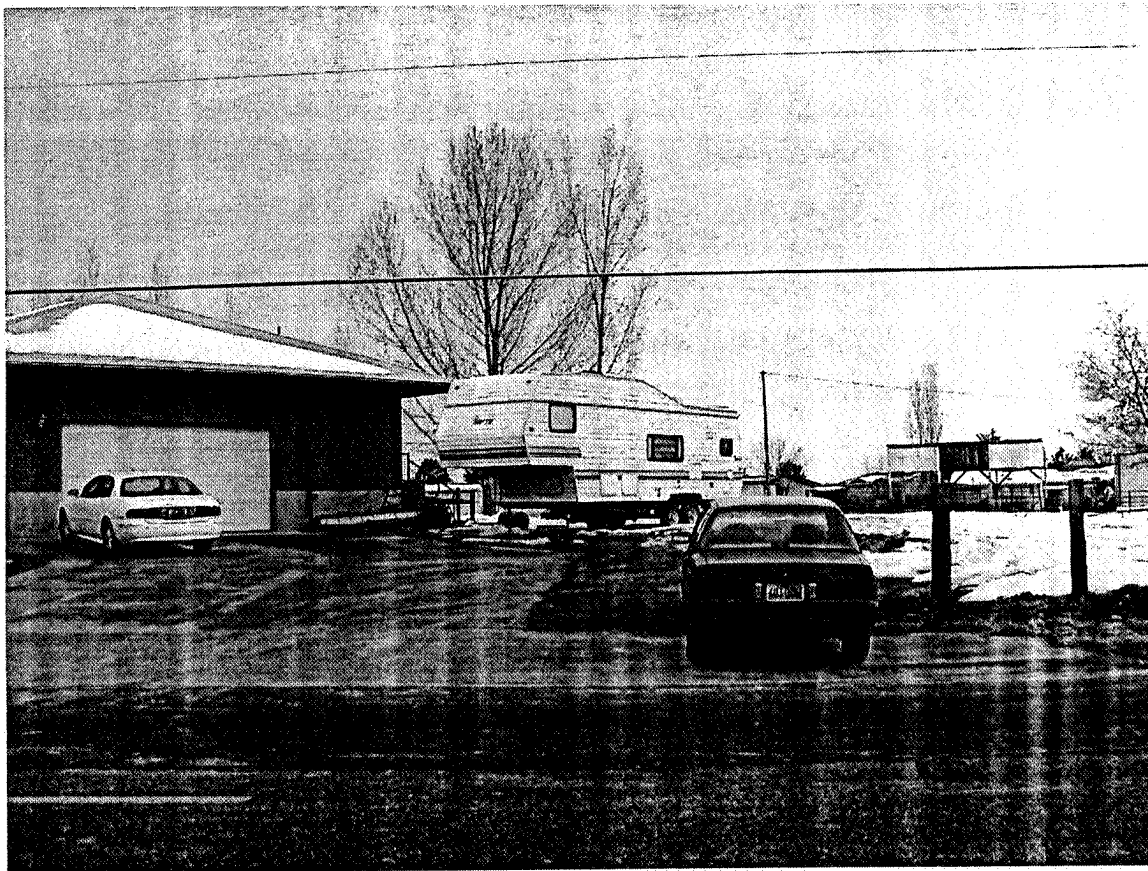
Pole 11206002.0 260500 to 260502, inadequate ground clearance., no make ready prior to placing additional cable.

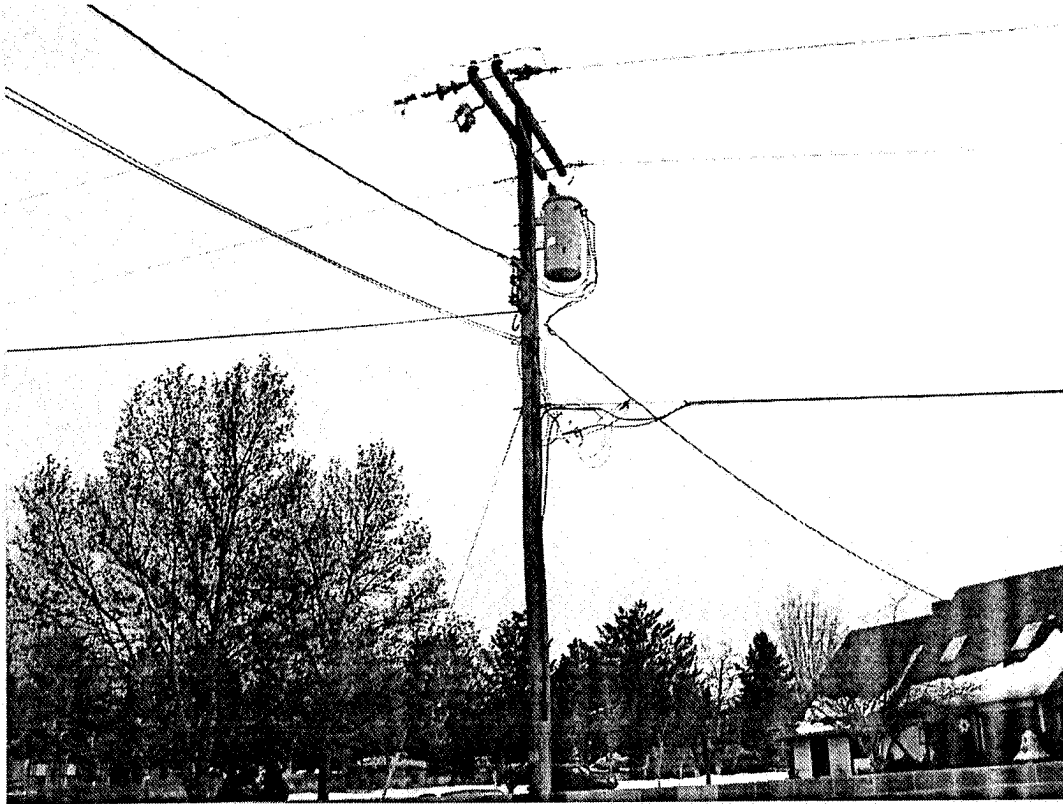
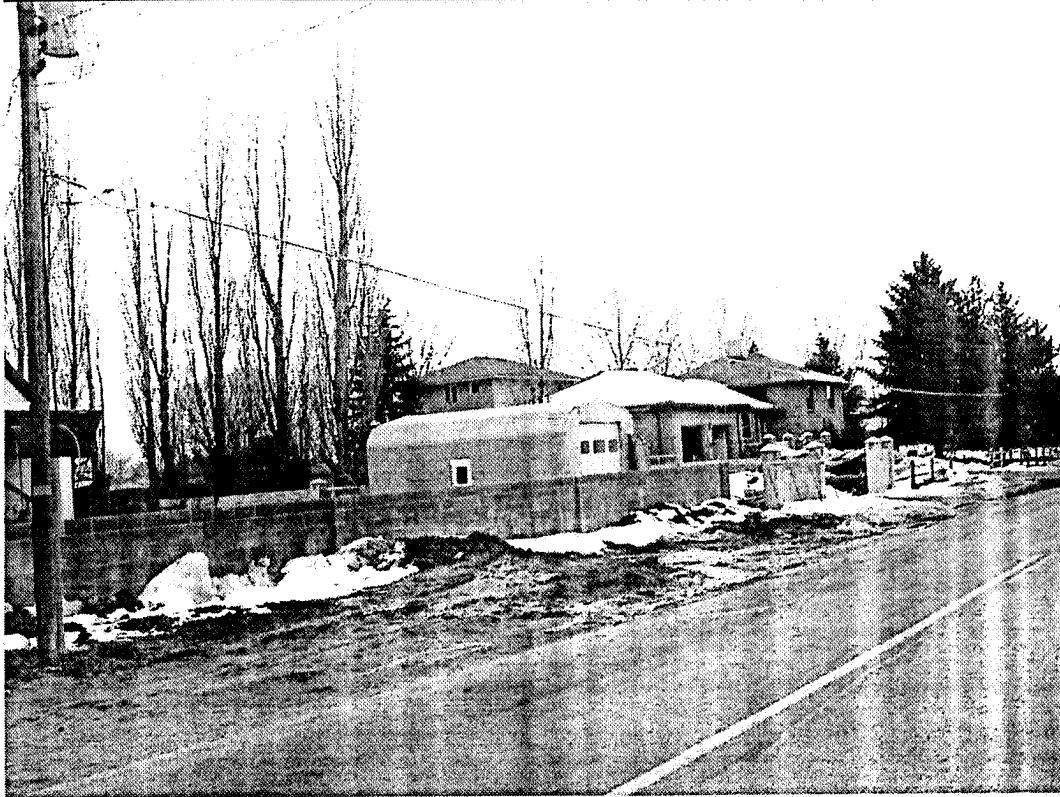
Pole 11206002.0 263403 on 2200 S. 40" violation, inadequate ground clearance to the west. Cannot maintain 40" and height of drops over roadway. No make ready requested or performed by ComCast.

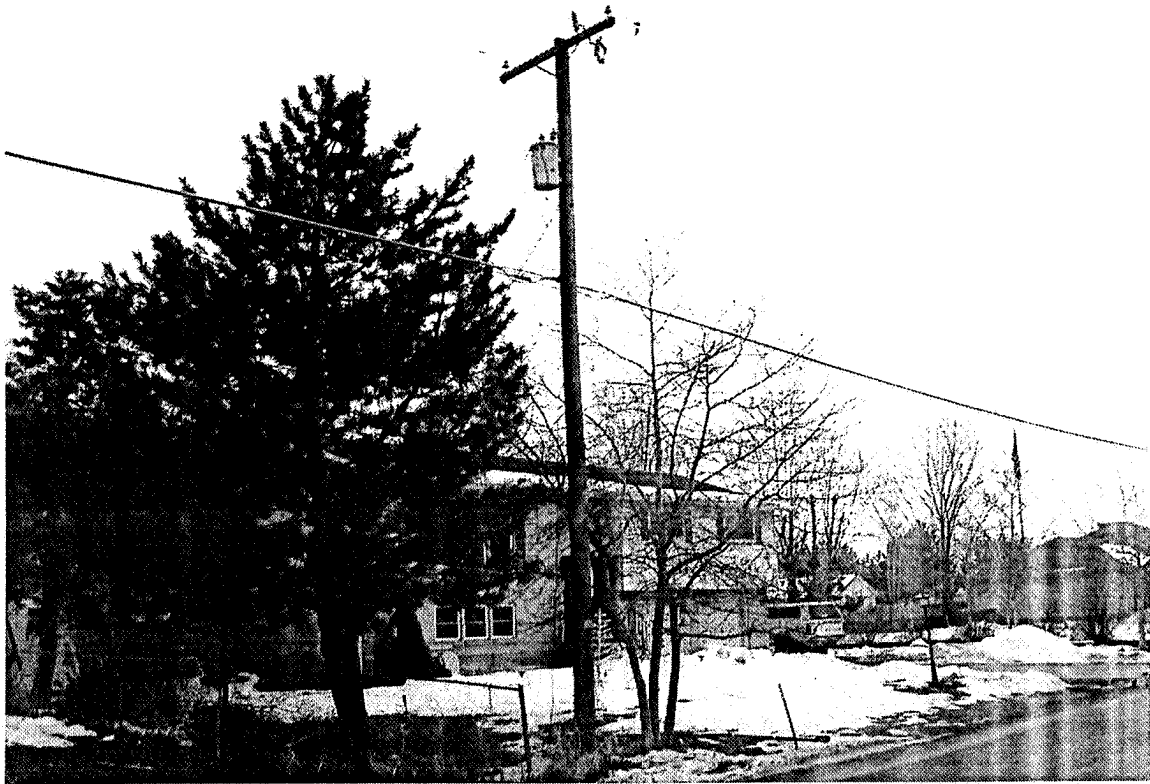
Pole 11206002.0 263400 on 2200 S, 40" violation, several drops hanging to ground unsecured down the pole.

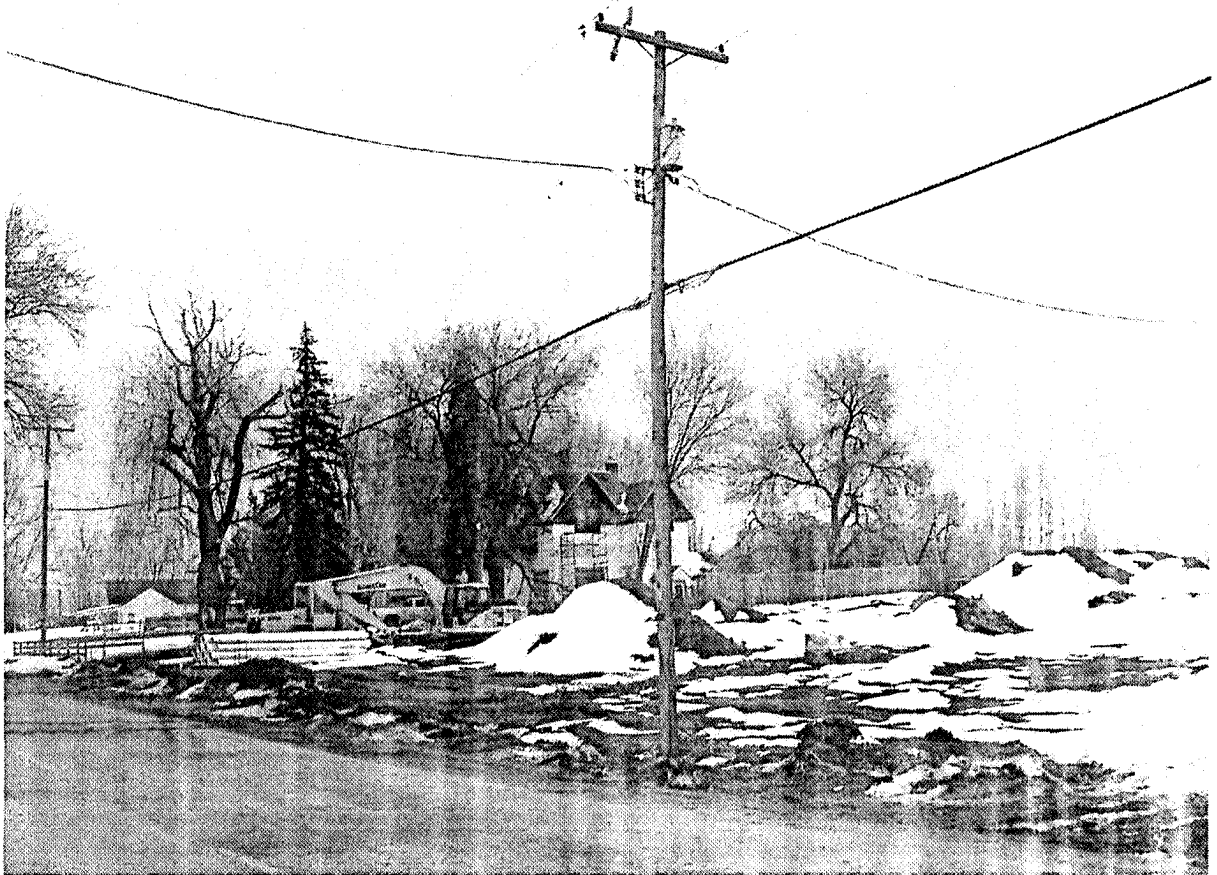
Pole 11206002.0 263406 on 2200 S, unsecured drops hanging down pole and laying on ground, hard to see in picture.

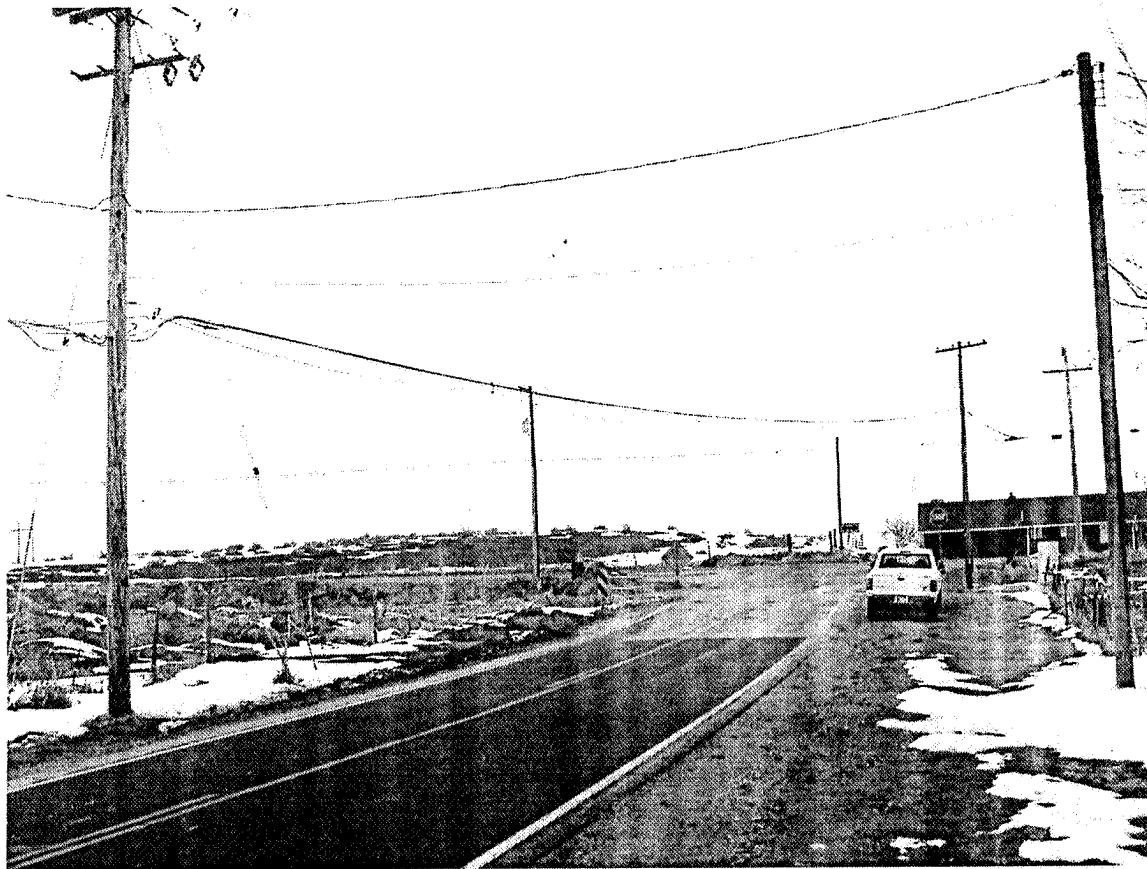
Pole 11206002.0 279904 to 260902 on 2700 W & 1800 S, New cable being placed without resolving existing road clearance violation. No make ready requested, secondary service needs to be raised so attachment can be raised for roadway clearance and maintain 40" clearance at pole. CATV also needs to place anchor and down-guy.

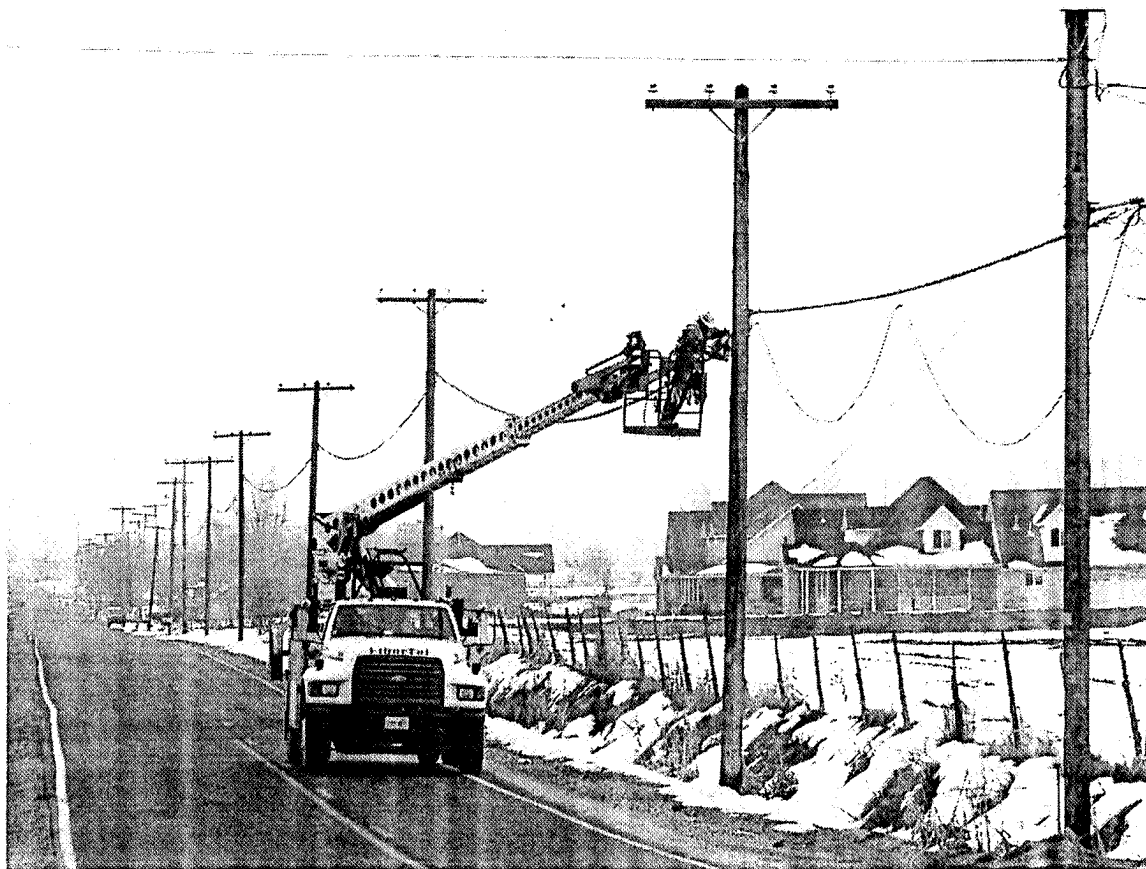
Communications work 2 spans south of Pole 11206002.0 279904, notice the stealth work area protection markers. Truck flashers were not in use either.

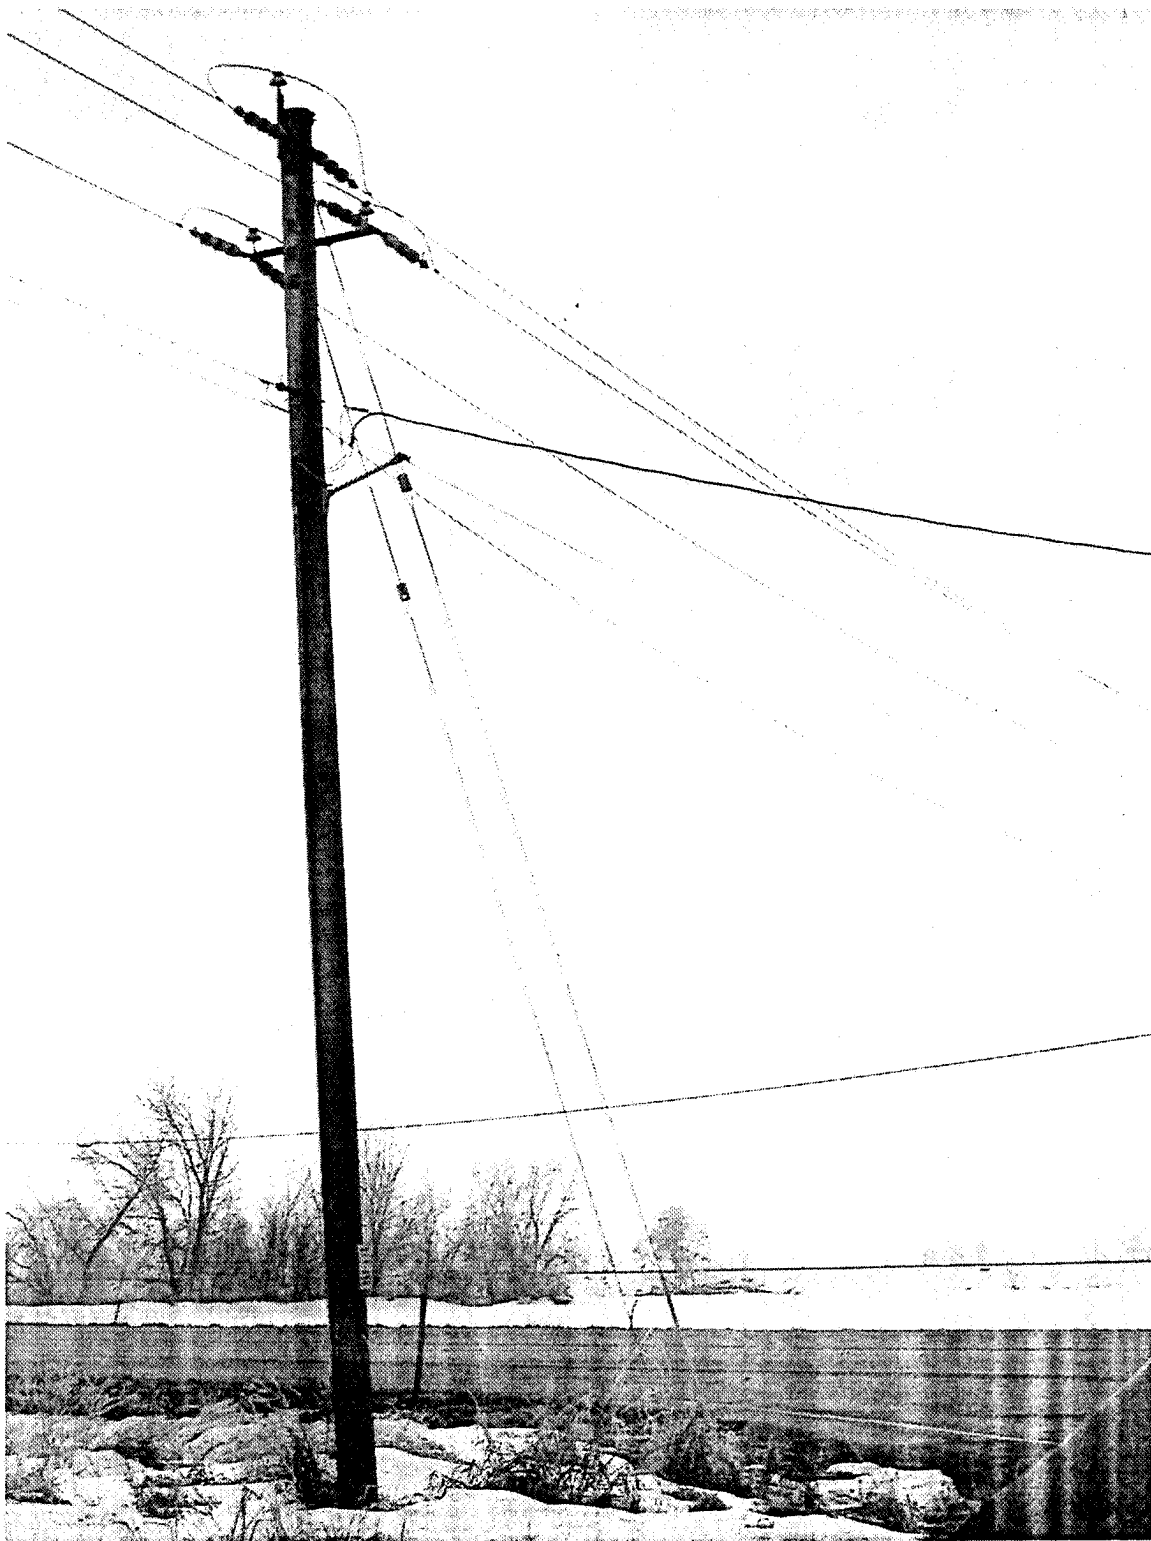
Pole 11206002.0 190901, 1200 S & 5900 W, ComCast stand off arm placed within 2" of lowest secondary. 40" violation, ComCast messenger also placed in violation of mid-span clearance to slack neutral across roadway to pole 190801 to the south. No make ready requested prior to ComCast creating violation.

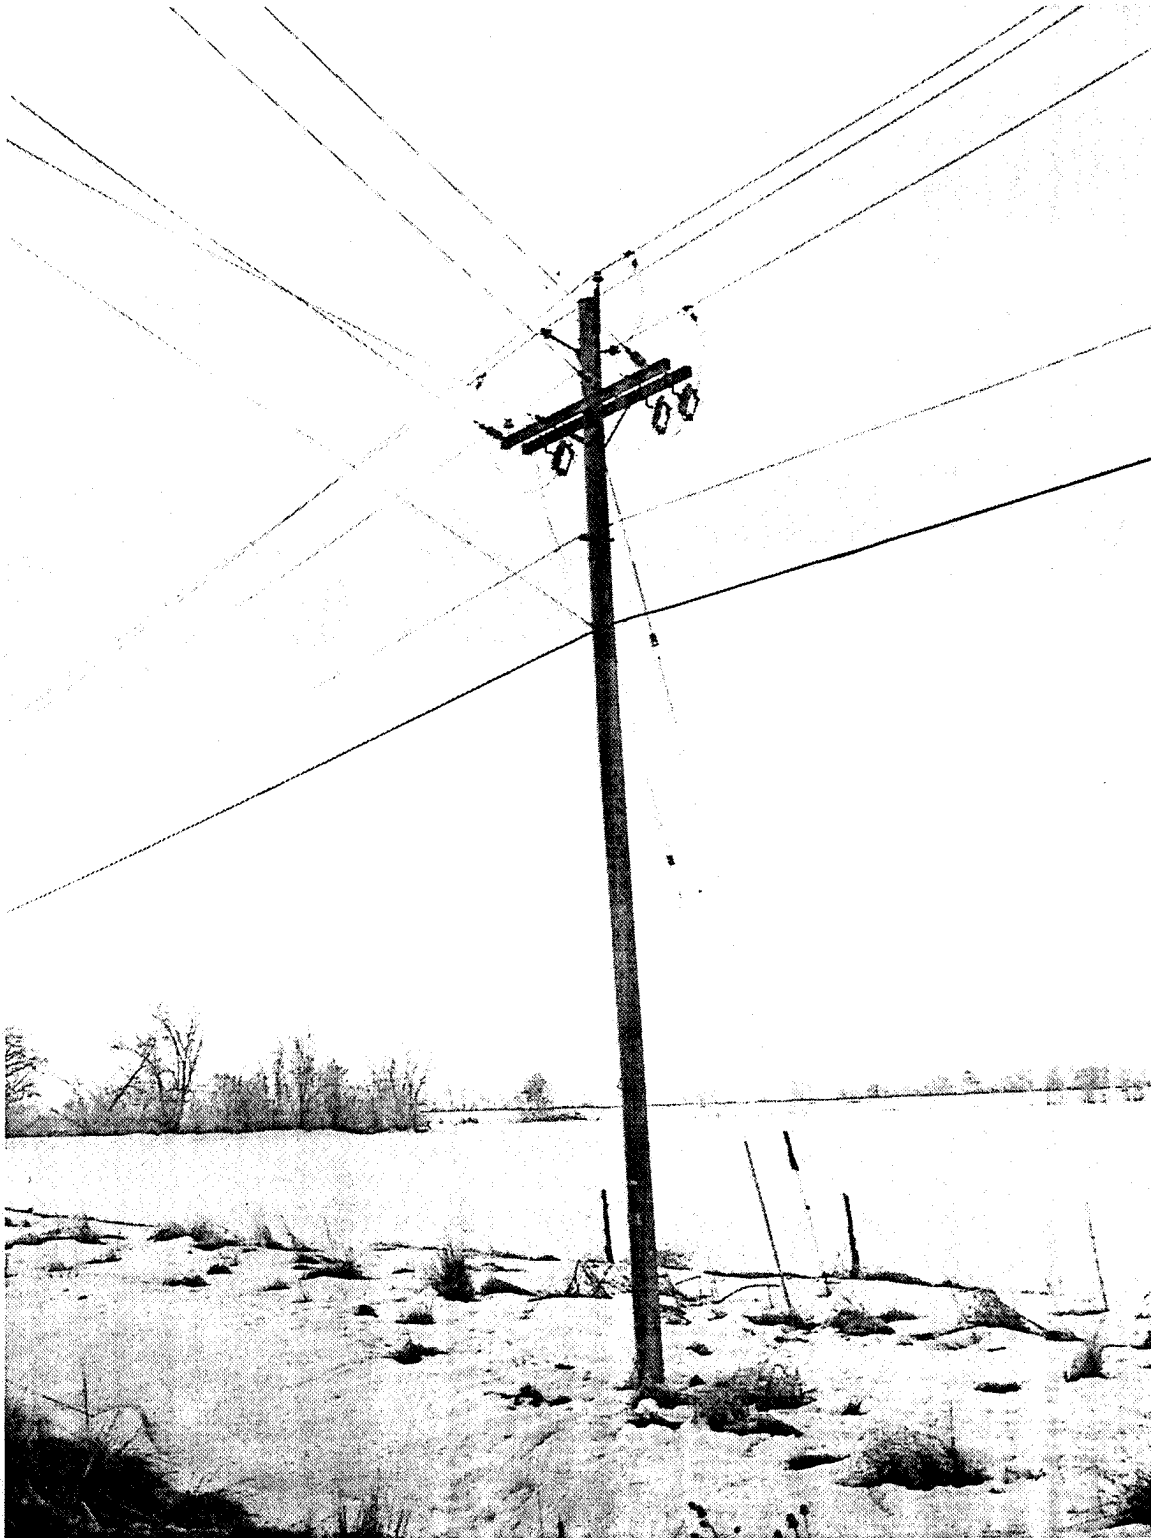
Pole 11206002.0 190801 1200 S & 5900 W, ComCast messenger placed in violation of clearance to PacifiCorp neutral. Neutral is slack and ComCast messenger will come in contact when wind blows. ComCast attachment on pole 190901 to the north is @ the same height as the lowest point of secondary. No make ready was requested.

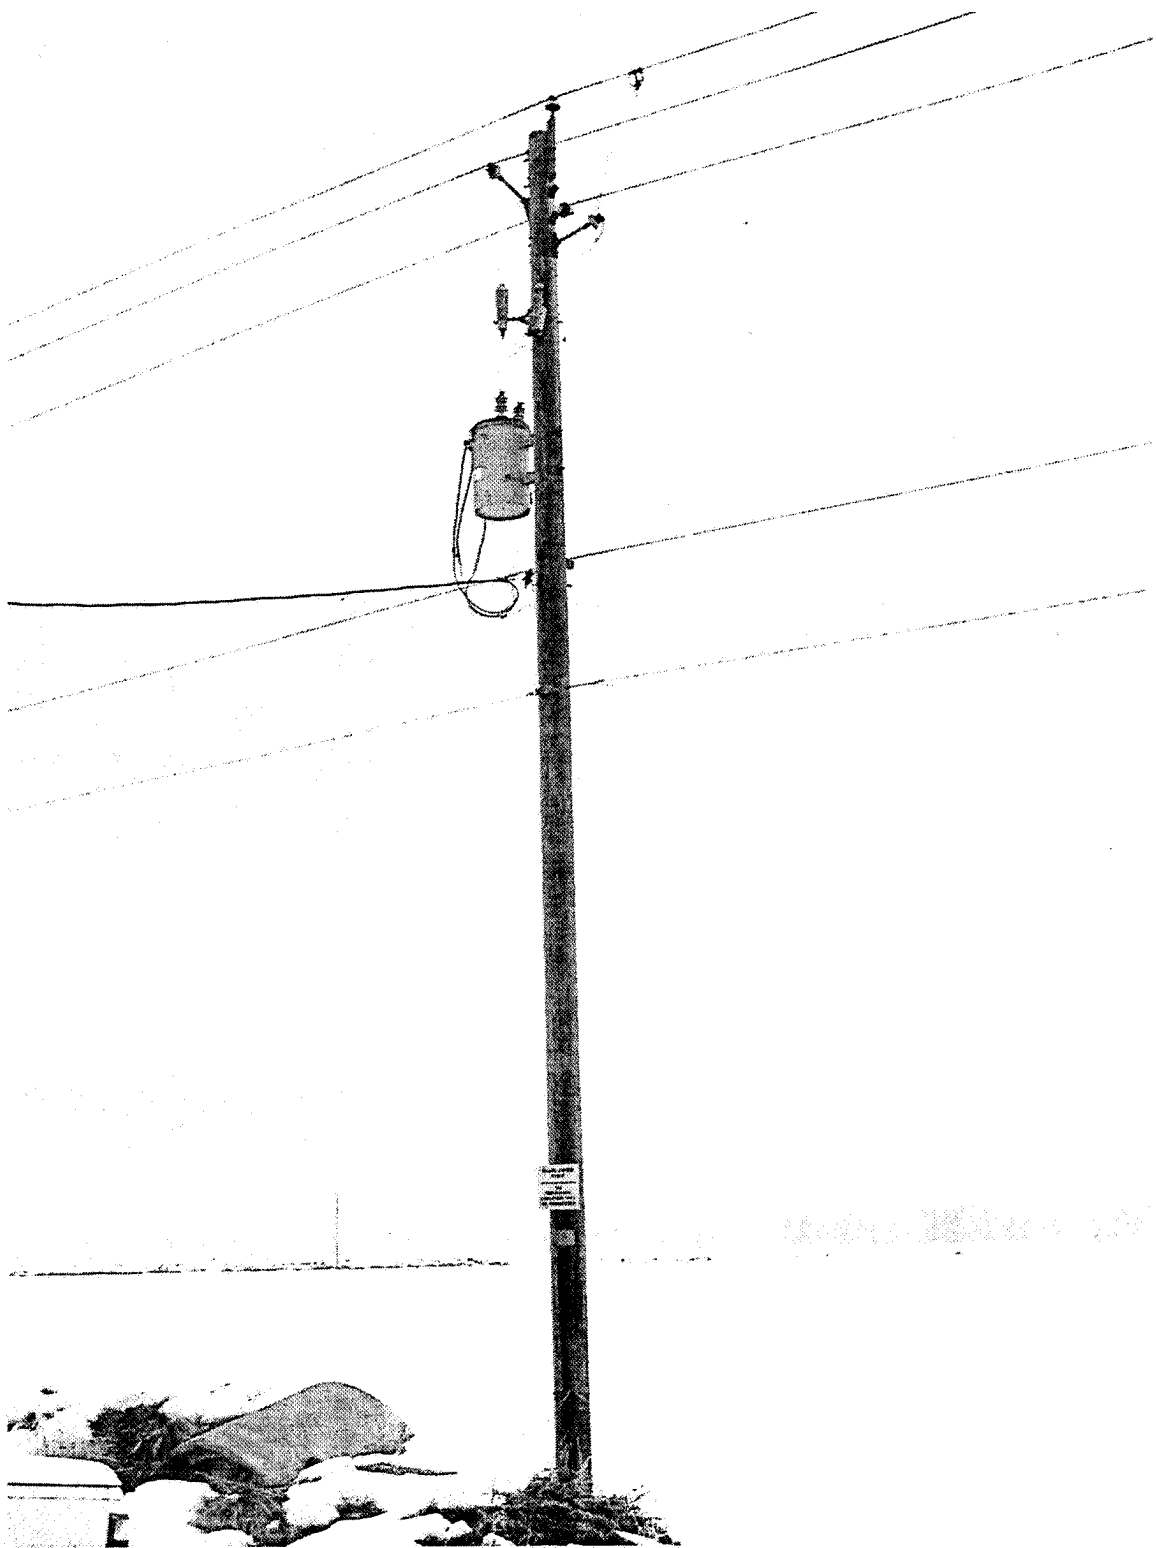
Pole 11206002.0 180201 on 5900 W, new messenger placed in 40" violation to secondary.

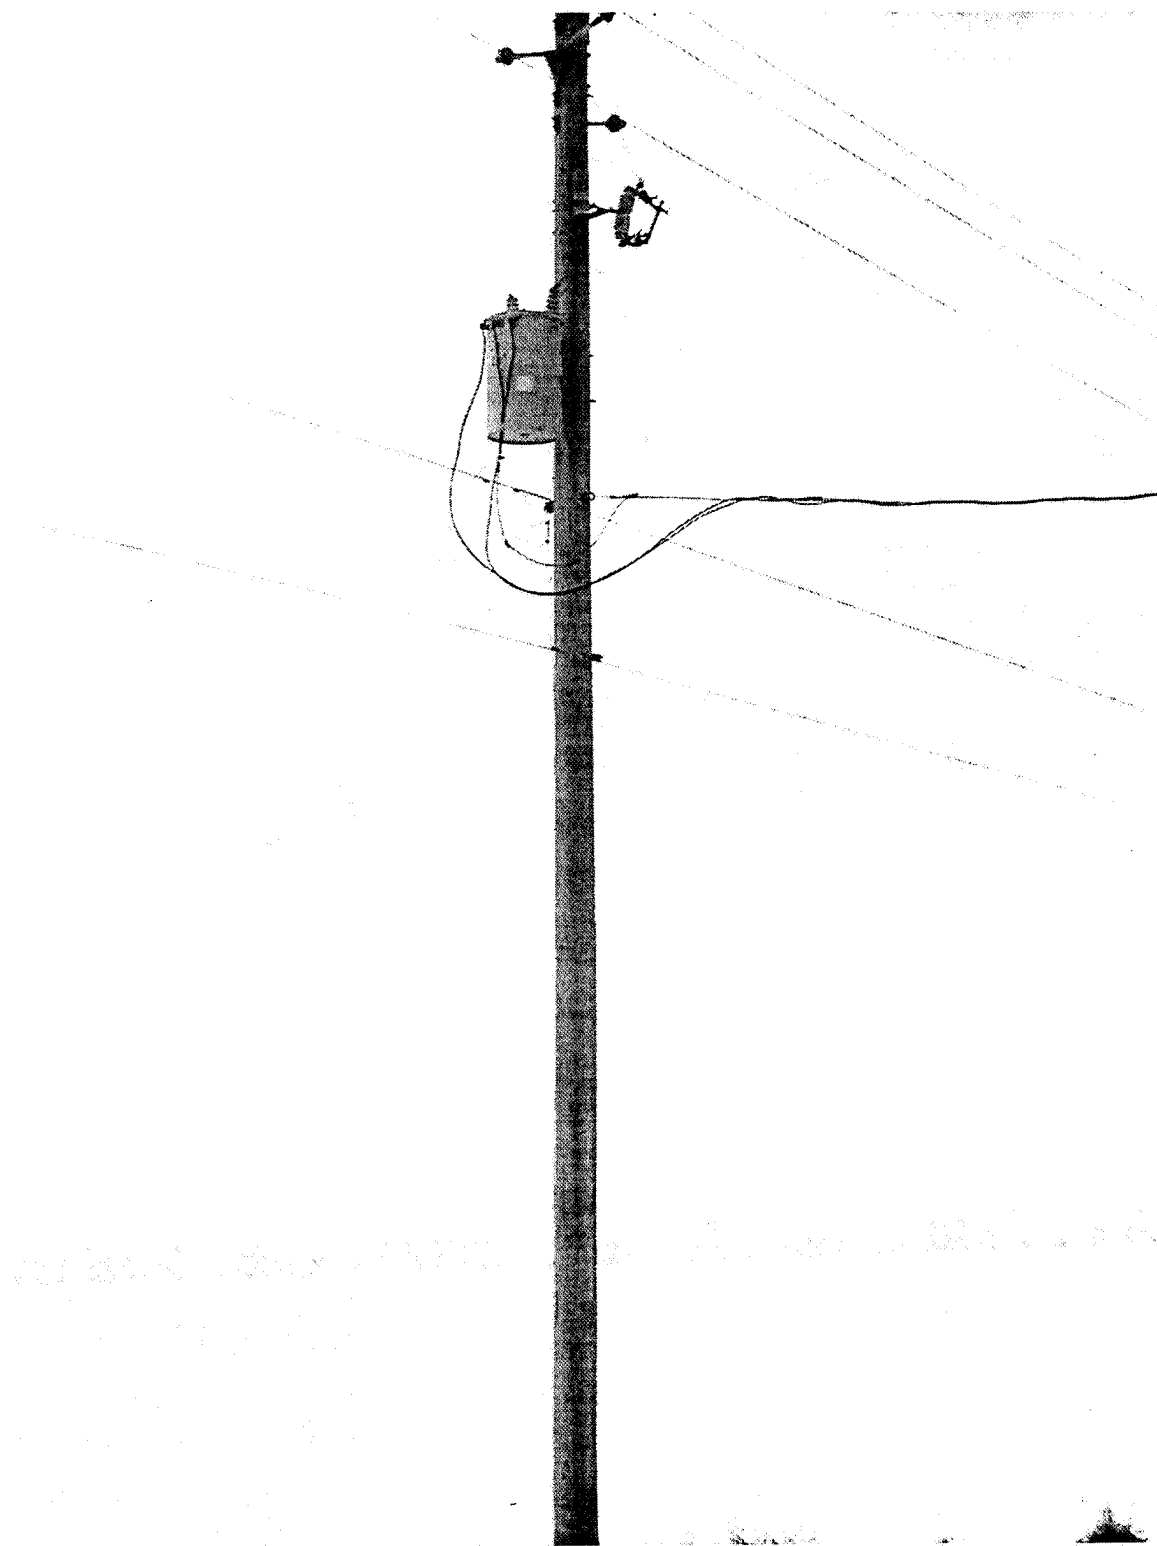
Pole 11206002.0 180301 on 5900 W, new messenger placed in 40" violation to secondary.
