Docket 07-035-08
Review of Dr. Richard Drake Complaint
against Rocky Mountain Power
Final Report

September 4, 2007

WCI *Williams Consulting, Inc.*

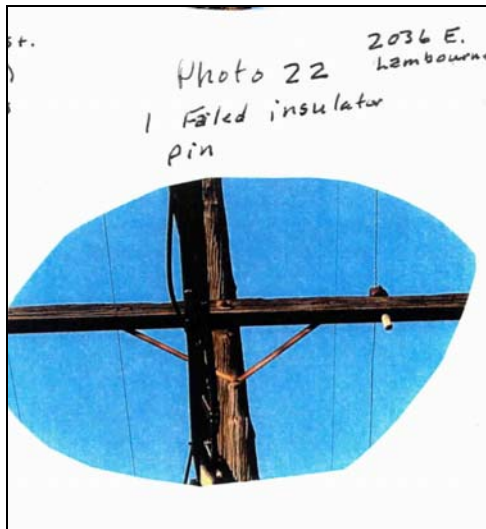
If photograph 22 provided by Dr. Drake (DR 0..3 – Lambourne Photographs), which claims "1 failed insulator pin," is the photograph described in the letter, the insulator is indeed a squatter, but the angle of the pin and the insulator clearly shows that the pin/insulator interface is intact. The entire pin is tilted likely due to elongation and wear in the drilled hole in the crossarm. This does not indicate a "floater" since the insulator is still held securely. A copy of the subject photo follows:
