# Powerdale Damage Assessment

November 14, 2006

## 2 - Powerdale Flood Damage 11/9/2006

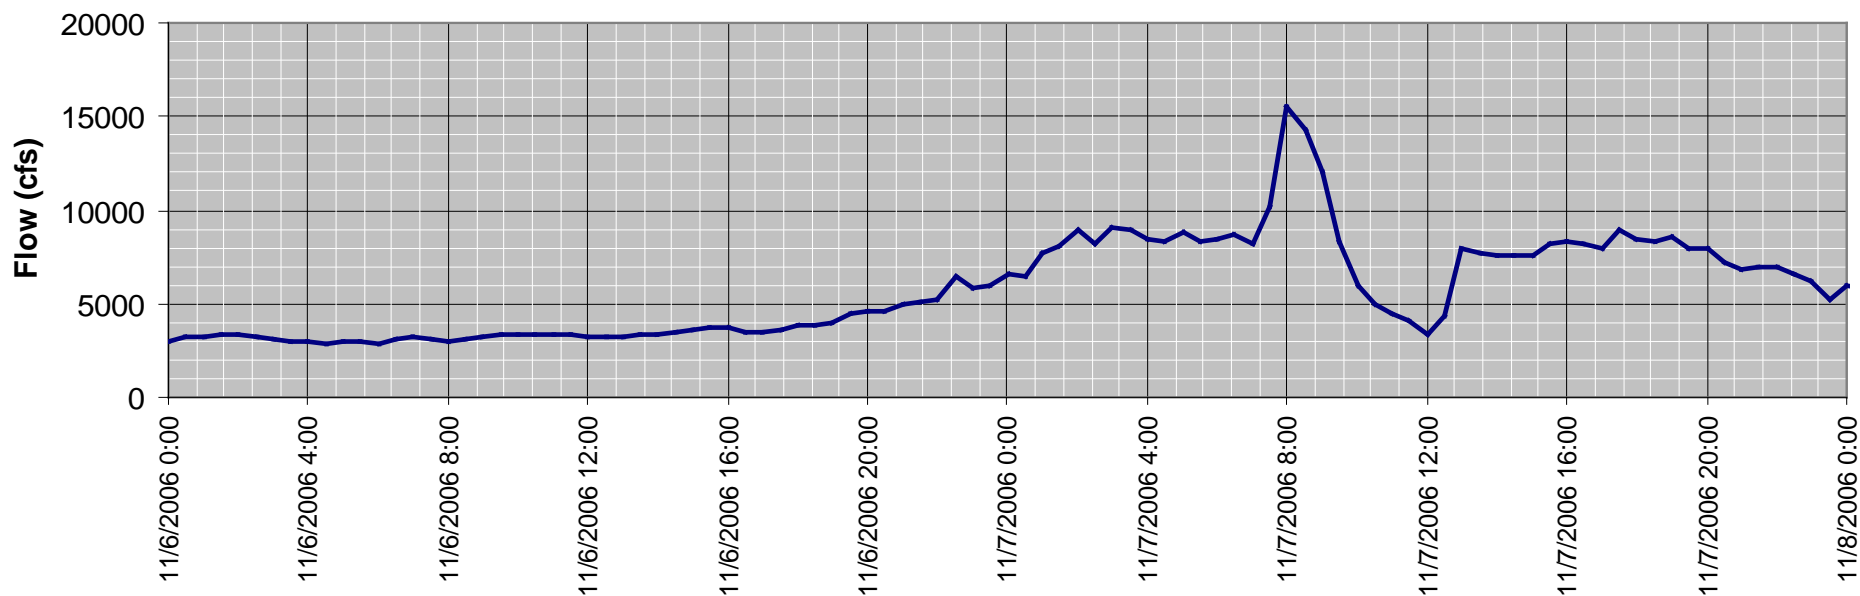
### Hood River at Tucker Bridge (USGS)

Based on Provisional Data. Gaging equipment suffered some malfunction during this event so hydrograph likely does not resemble rising limb. USGS is in the process of reconstructing this event.

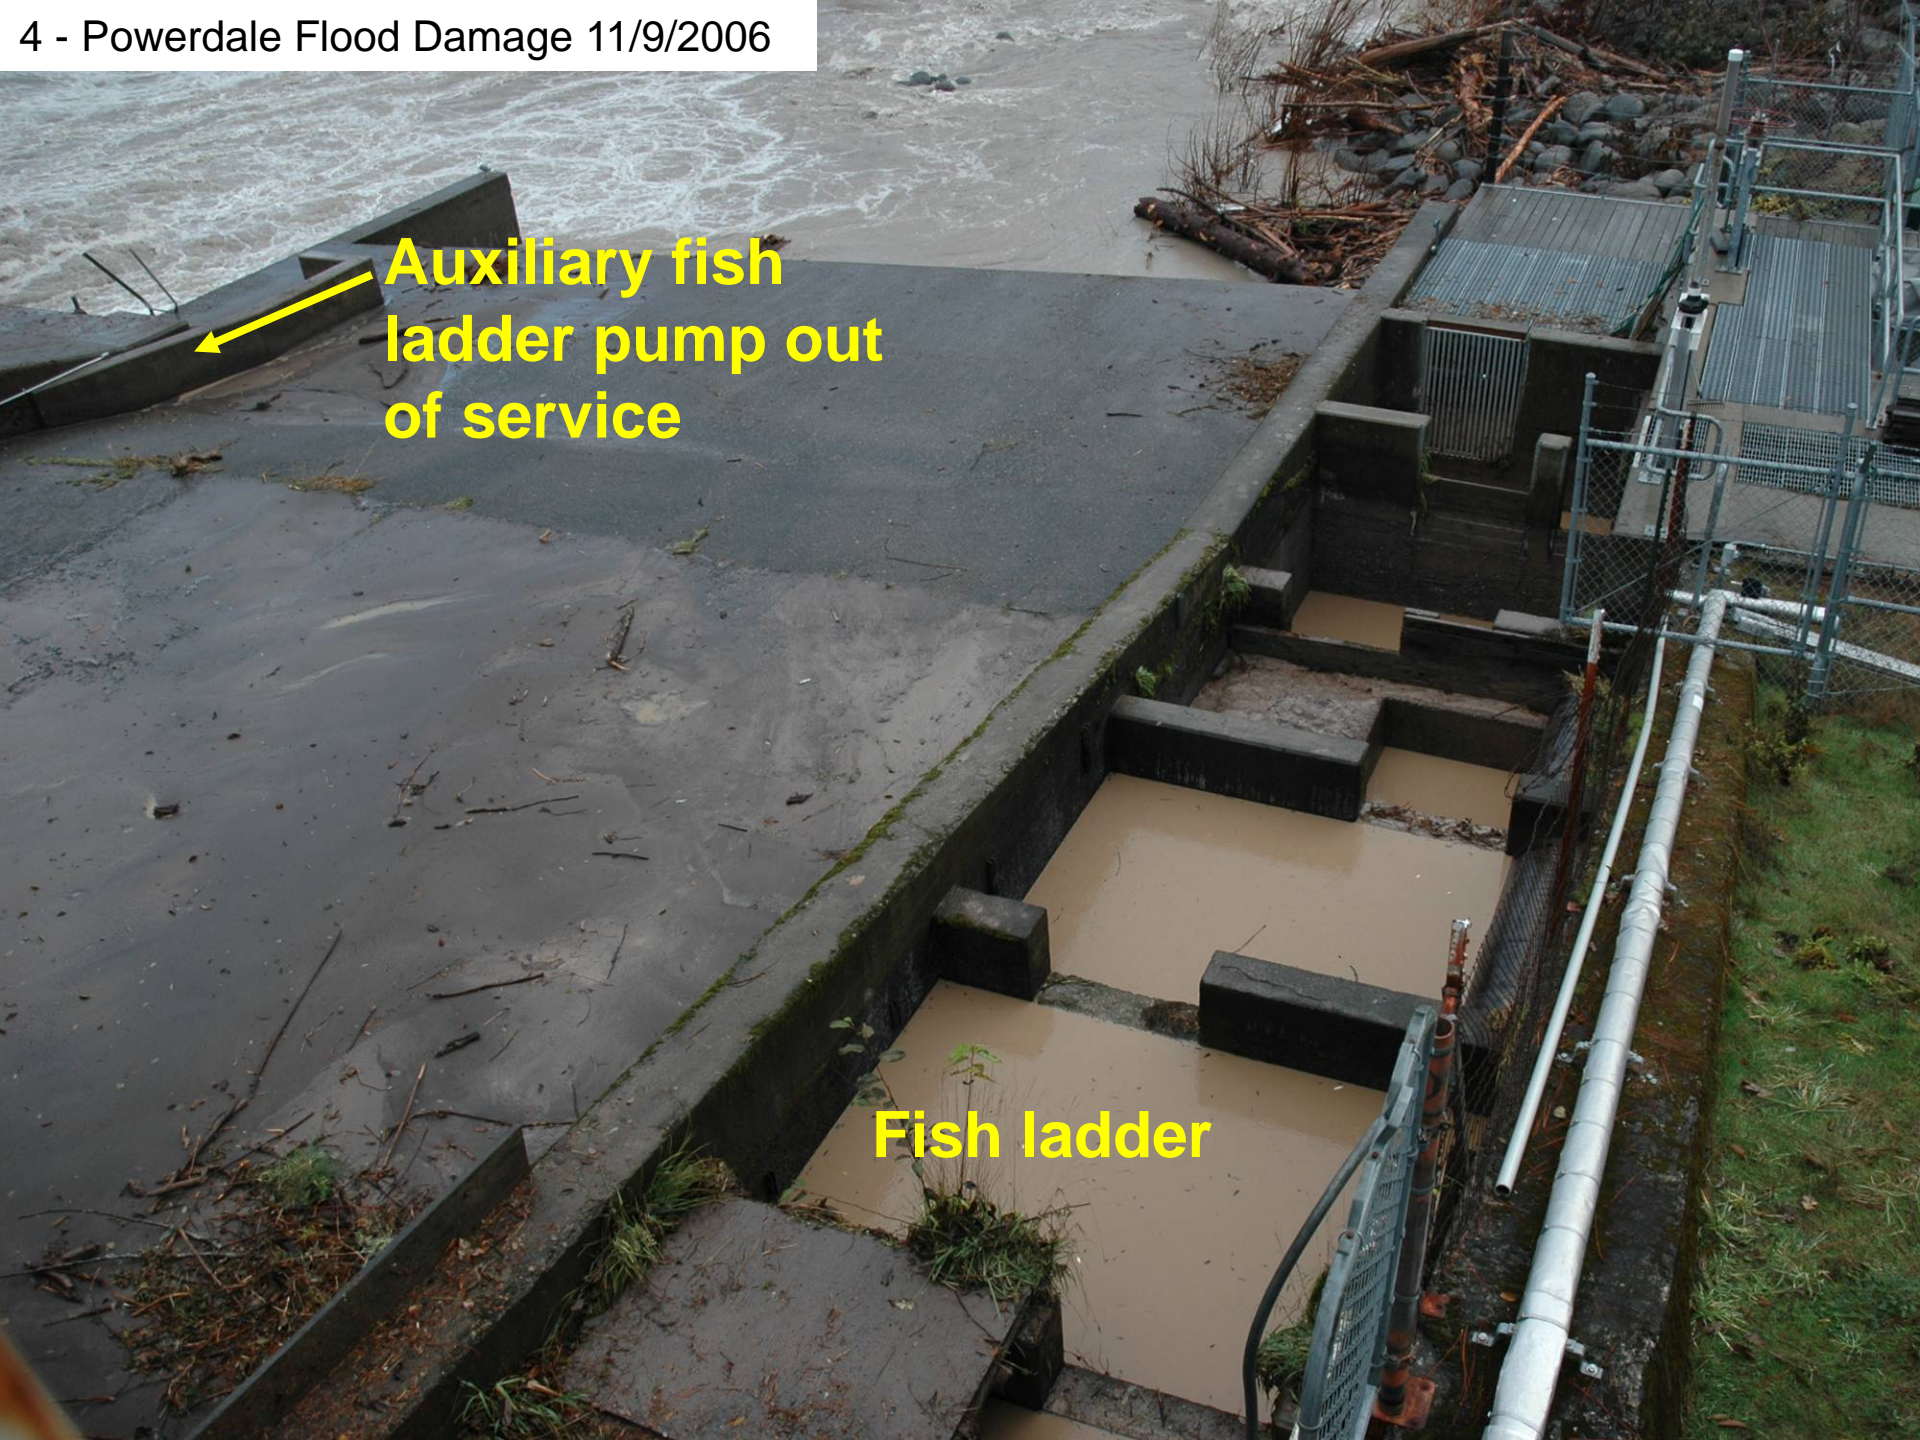
**Auxiliary fish  
ladder pump out  
of service**

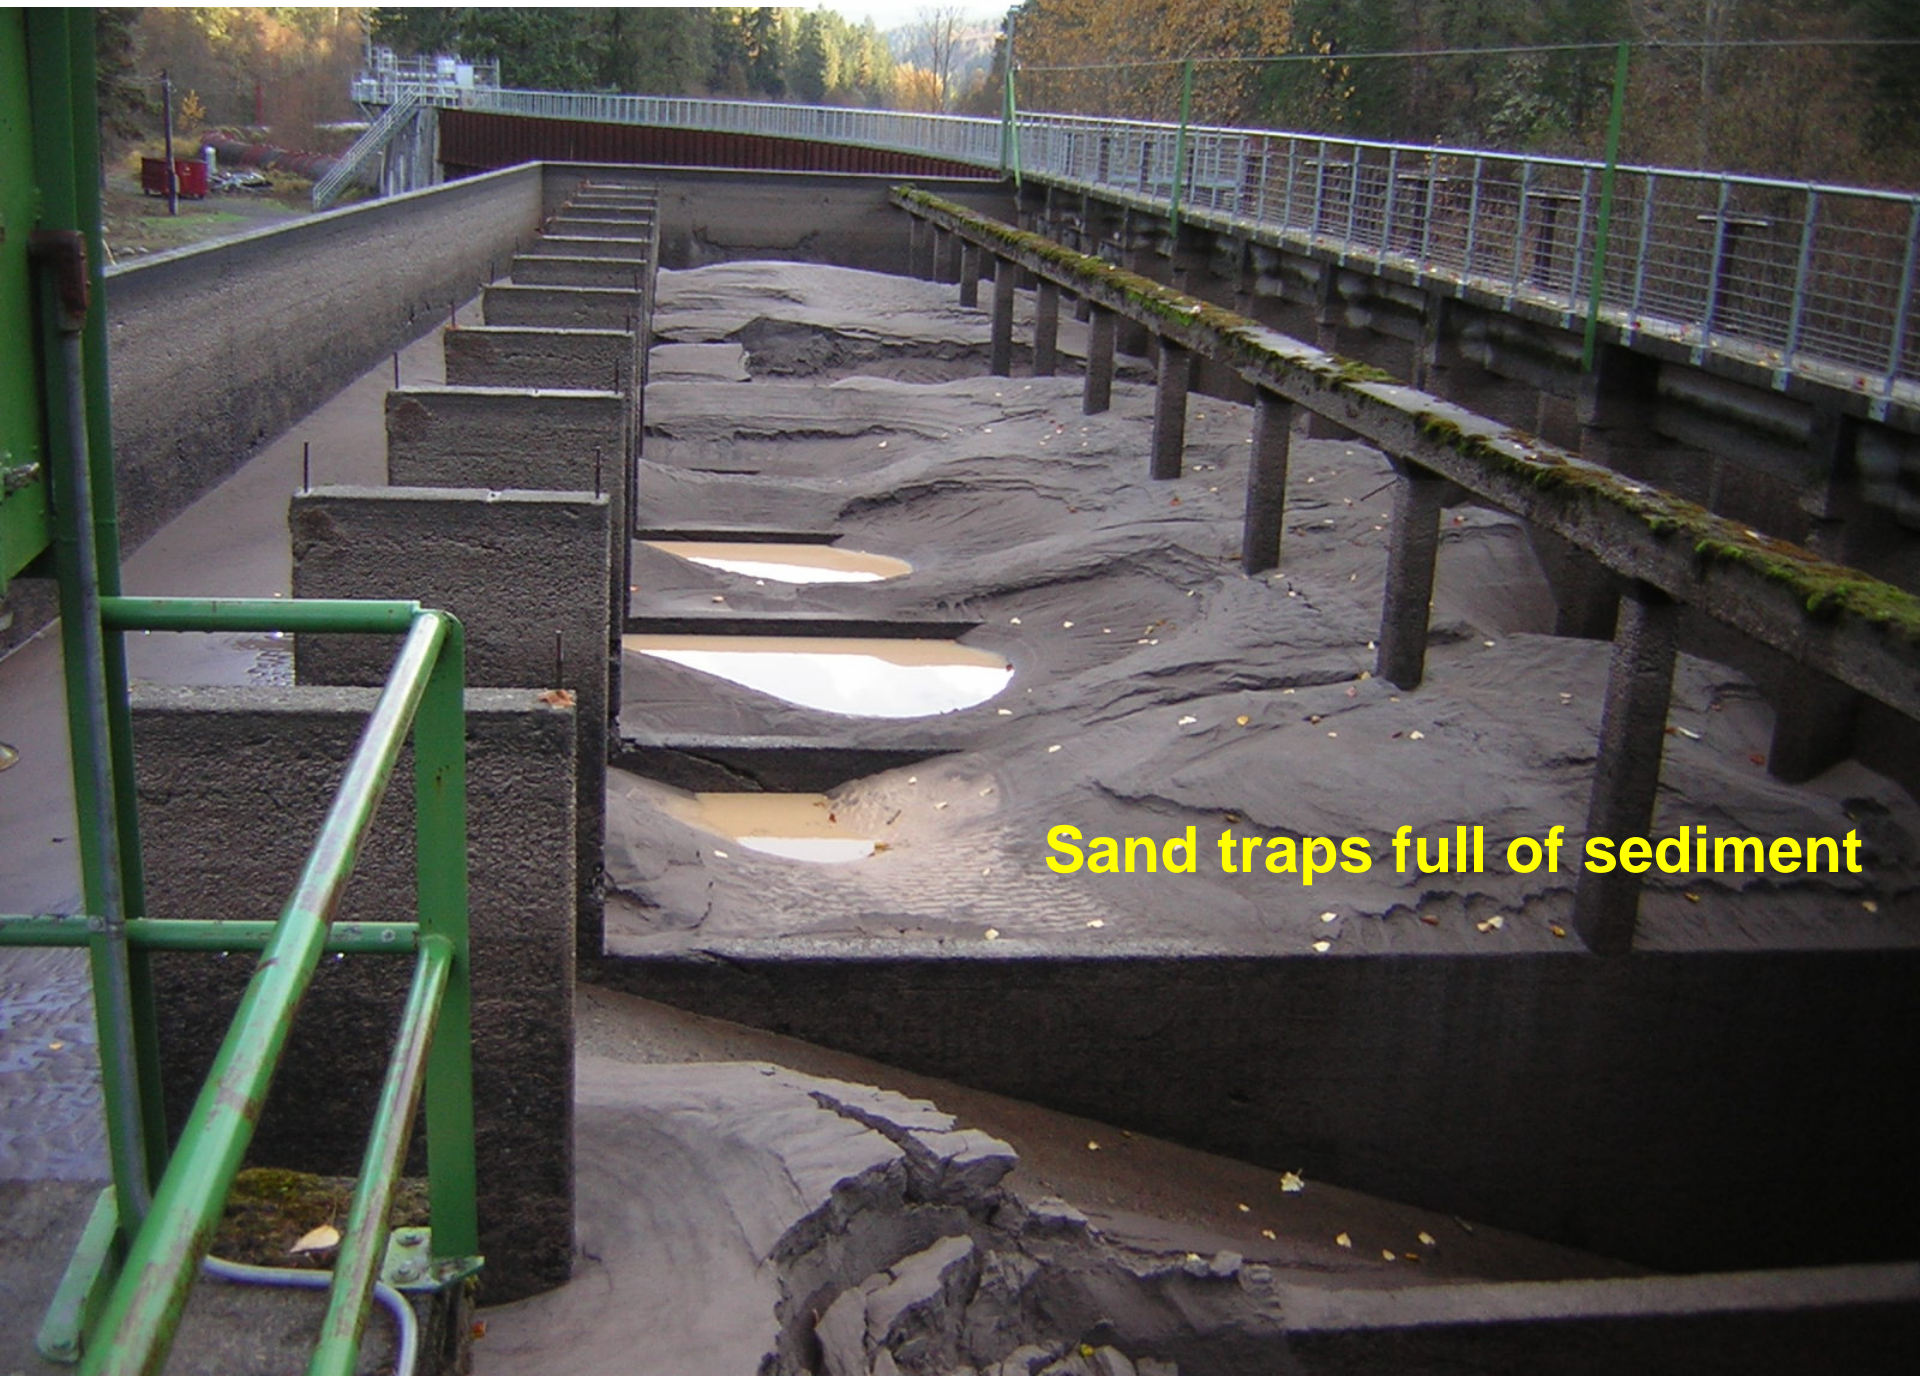
**Sand traps full of sediment**

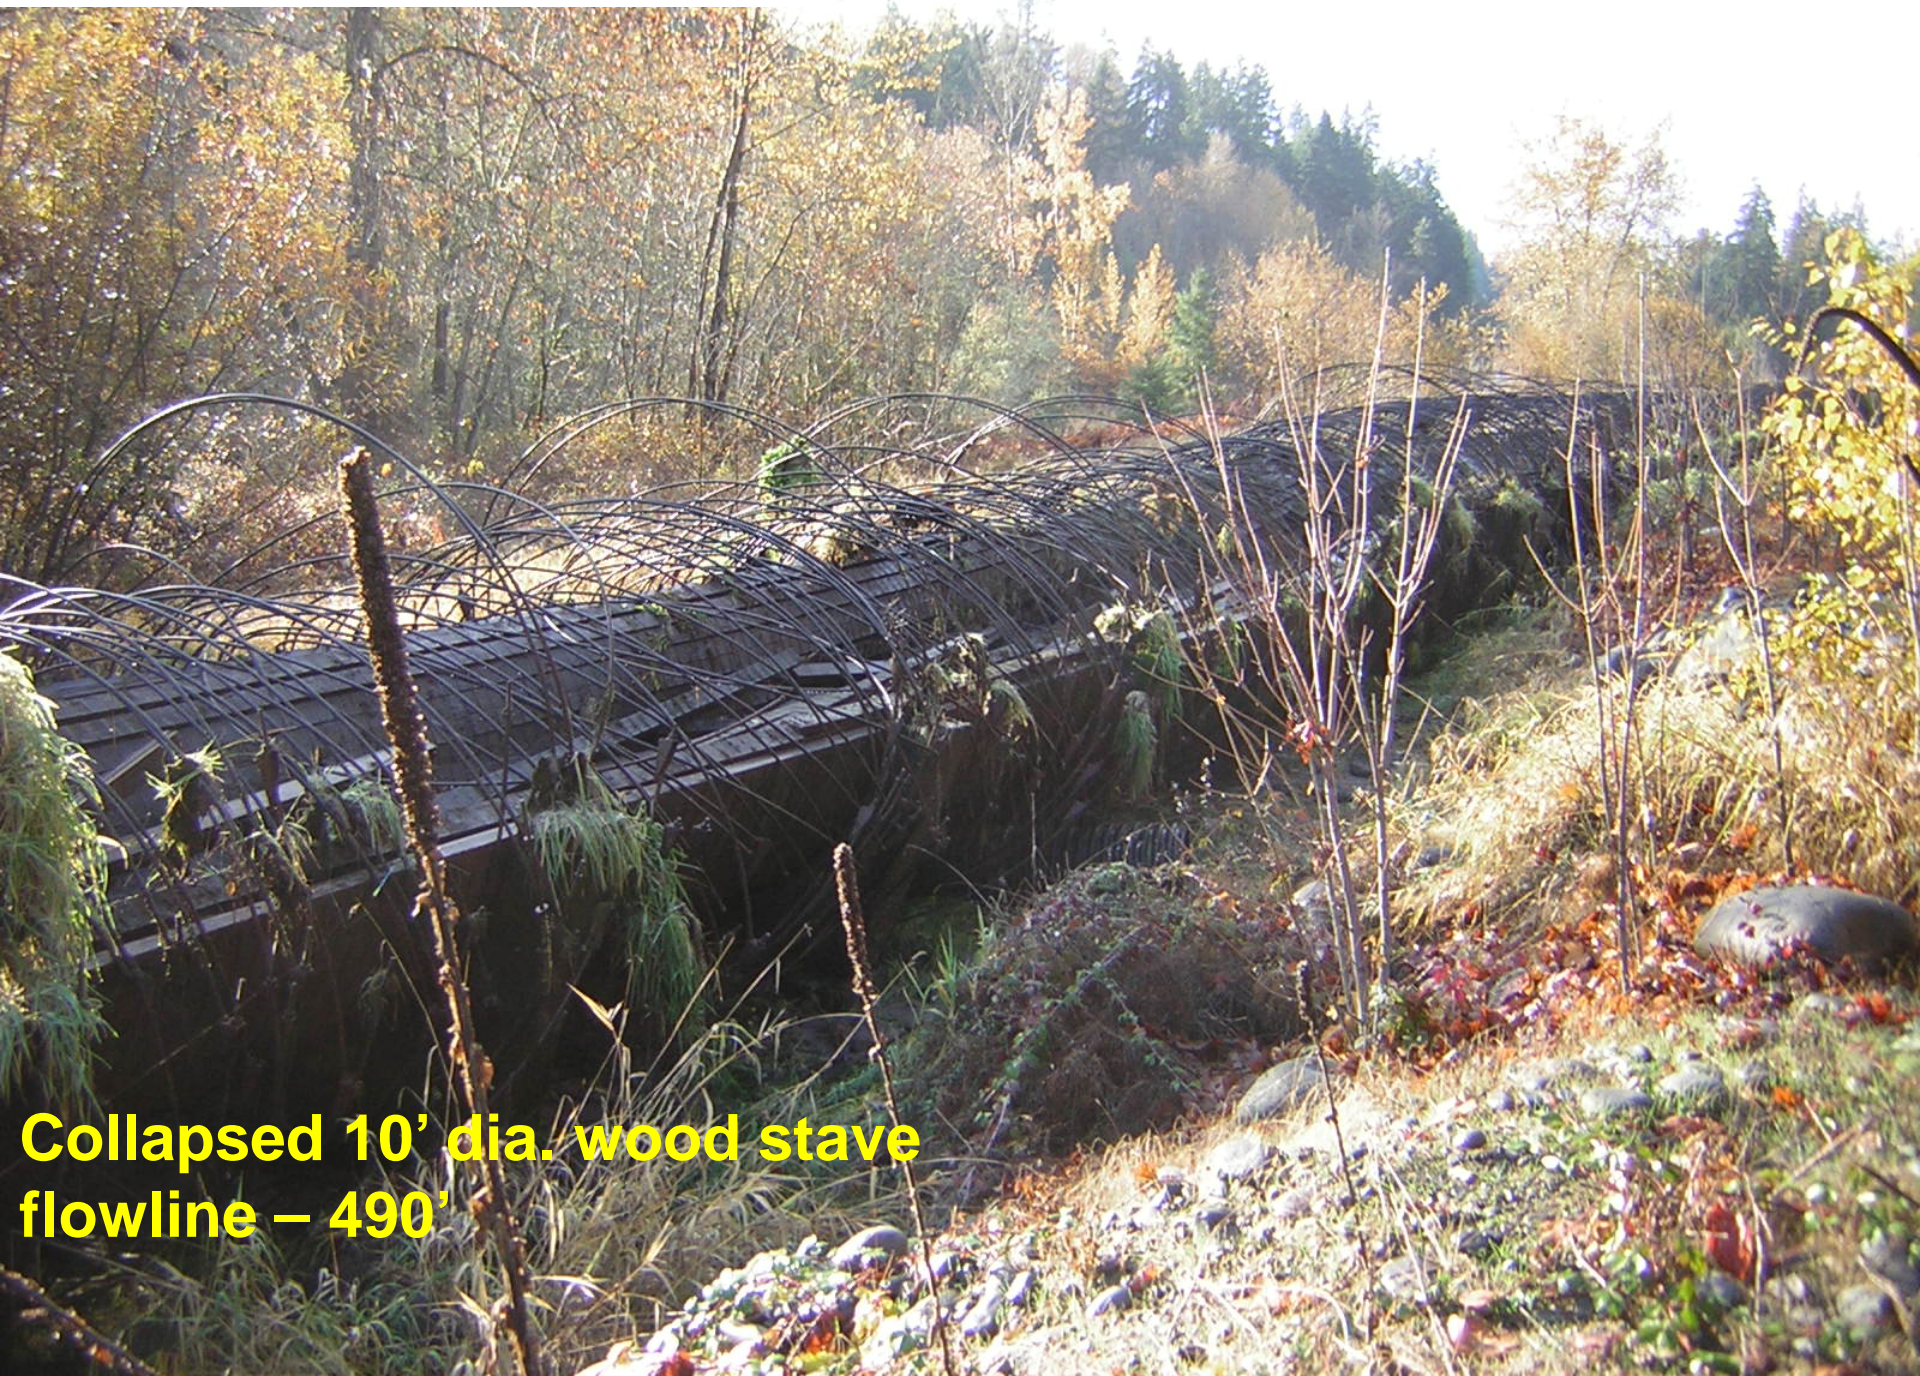
**Collapsed 10' dia. wood stave  
flowline – 490'**

Walkway section lost downstream – location unknown

Foundation washed ¼ mile downriver

Steel flowline – 325'

– 170' collapsed

– 155' slid north 5 inches failing foundations

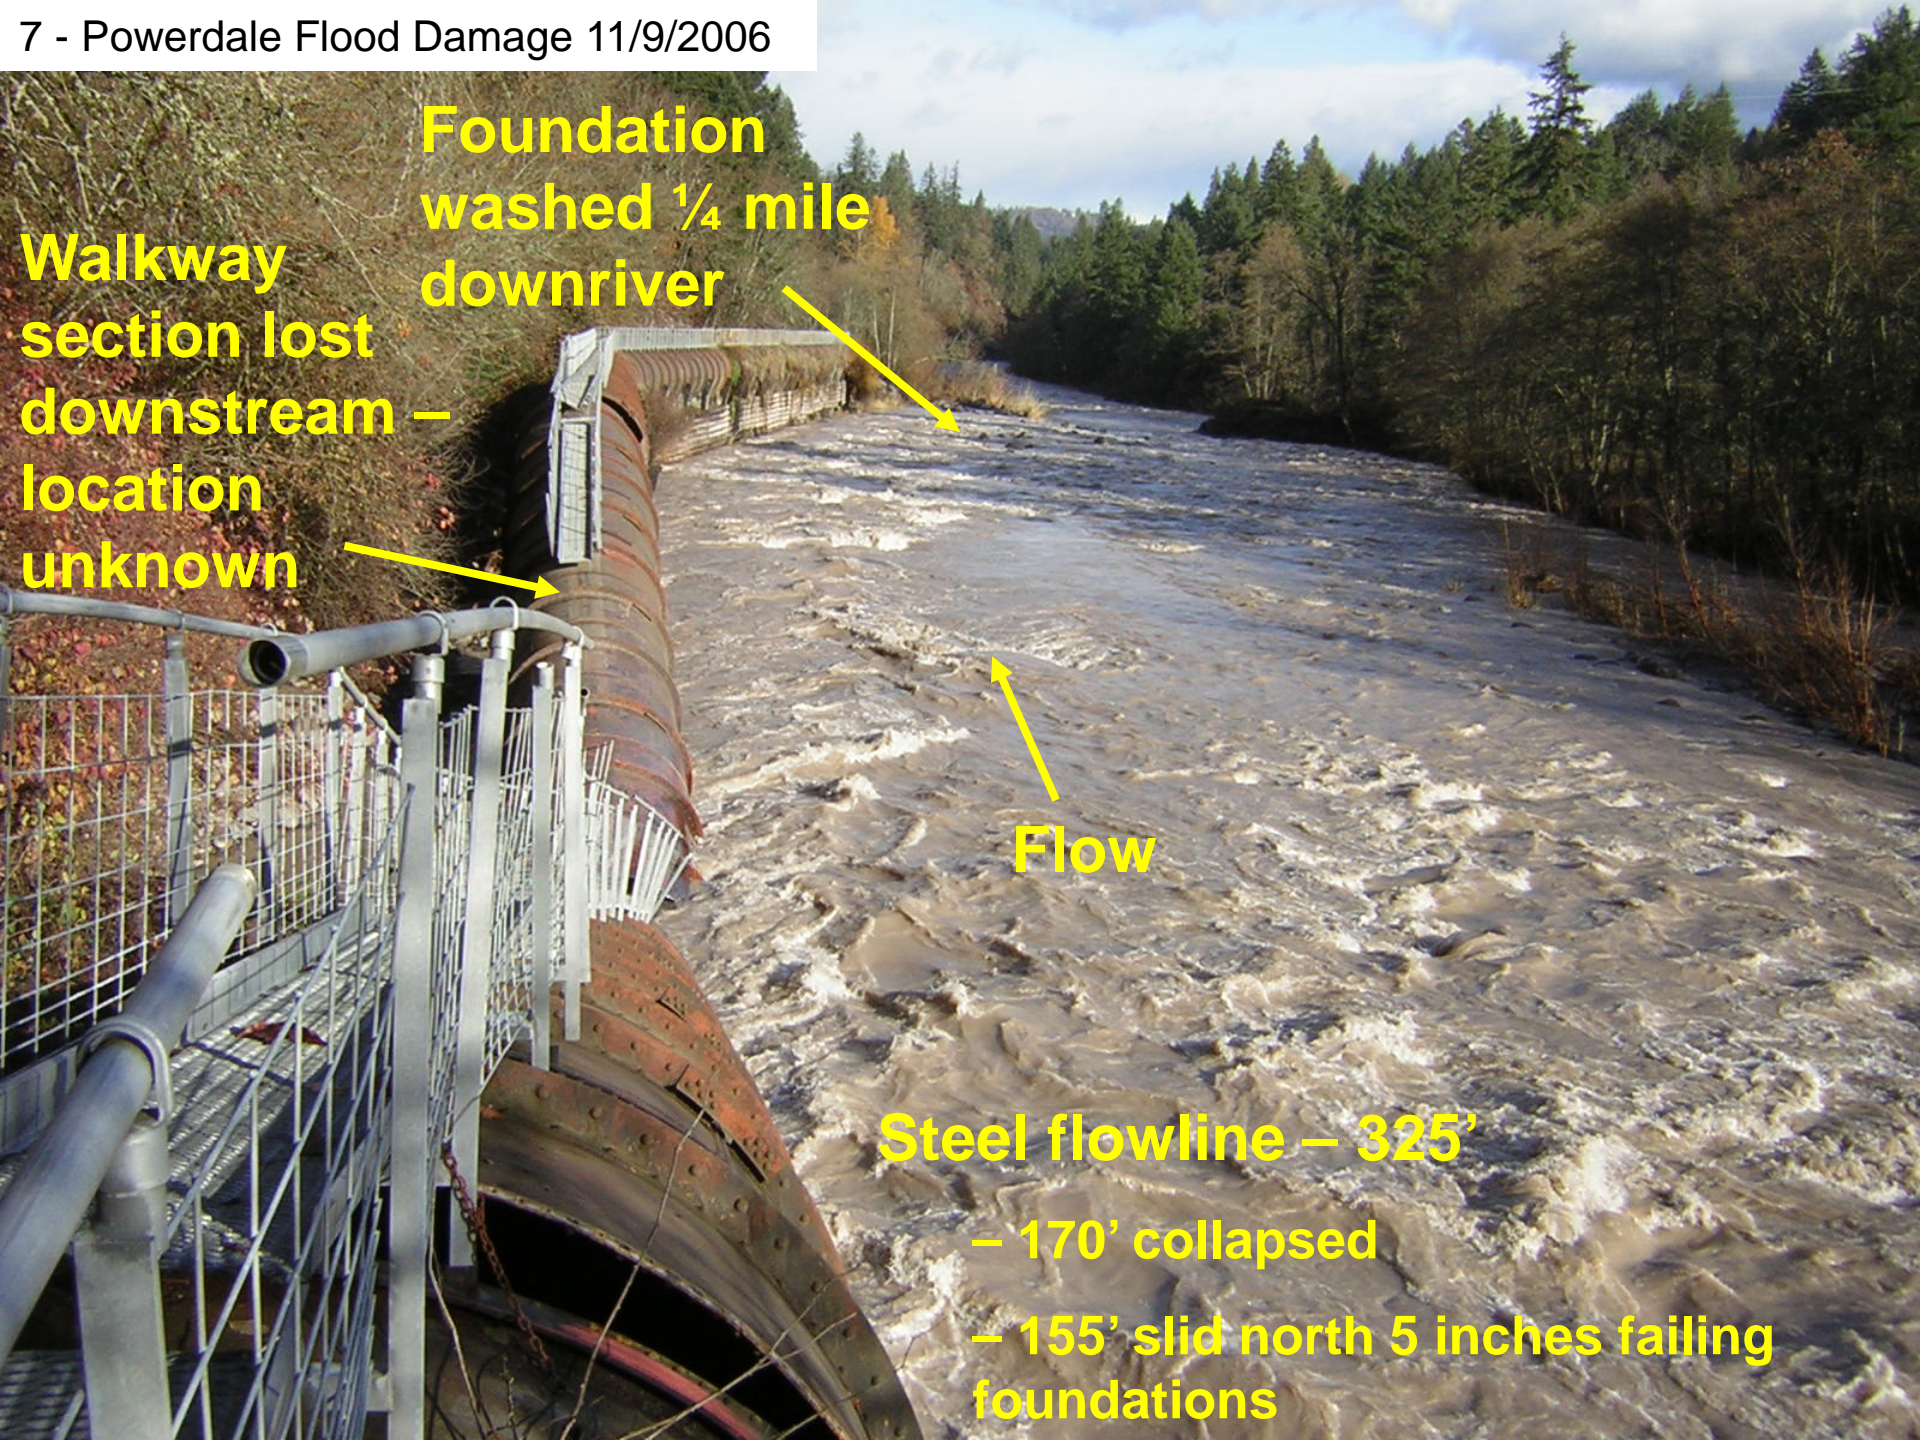
**Collapsed steel flowline – 325' requiring replacement**

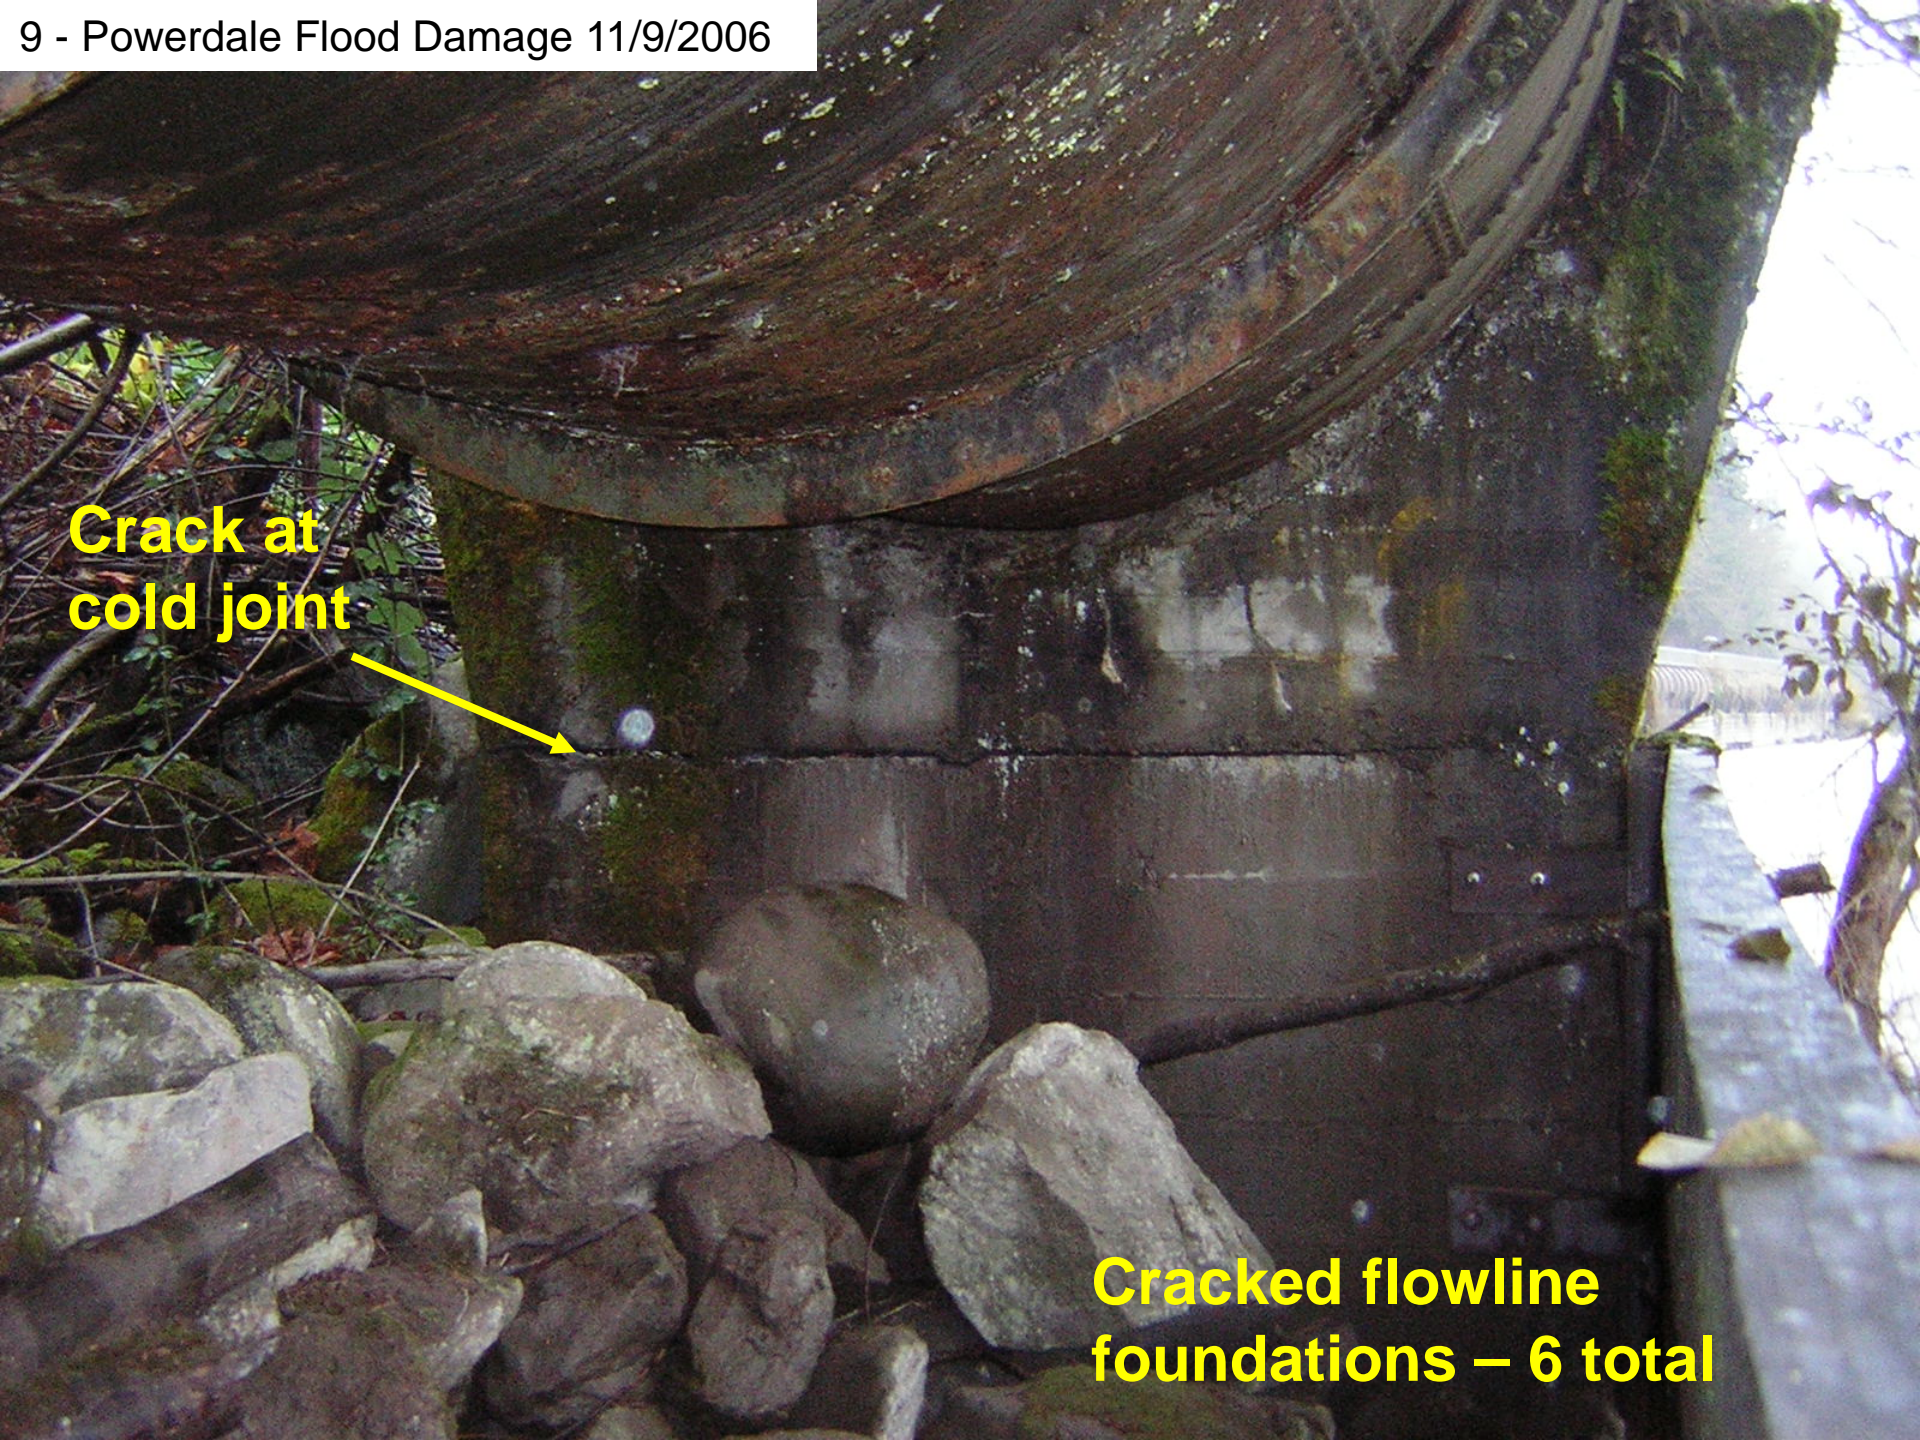
**Crack at  
cold joint**

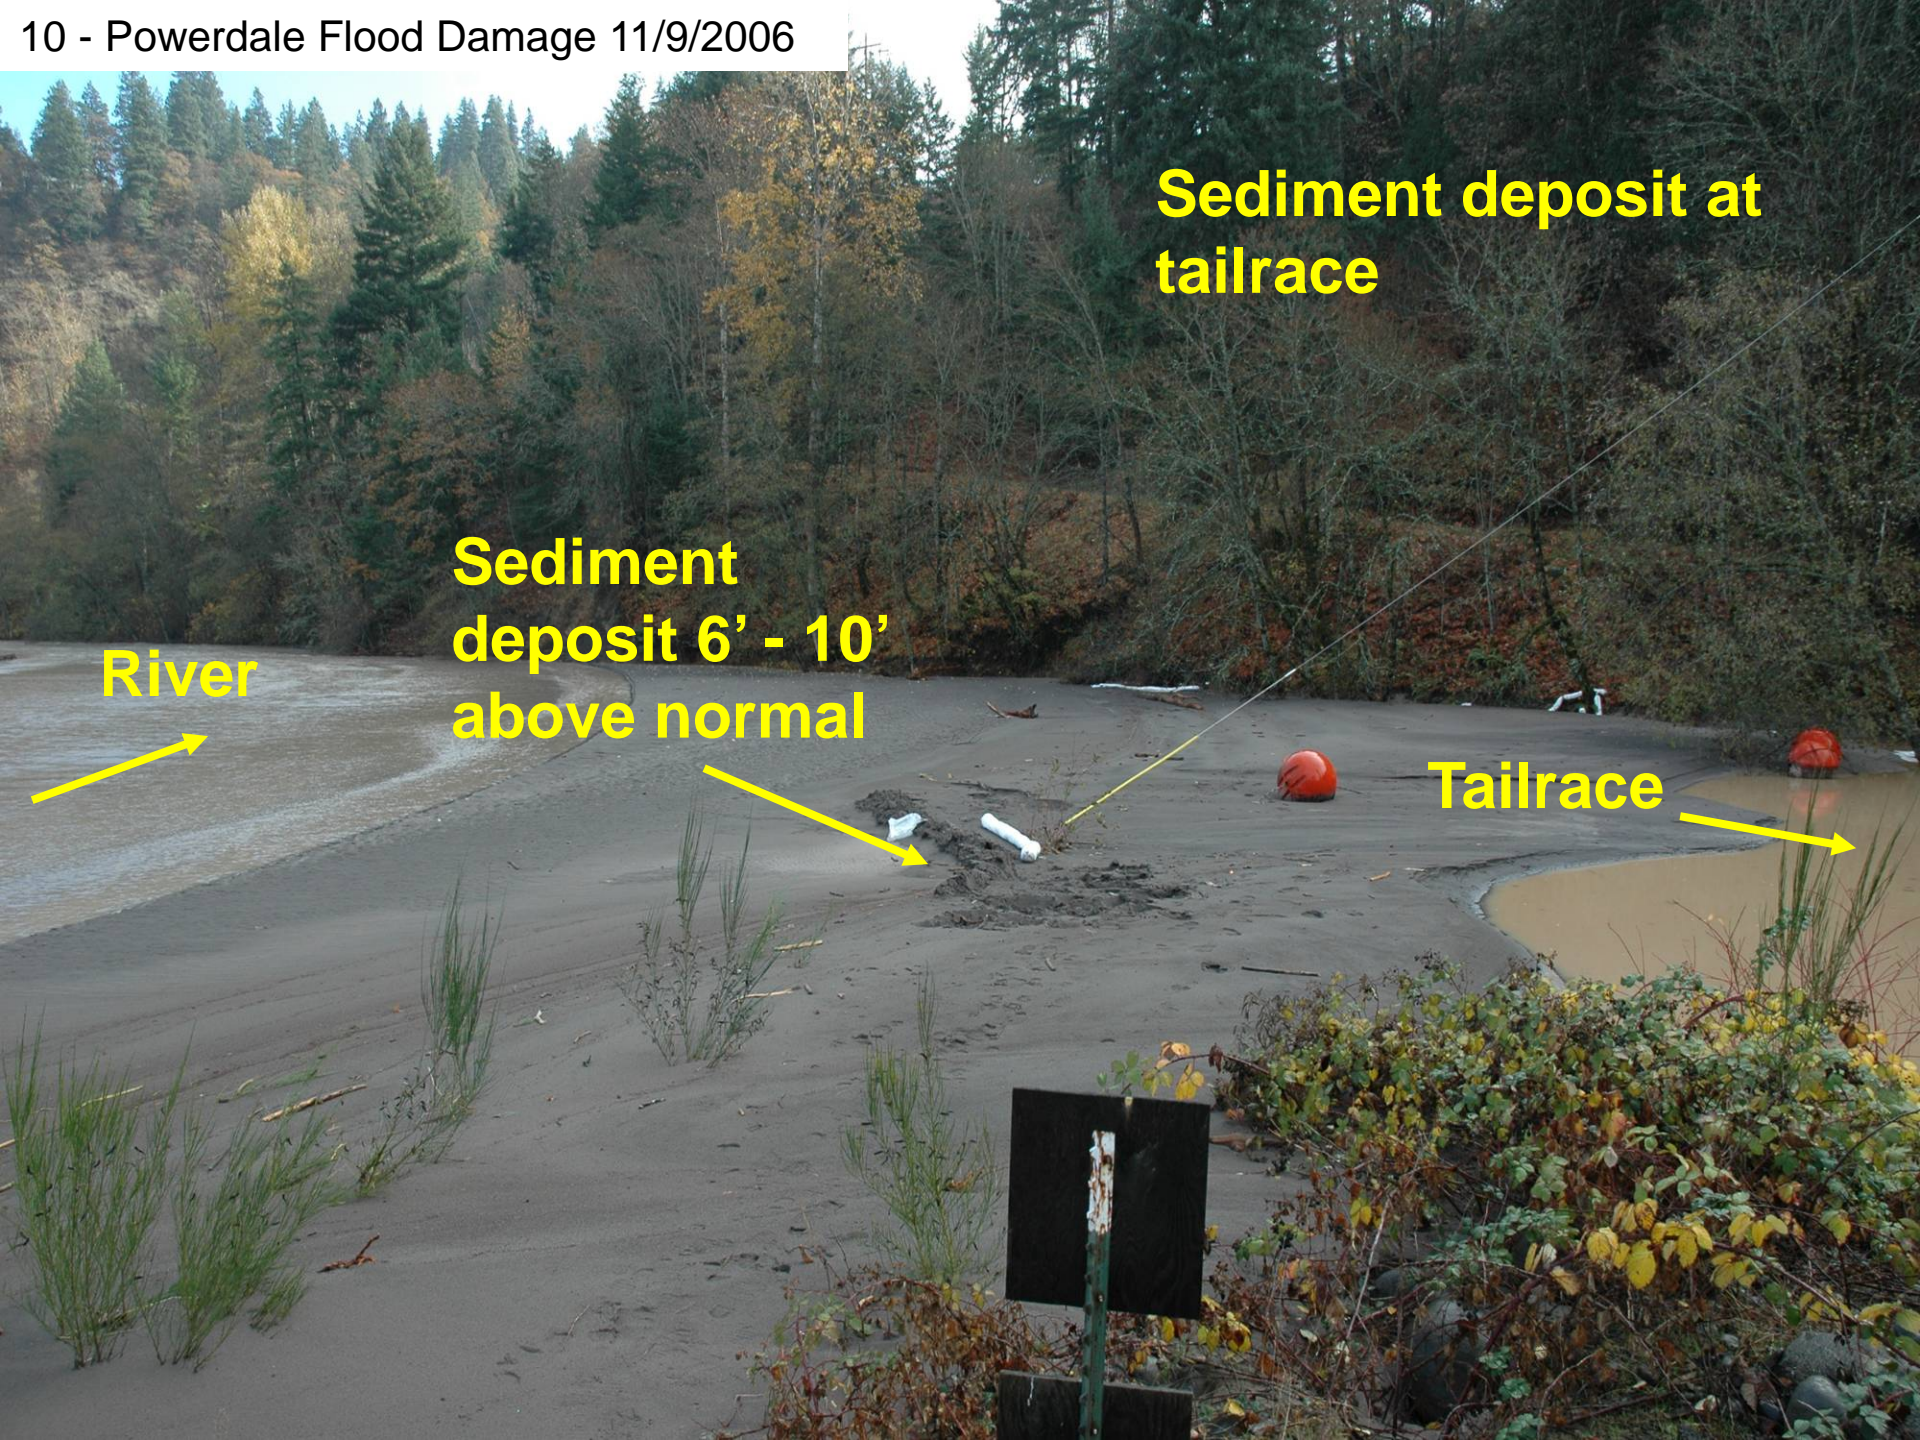
**Sediment deposit at tailrace**

**Sediment deposit 6' - 10' above normal**
