259 Matterhorn Way

PSC DOCKET NO. 21-057-03
Looking East from DEU EXHIBIT B, page 4 of 10
SW side of 259.

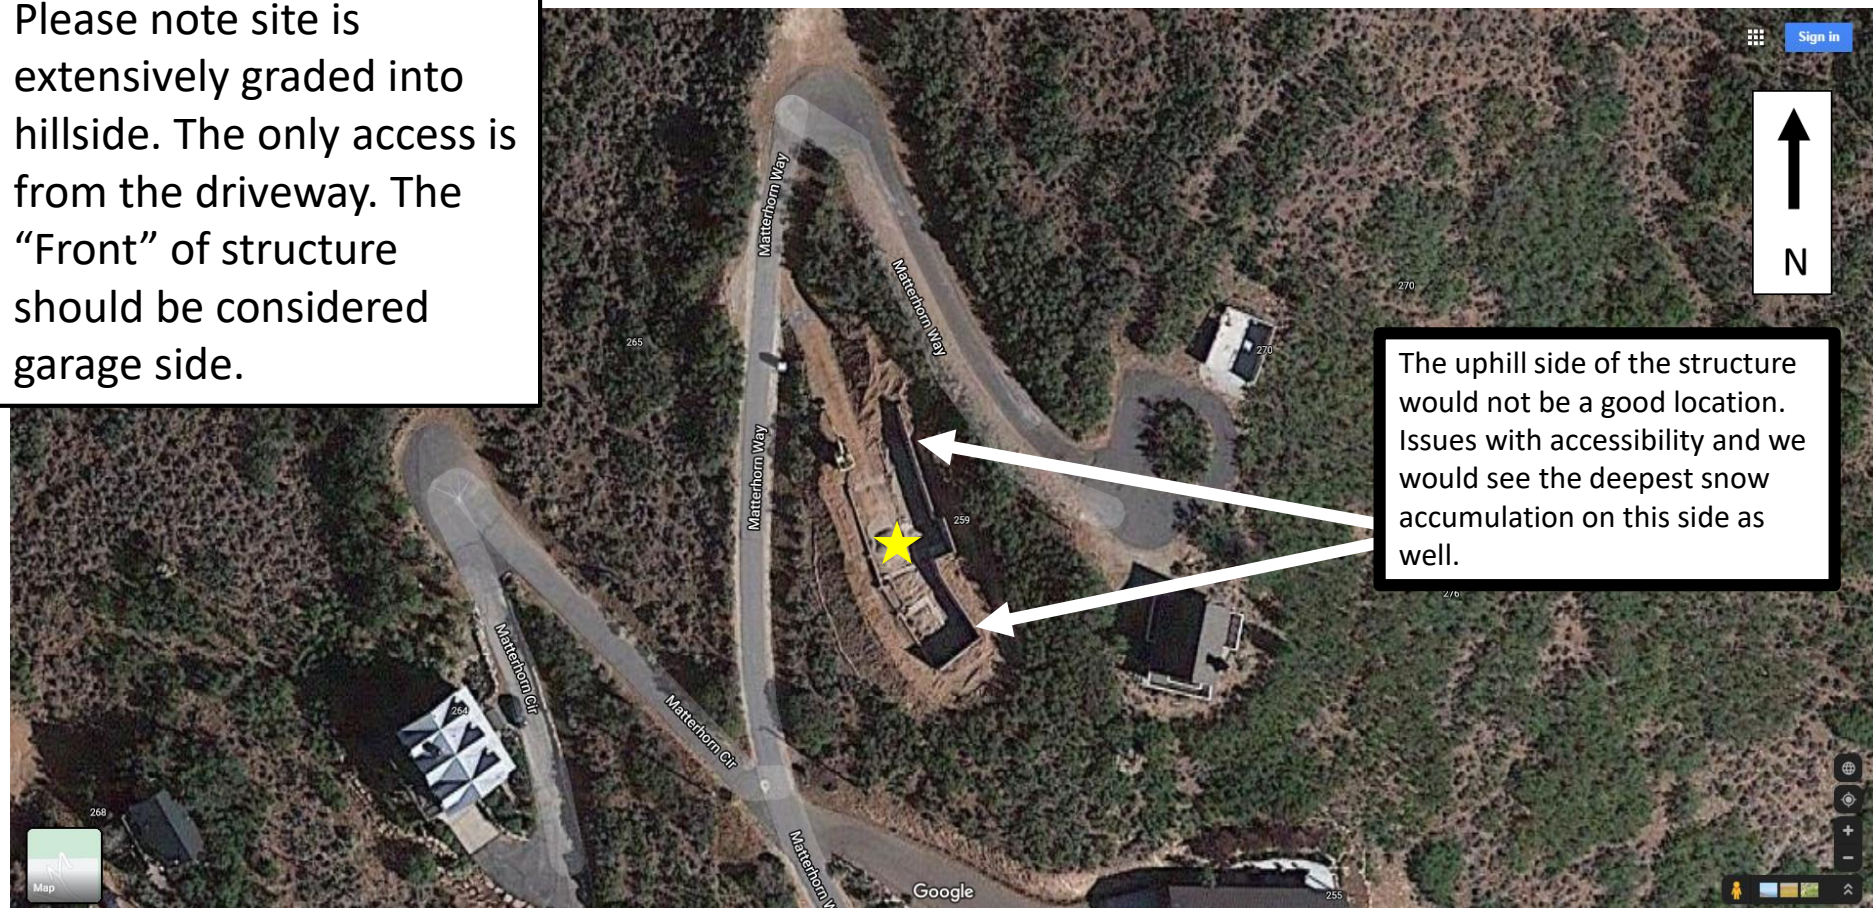
Please note site is extensively graded into hillside. The only access is from the driveway. The “Front” of structure should be considered garage side.

The uphill side of the structure would not be a good location. Issues with accessibility and we would see the deepest snow accumulation on this side as well.

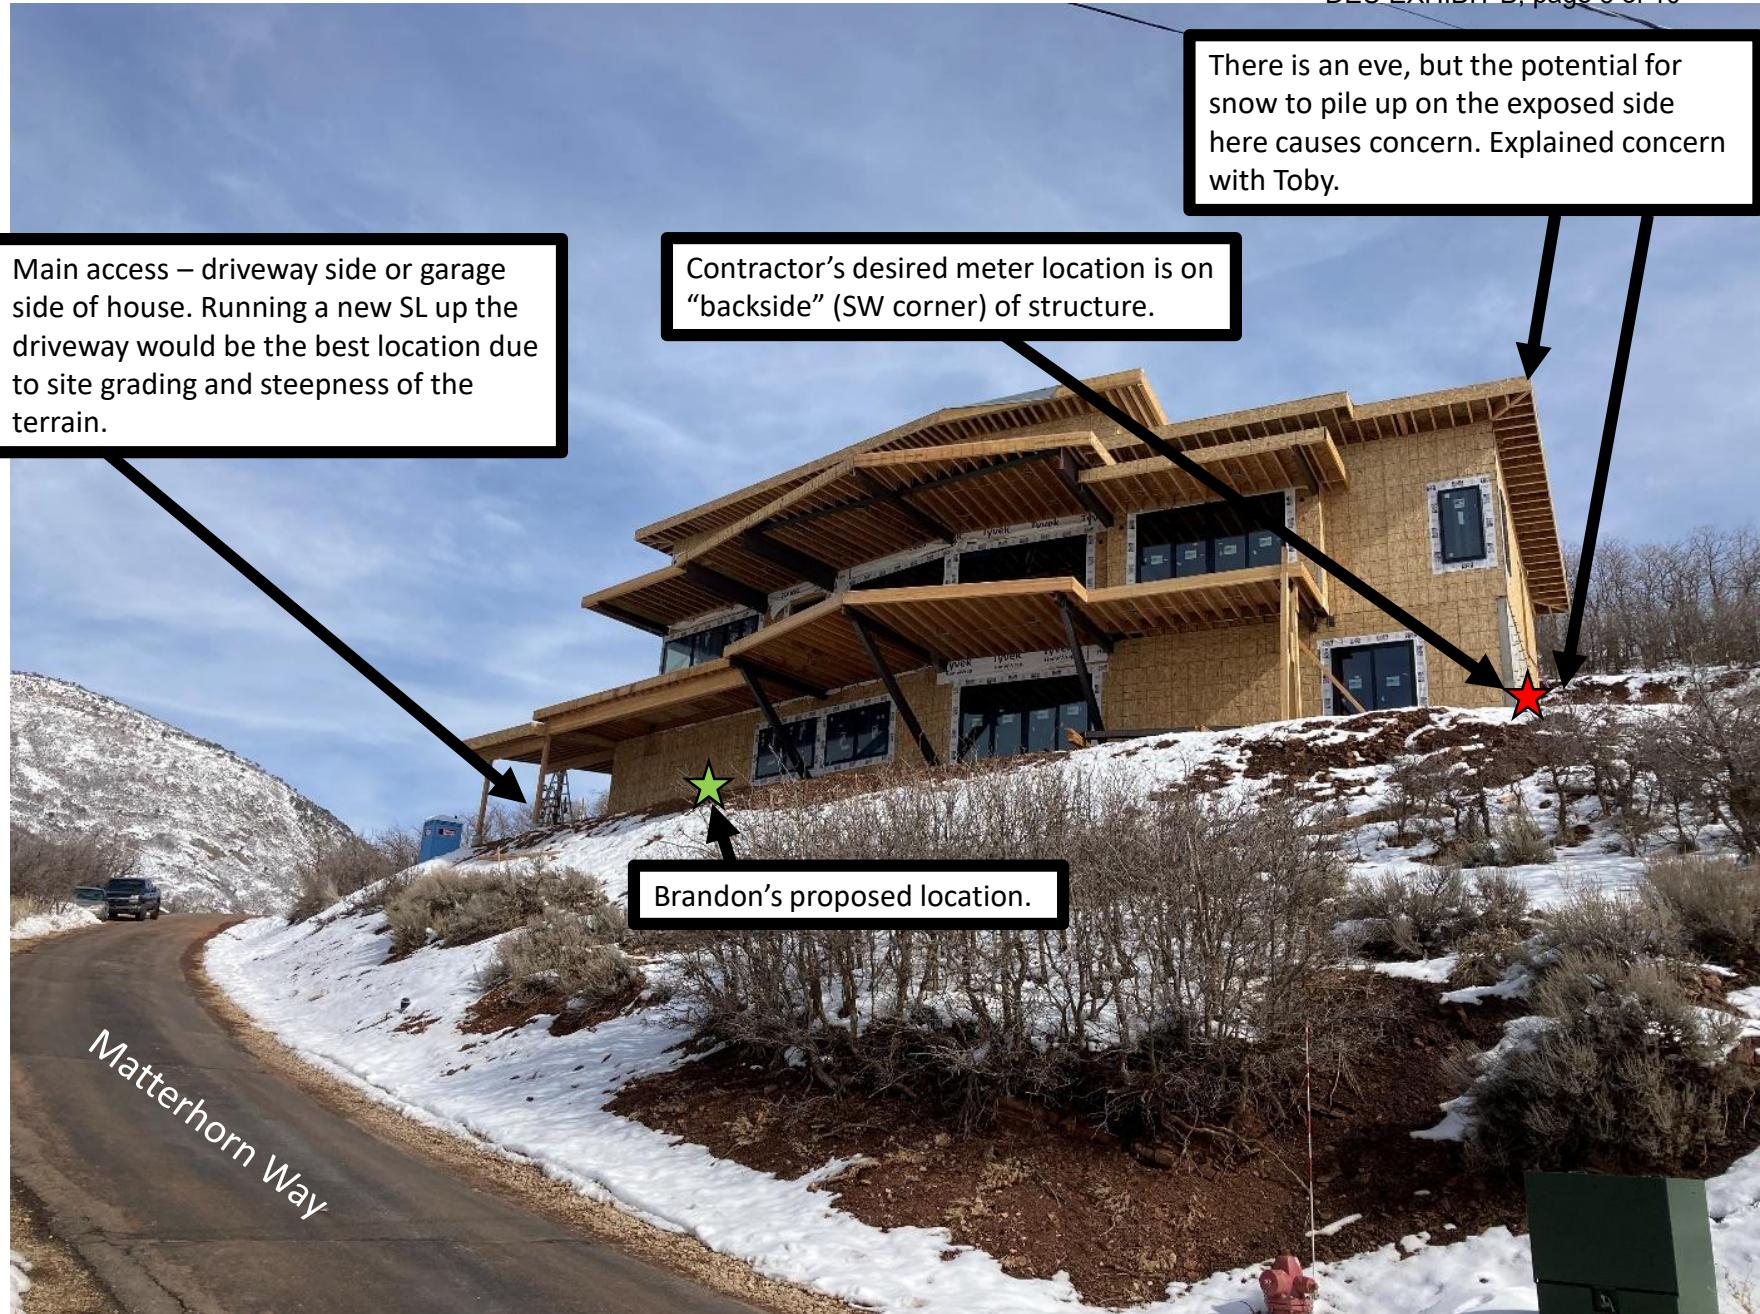
Contractor’s desired meter location is on “backside” (SW corner) of structure.

There is an eve, but the potential for snow to pile up on the exposed side here causes concern. Explained concern with Toby.

Brandon’s proposed location.

Main access – driveway side or garage side of house. Running a new SL up the driveway would be the best location due to site grading and steepness of the terrain.

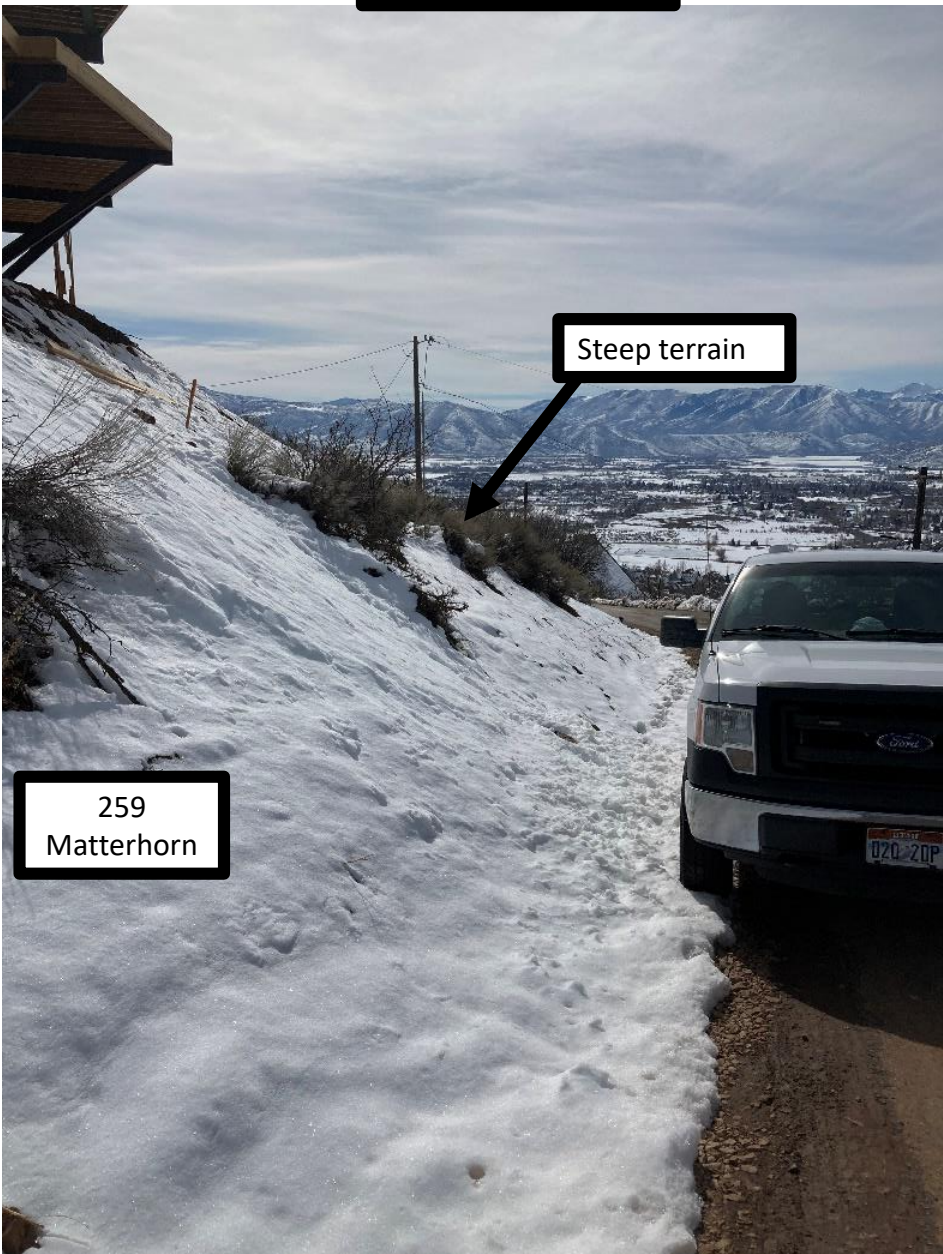
Looking South from NW side of 259.

Steep terrain

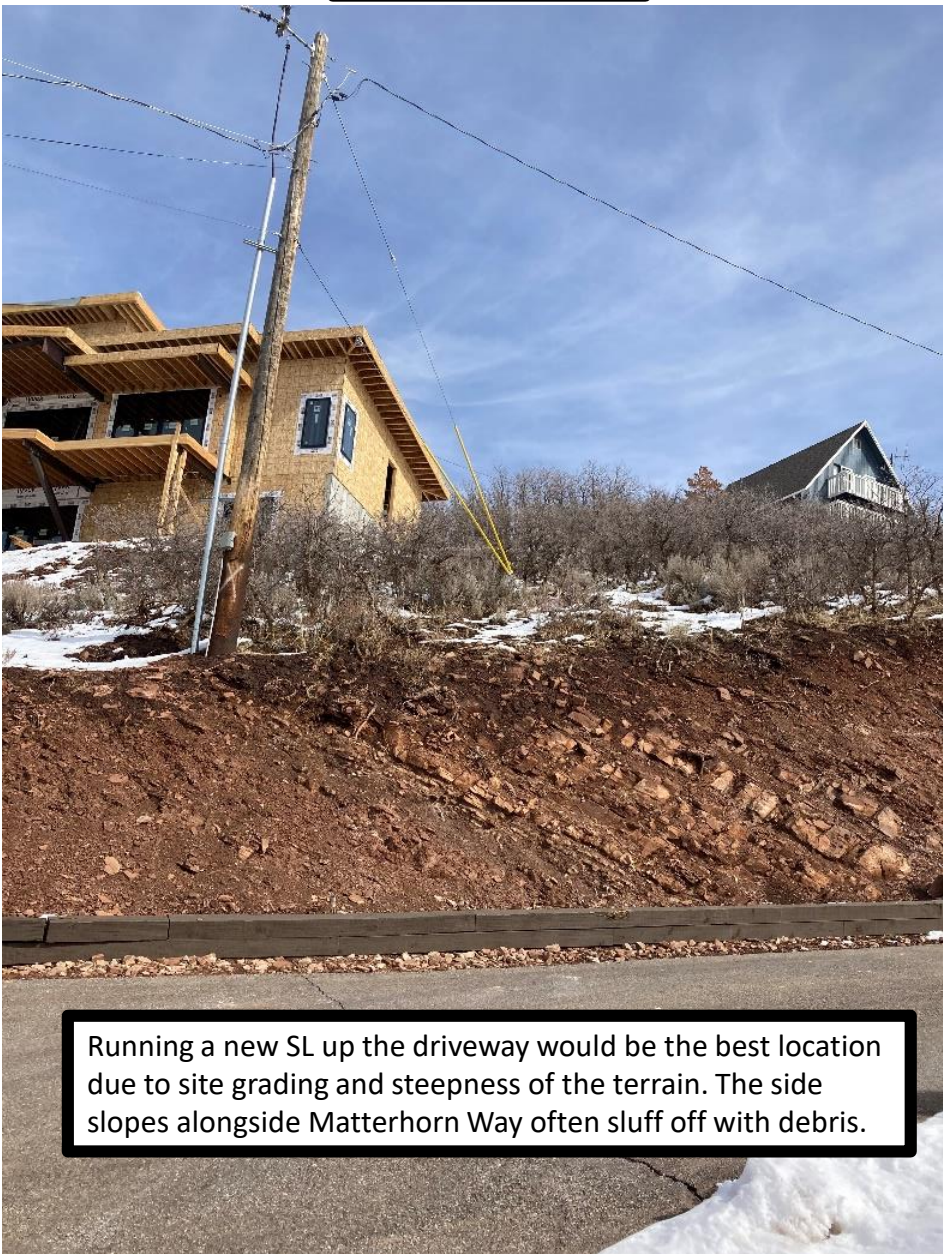
Running a new SL up the driveway would be the best location due to site grading and steepness of the terrain. The side slopes alongside Matterhorn Way often sluff off with debris.

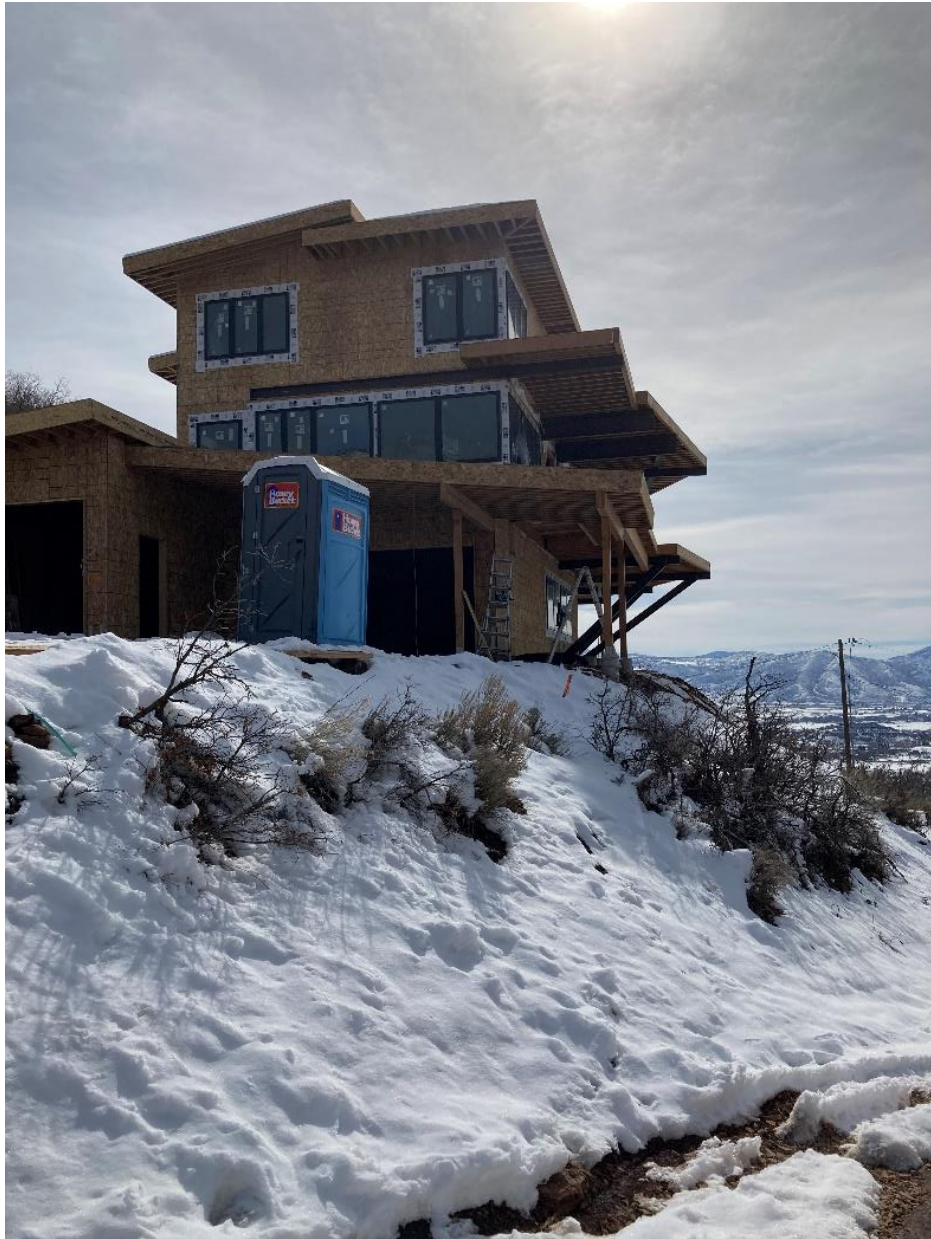
Northside 259,
looking South

Unable to install meter here.
Not accessible, insufficient
room for meter, snow
accumulation hazard.

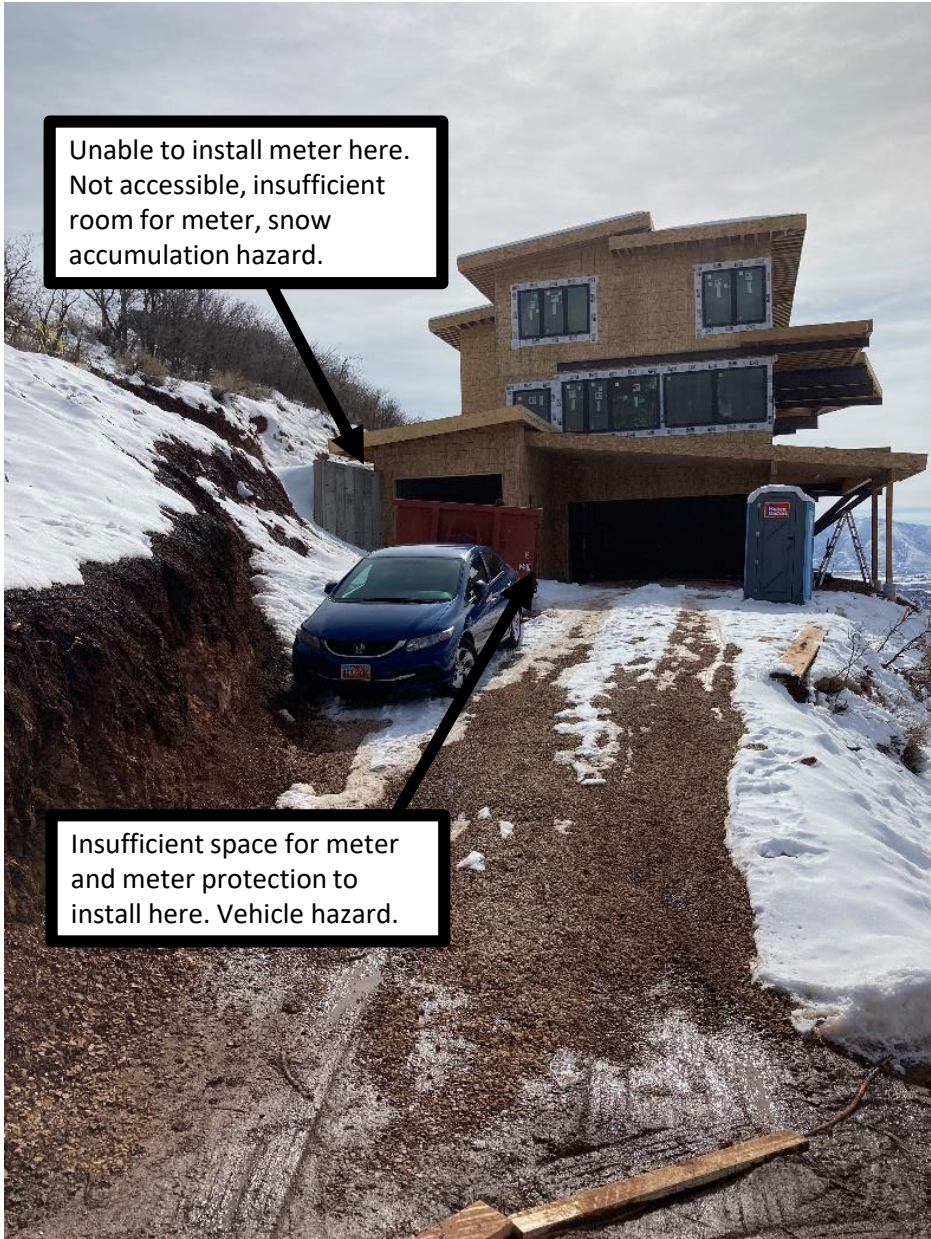
Insufficient space for meter
and meter protection to
install here. Vehicle hazard.

Toby explained this retaining wall would be extended further down the driveway. Very steep through this space where the snow is shown.

Unable to install meter here on the backside of the wall on garage. It would be inaccessible, have insufficient room for meter, and a snow accumulation hazard.

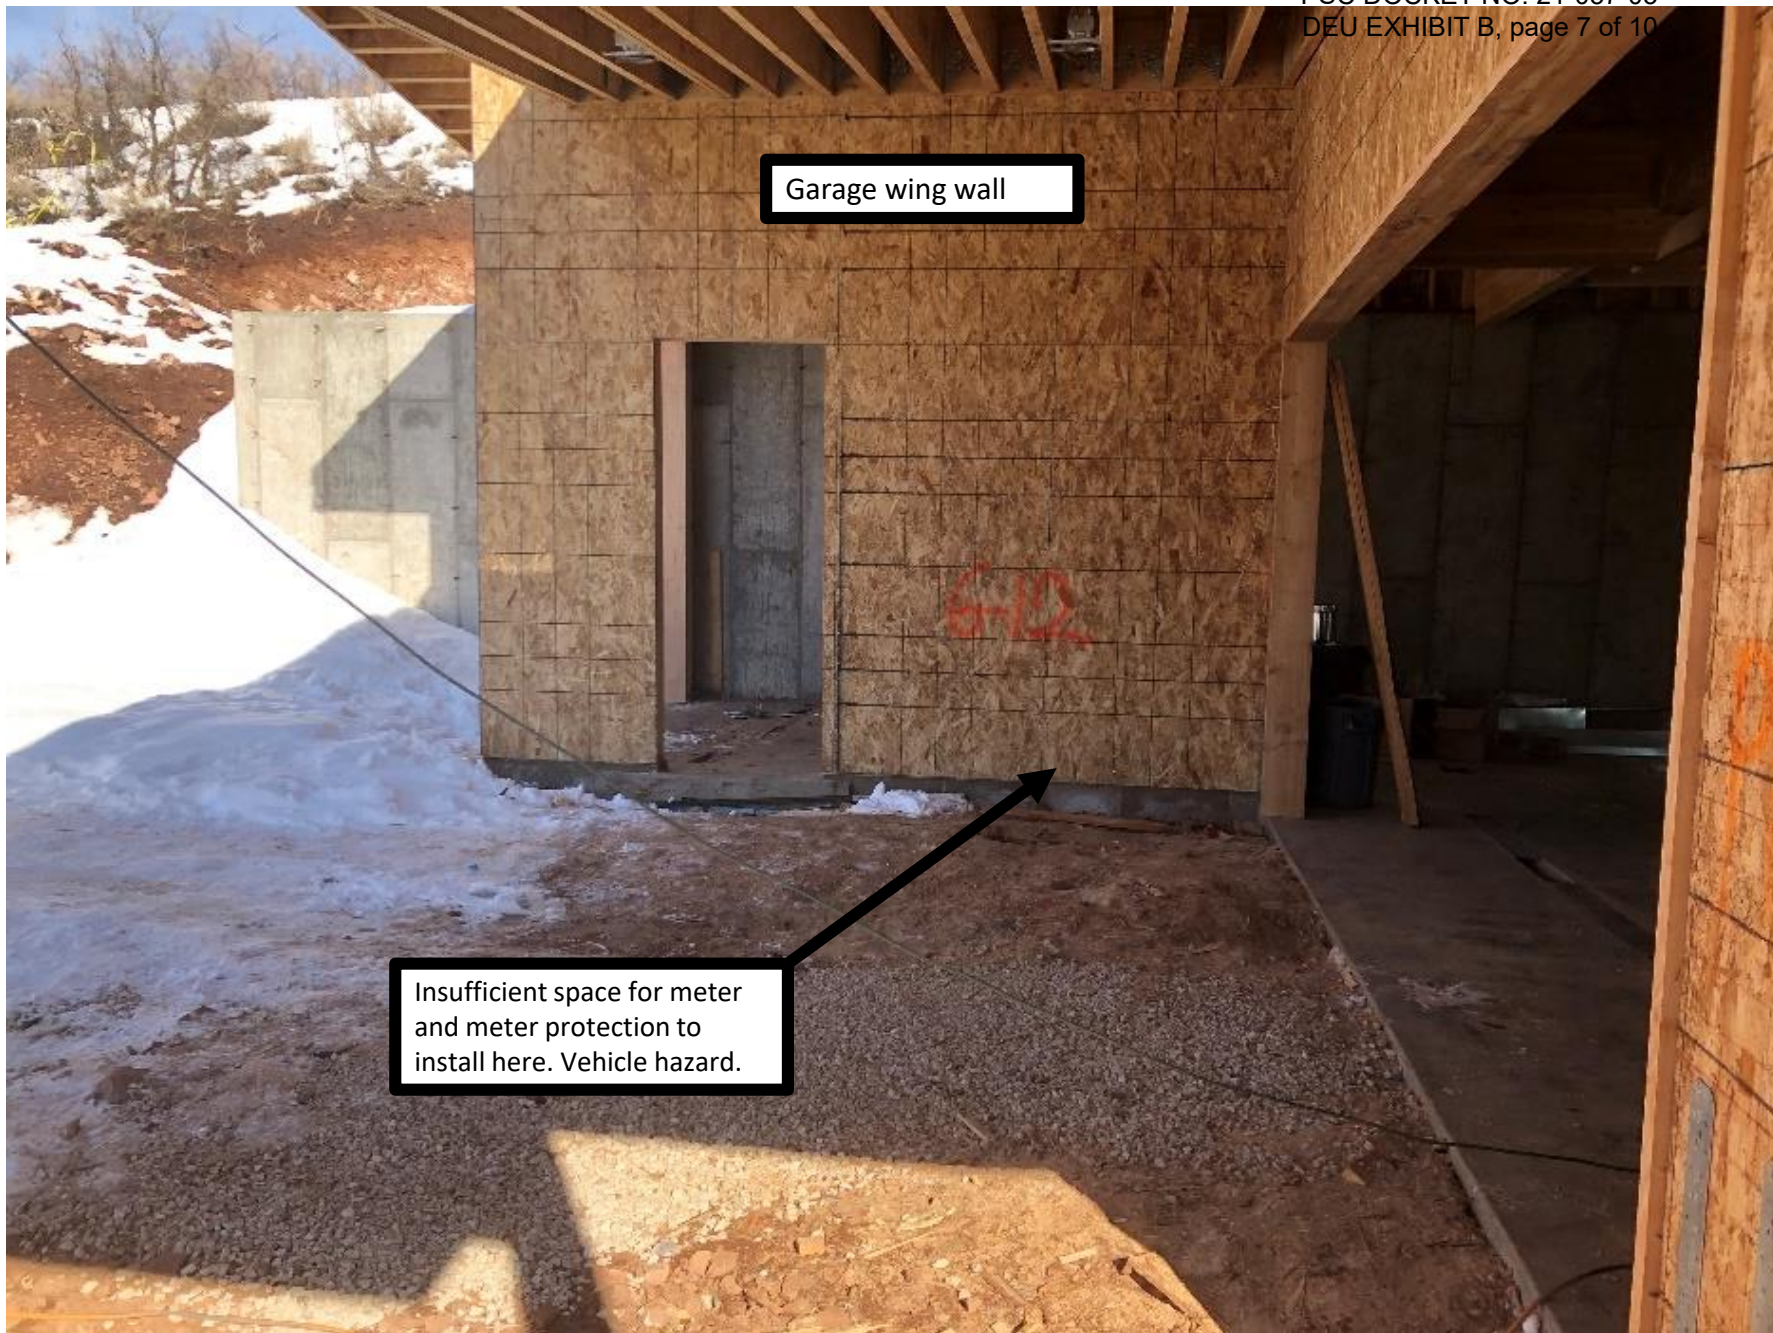
Garage wing wall

Insufficient space for meter and meter protection to install here. Vehicle hazard.

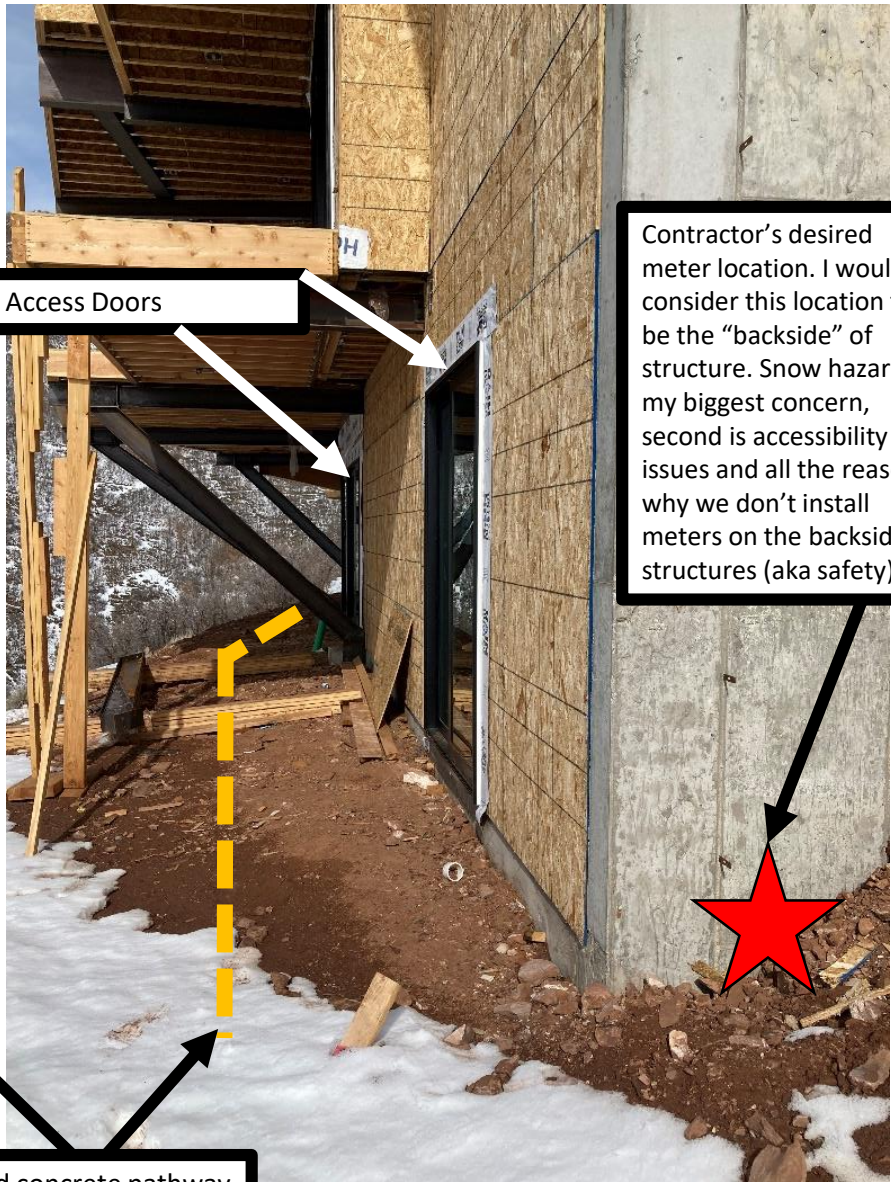
SW Corner of 259 looking North.

Brandon has spoken with the Contractor previously about not being able to install a meter at this location. Same concerns as noted above.

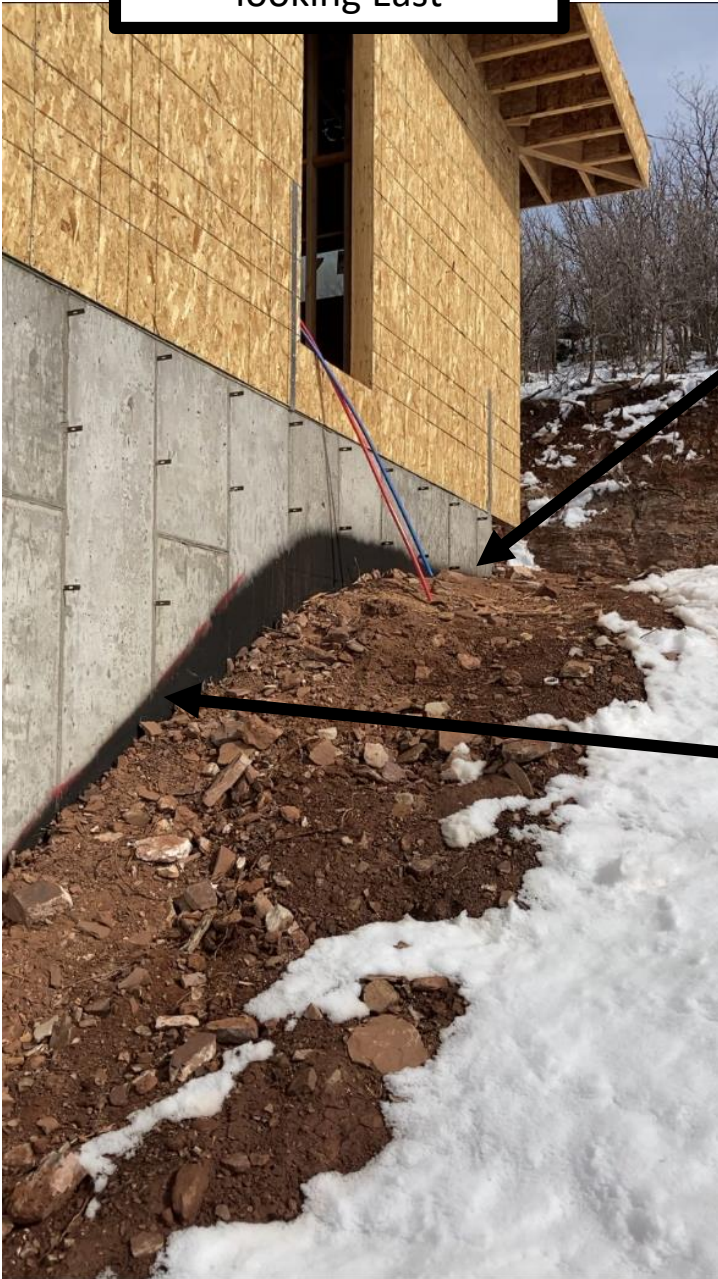
SW Corner of 259
looking East

Brandon's
specified
meter
location

Staircase landing
foundation

I would recommend sticking
the meter in this general
area since the landing of the
stairs will limit accessibility
to the meter.

I asked Toby if the homeowners main concern with this location was aesthetics of the meter. He indicated that it was. I suggested he could build a well ventilated structure to disguise the meter and that we could send him our specs on that. I told him the door or the structure would need to have enough clearances around the meter so we could maintain it.
