Beehive Telephone Company, Inc.
Description of Outage Affecting Ibapah, UT

1.0 Description of Incident

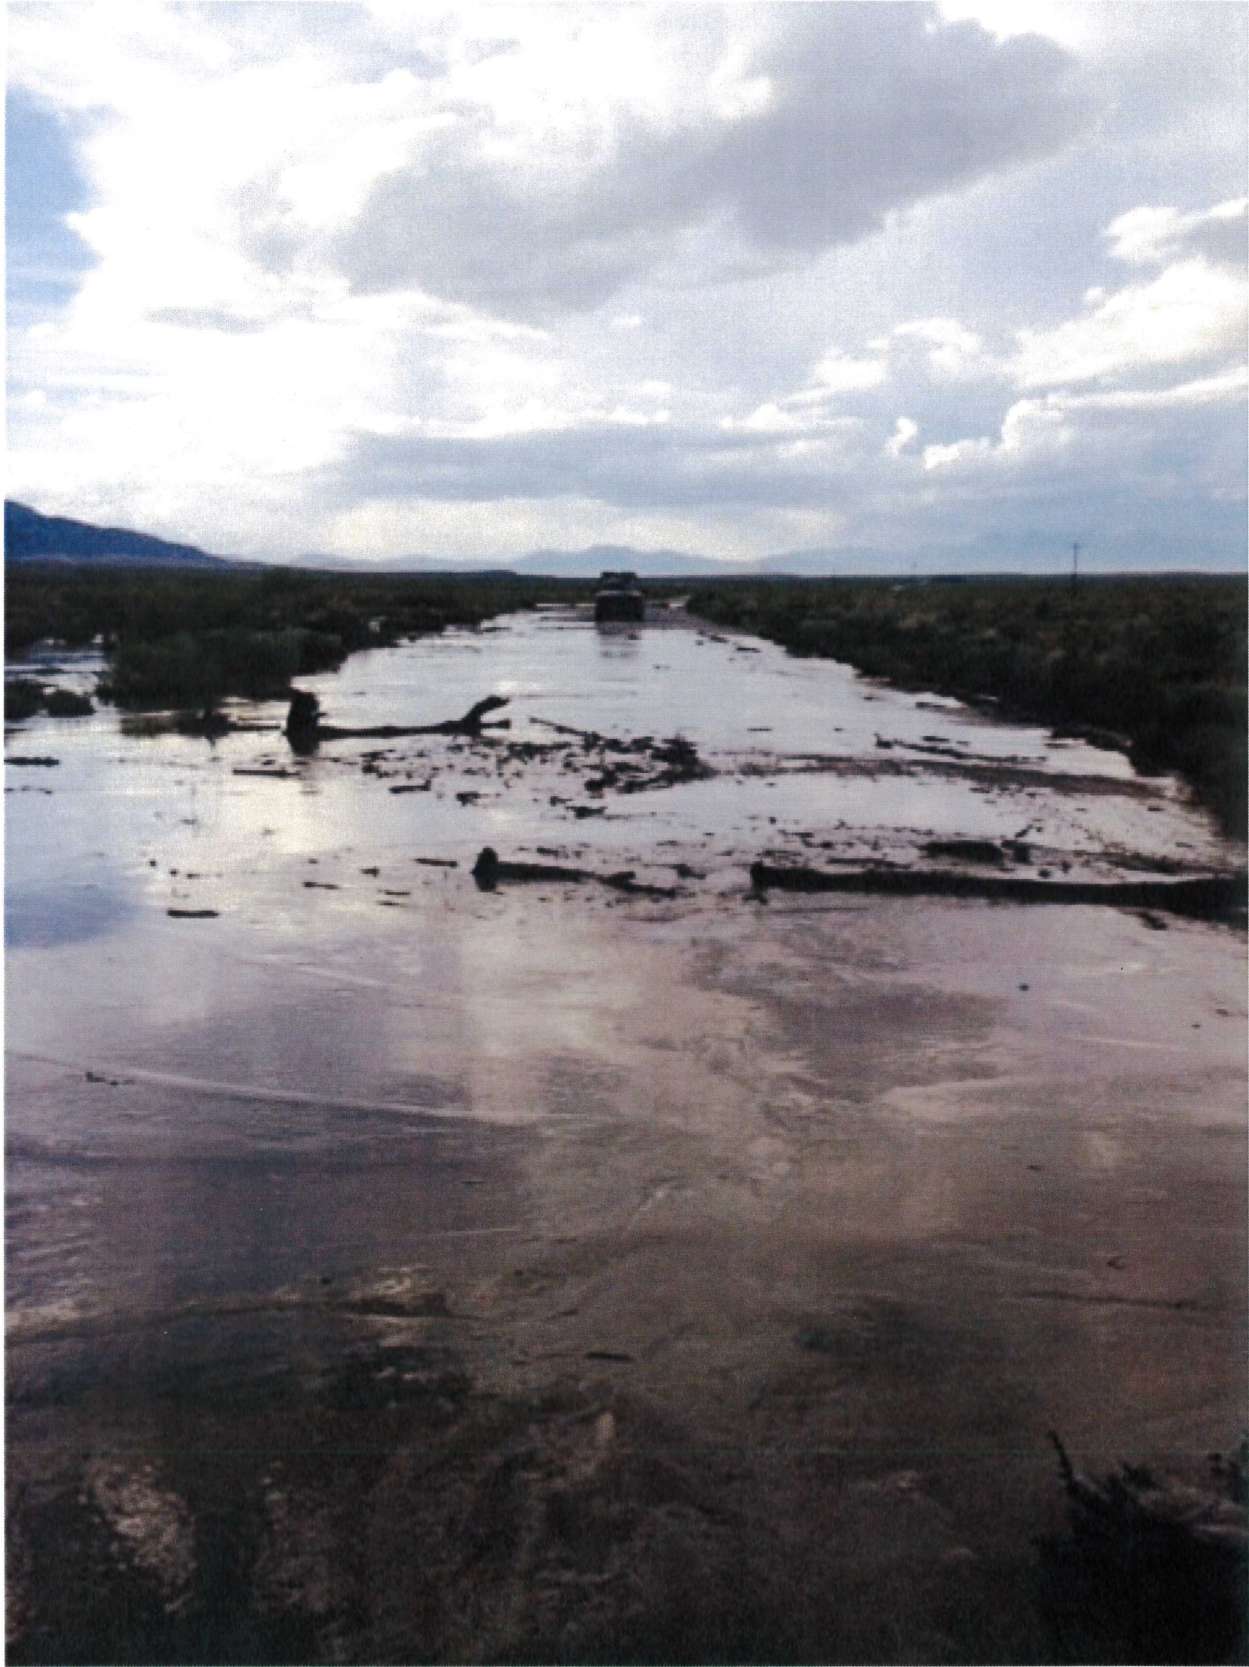
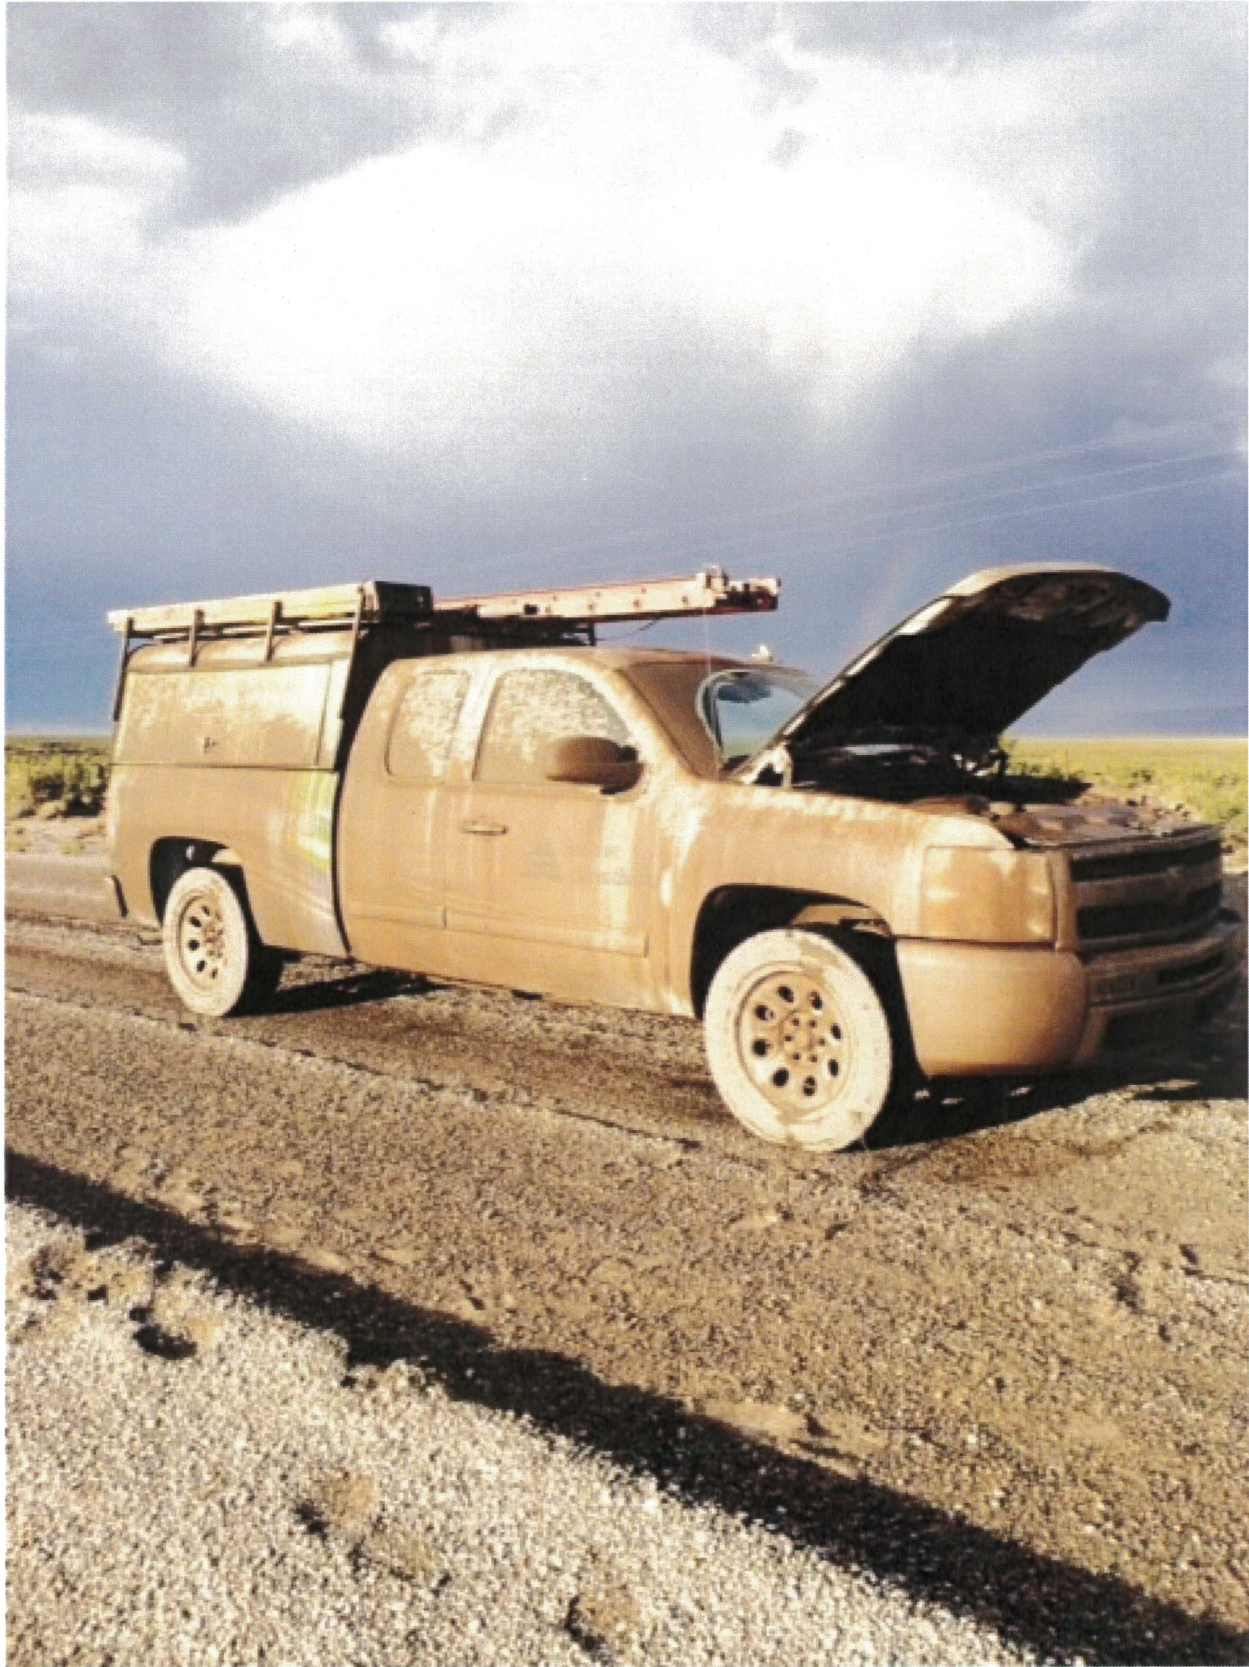
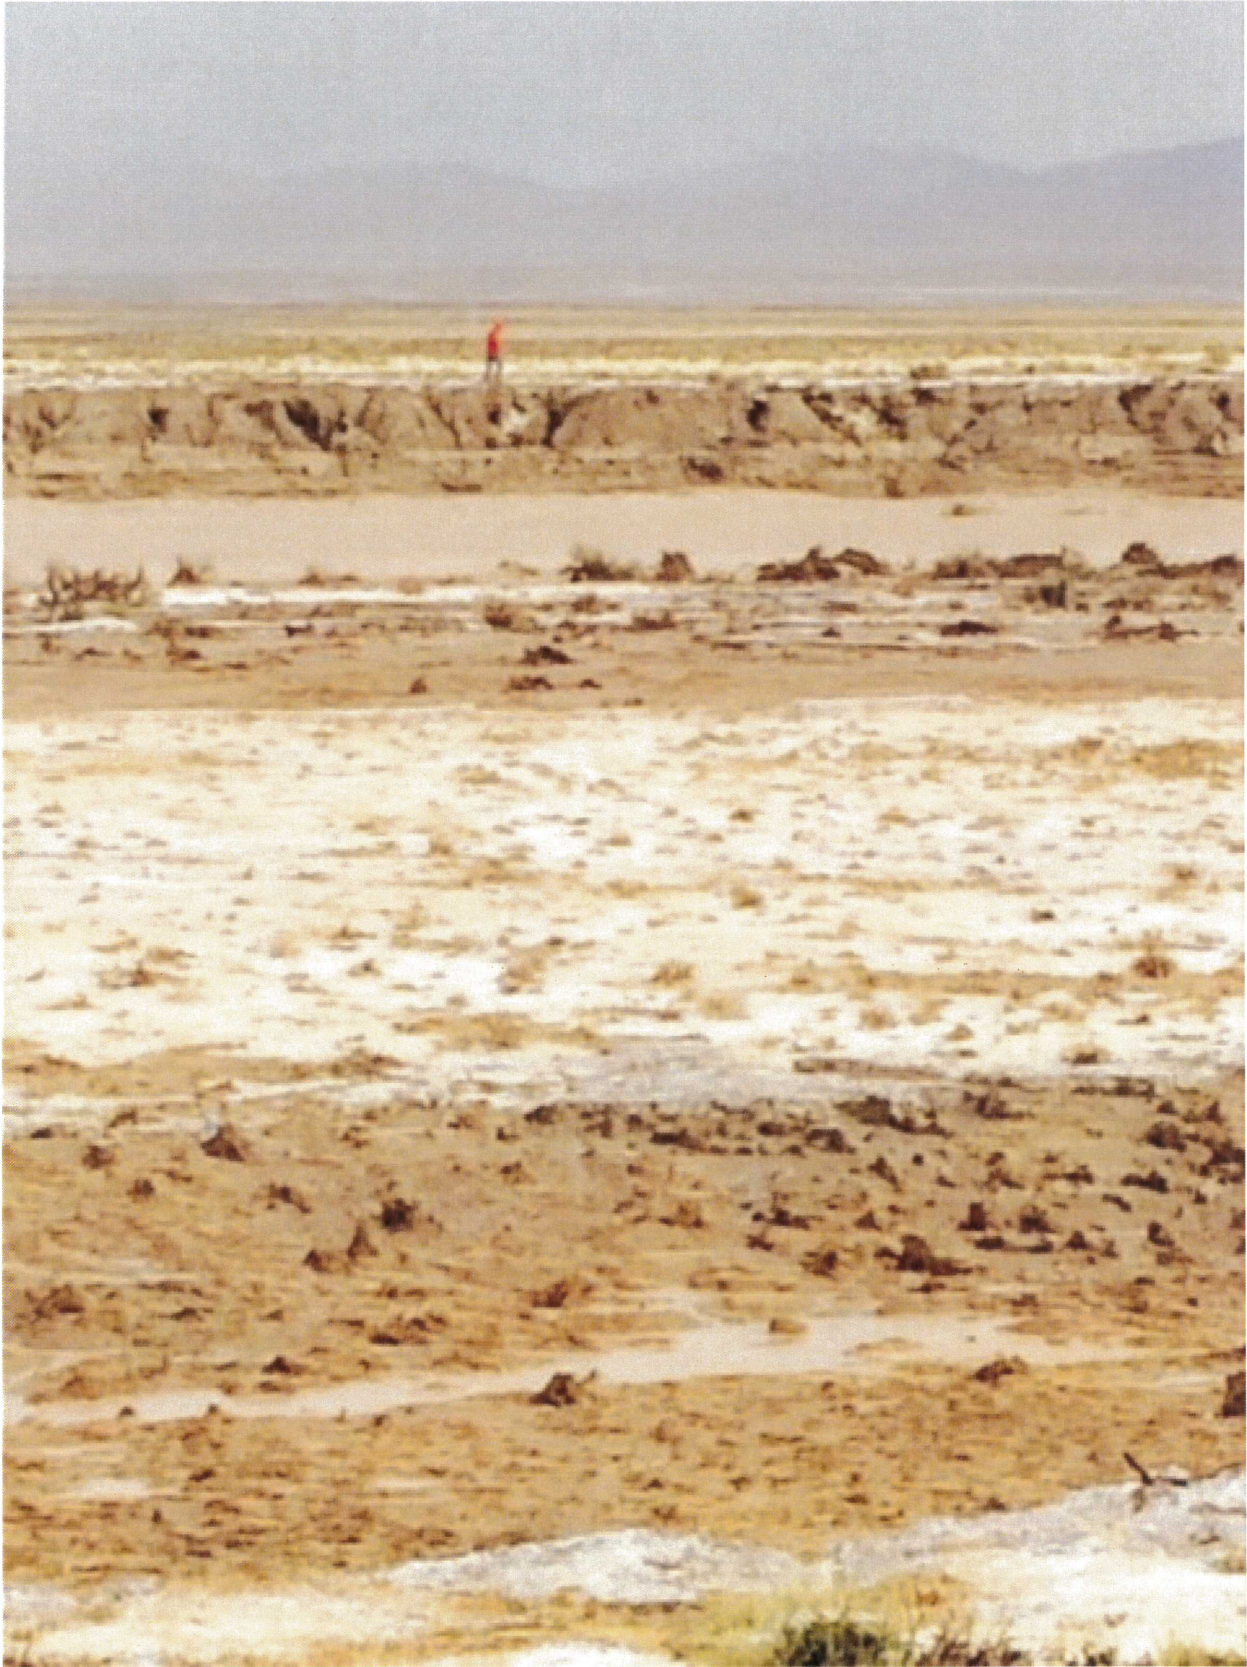
Exhibit A
Photographs of Flood

- 2.5 While traveling to Wendover our technicians were delayed due to flash flooding. The road they were traveling on was flooded out. They then tried to travel around the flood by traveling south to Garrison, UT. While traveling south on Snake Valley Road our technicians got stuck due to flooding. Their truck was disabled. They then hiked approximately six miles to find shelter at the Border Inn in Garrison, UT. The remainder of August 13th was spent at the Border Inn. Photographs of the disabled truck and flooding is attached in Exhibit A.
