LAKE SIDE

VILLAGE

LAKE SIDE VILLAGE SITE PLAN

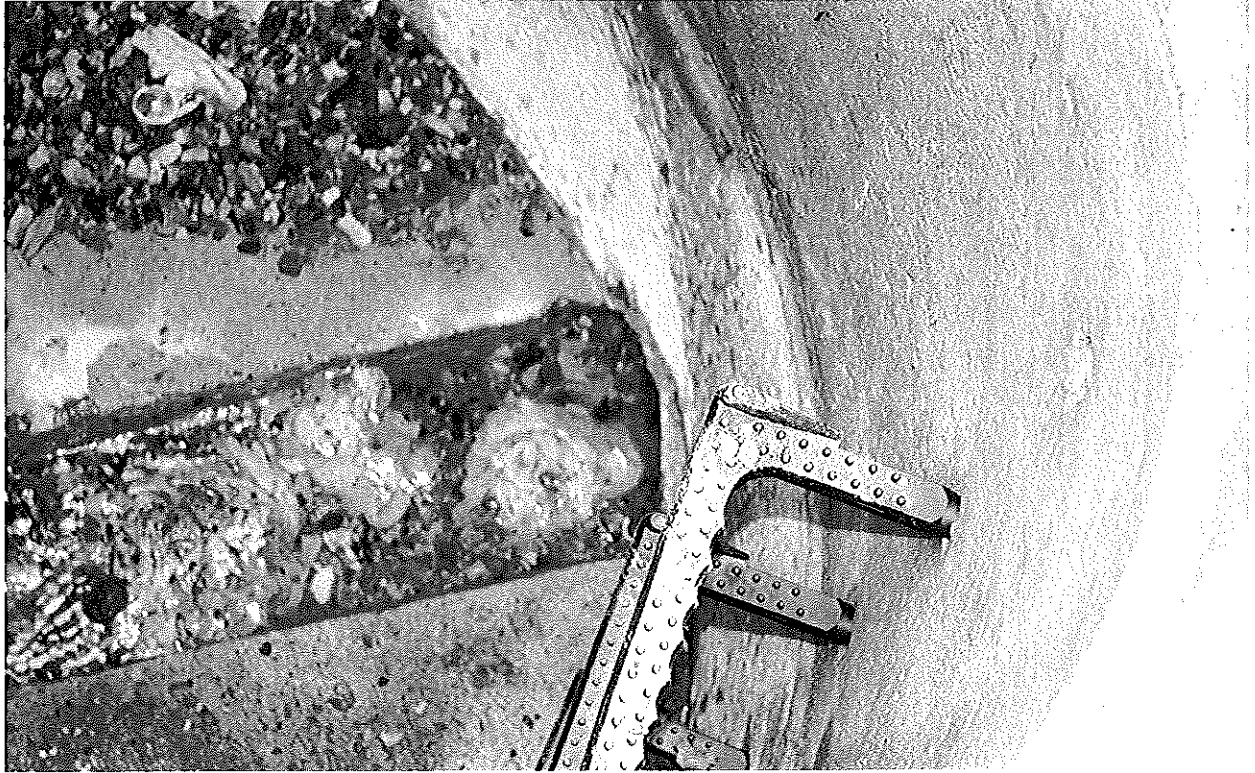
“Exhibit C”

Taken 3/18/2011 @ 6:30pm. Shows sewer inflow. 8 inch pipe. Obstructed flow of pipe limited to approximately 3 inches free flow. Water flowing thru was at same rate as that flowing in Hwy 39 ditch flowing toward intersection above ground storm drain under Hwy 39. Water flowing thru sewer was very pristine and as clear as that in ditch.

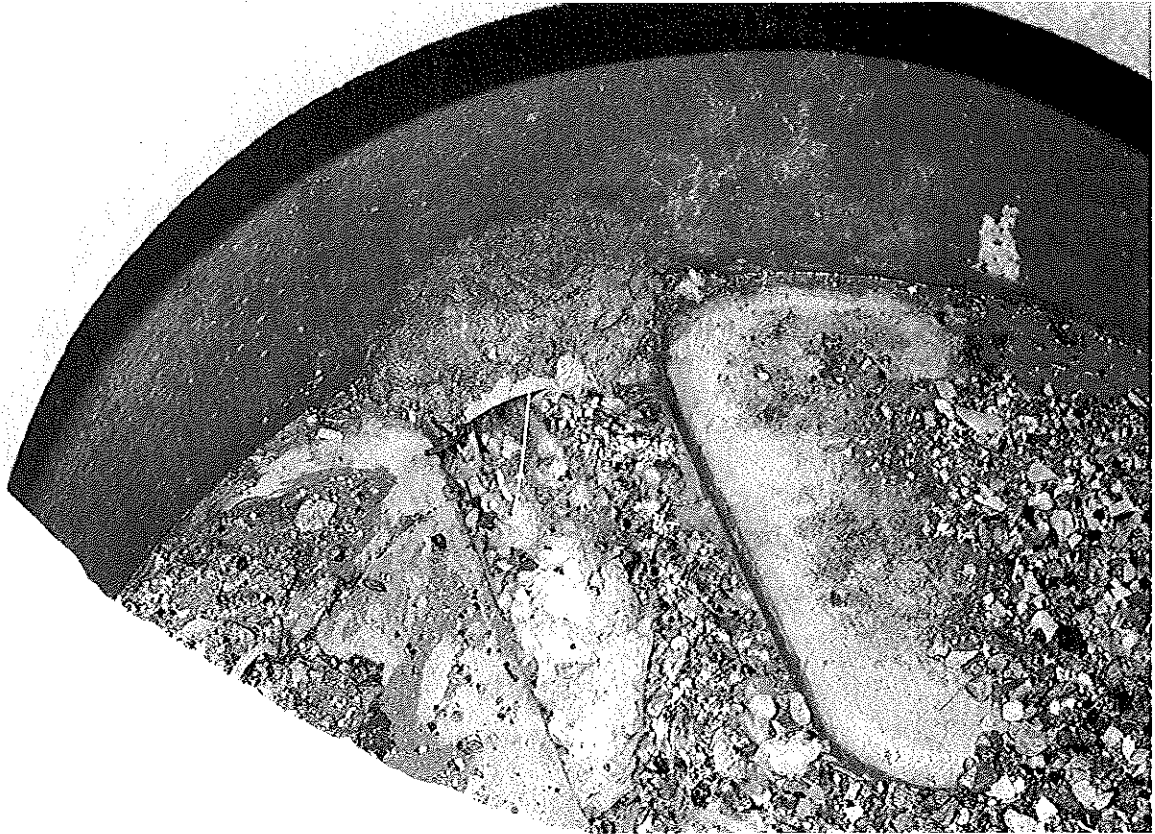
Taken 3/18/2011 @ 6:31pm. 8 inch outflow pipe. Has only about 1 to 1.5 inches max of clear free flow.

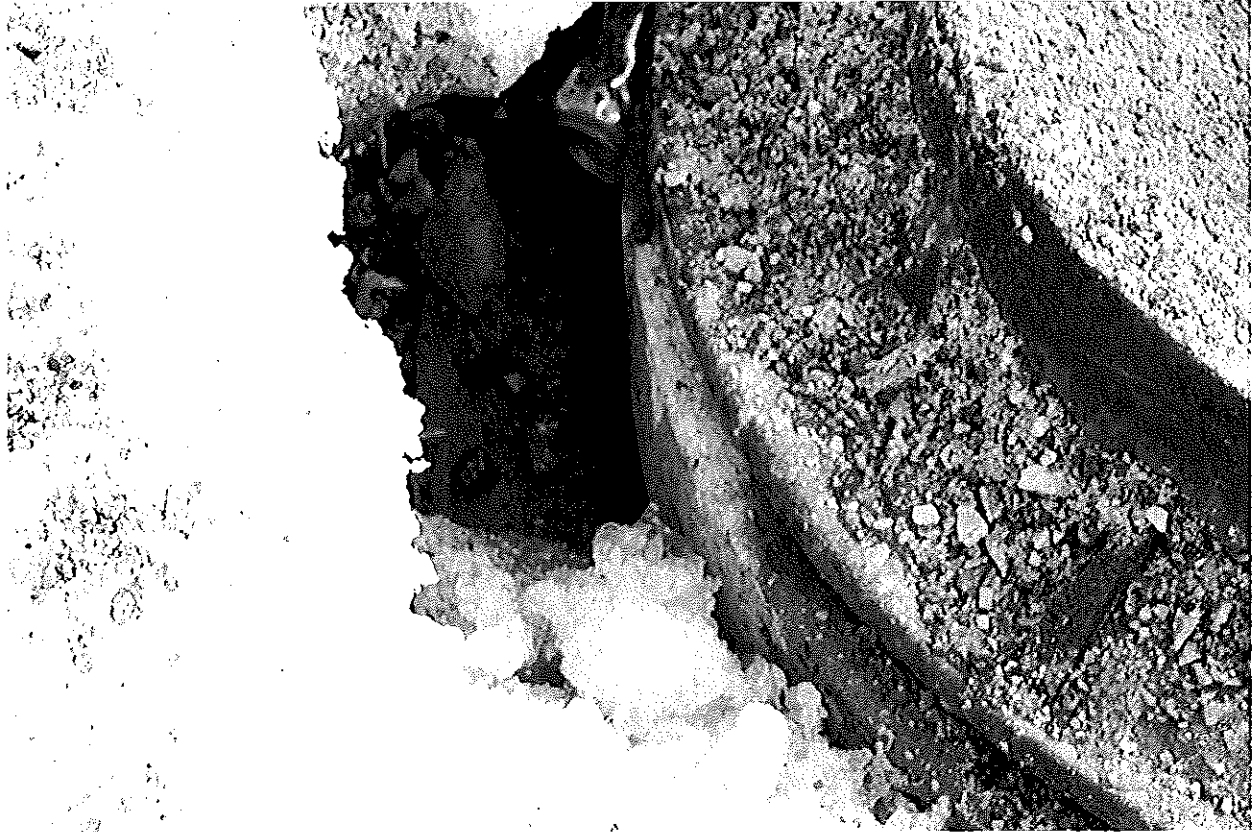
“Exhibit E”

Taken 3/17/2011 @ 4:26pm. Sewer manhole cover slid & first grade ring slid approx 1 to 1.5 inches off center from the 2nd grade ring.

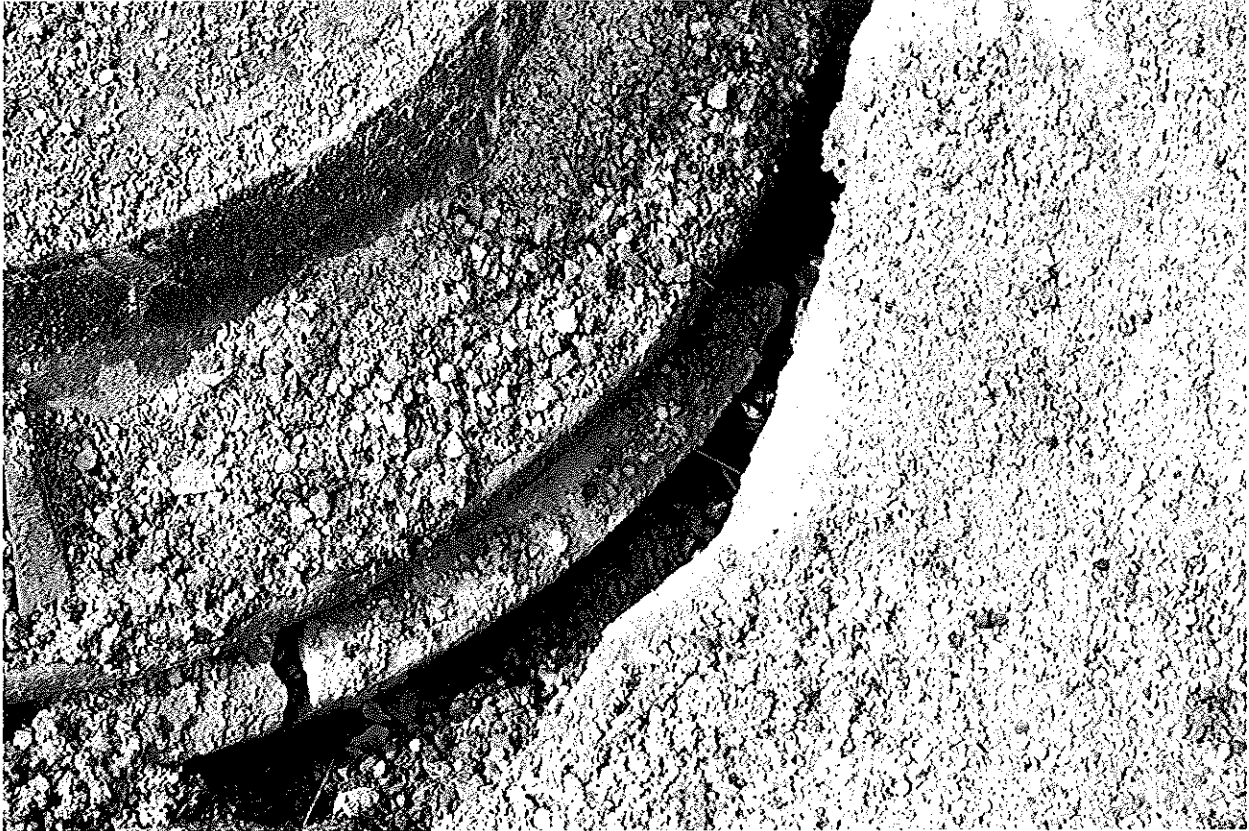
Taken 3/17/2011 @ 4:27pm. Showing broken first or last level grade ring.
