# **APPENDIX 1**

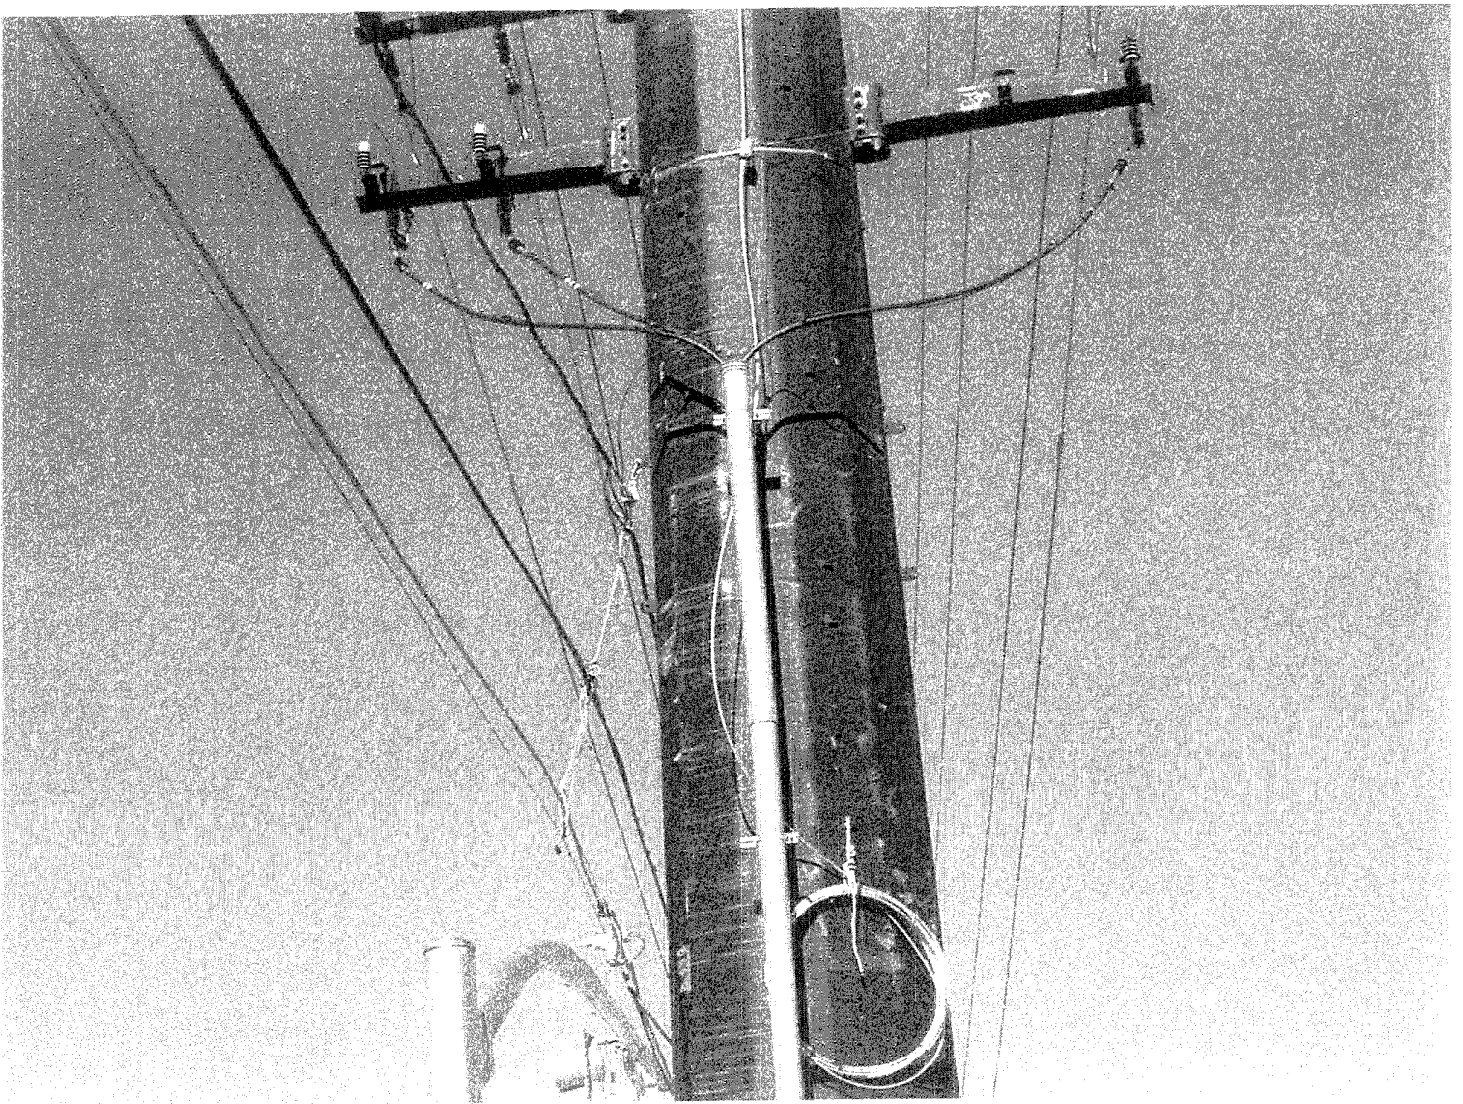
# PHOTO 1

This is the pole that I mentioned in my initial testimony. The power company transferred Comcast's cable from the old pole to this new large black transmission structure and "secured" the Comcast cable to electric conductors above it with rope. This is a very unsafe practice because the rope deteriorates quickly in the sunlight and breaks. PacifiCorp, as is its current practice, provided no notice to Comcast that it was doing this.

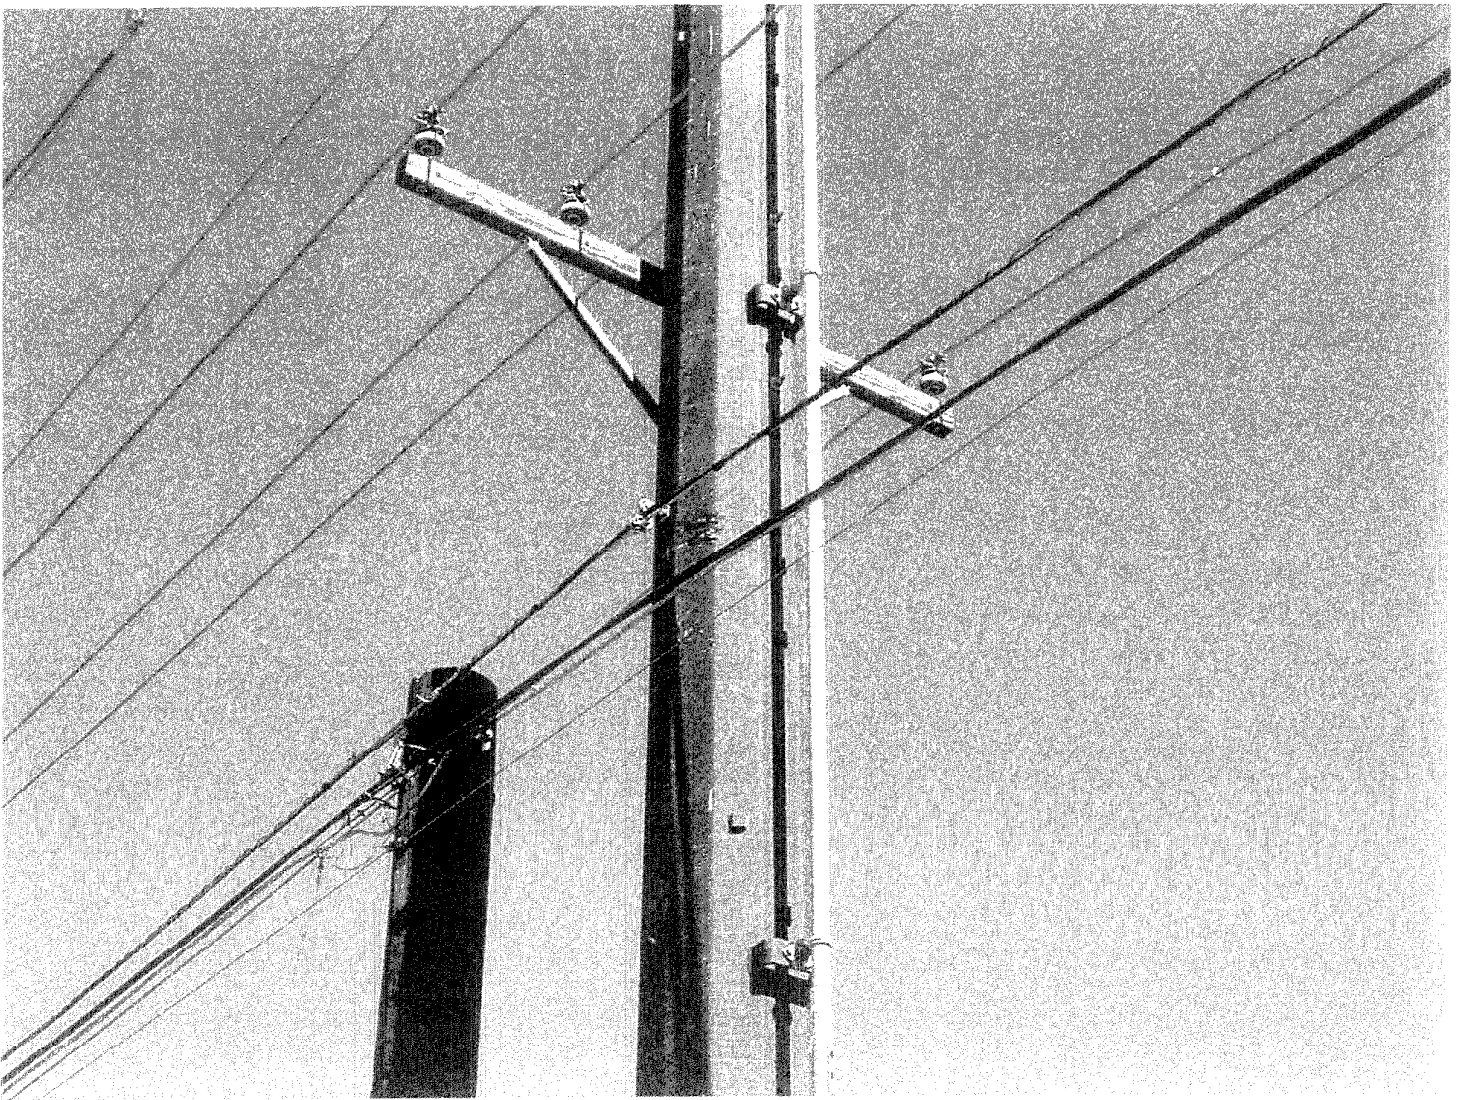
## PHOTOS 2 and 3

These two photos show that PacifiCorp has replaced an existing wooden pole with a large metal transmission structure with under-built distribution circuits. PacifiCorp has built down on the new transmission pole to within inches of Comcast's facilities so that Comcast will not be able to lower its facilities sufficiently to transfer from the old pole to the new structure. Comcast will most likely need to place its facilities underground at considerable cost. This situation could have been avoided if PacifiCorp had raised its facilities sufficiently to allow Comcast to make the transfer and I think illustrates the need for cooperation and good communication between joint users that I have emphasized throughout my testimony.

The second photograph identifies the old wooden pole that is in the first photo of this series.

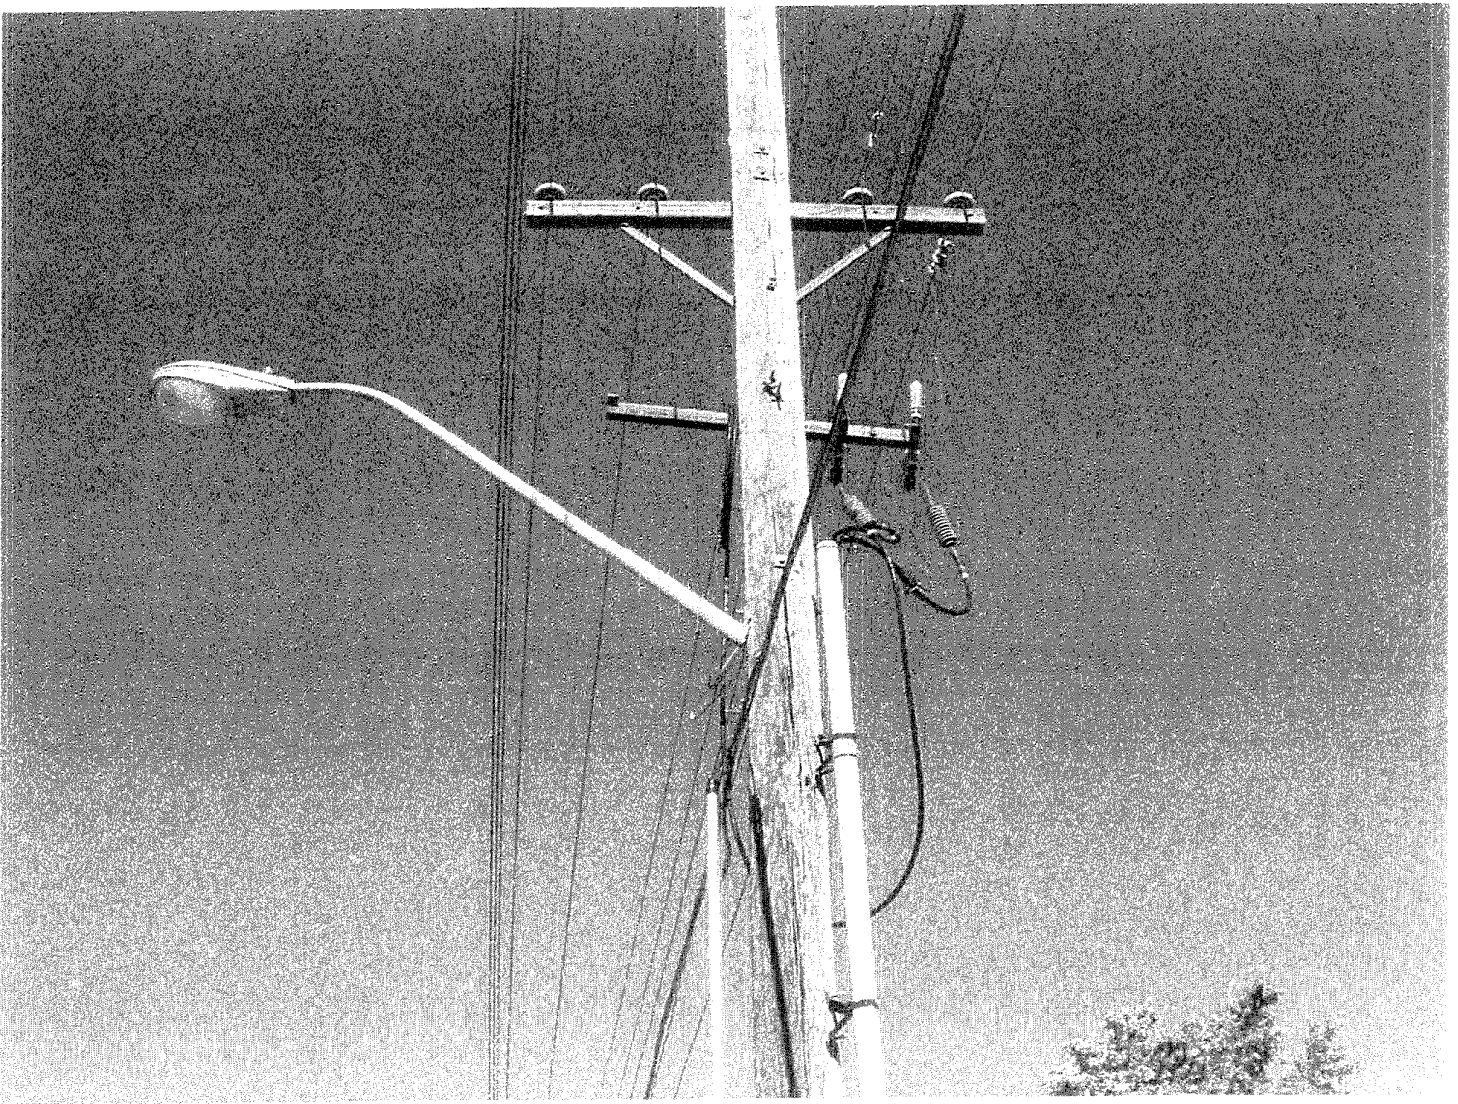
#### PHOTO 4

This photo shows a number of very unsafe PacifiCorp construction practices. It can be clearly seen that PacifiCorp has left an (ungrounded) primary voltage cable looping out of the riser conduit, behind the pole, under communications and then coiled on the opposite side of the pole around the lower cross arm. This violates a number of clear-cut safety standards including work rules in NESC Part 4 and the PacifiCorp construction standards. This photo also shows that the street light lead is less than 12 inches above the communications cable. The cable tv line has been in place for many years. It is likely that the light has been placed or replaced after the cable was installed.

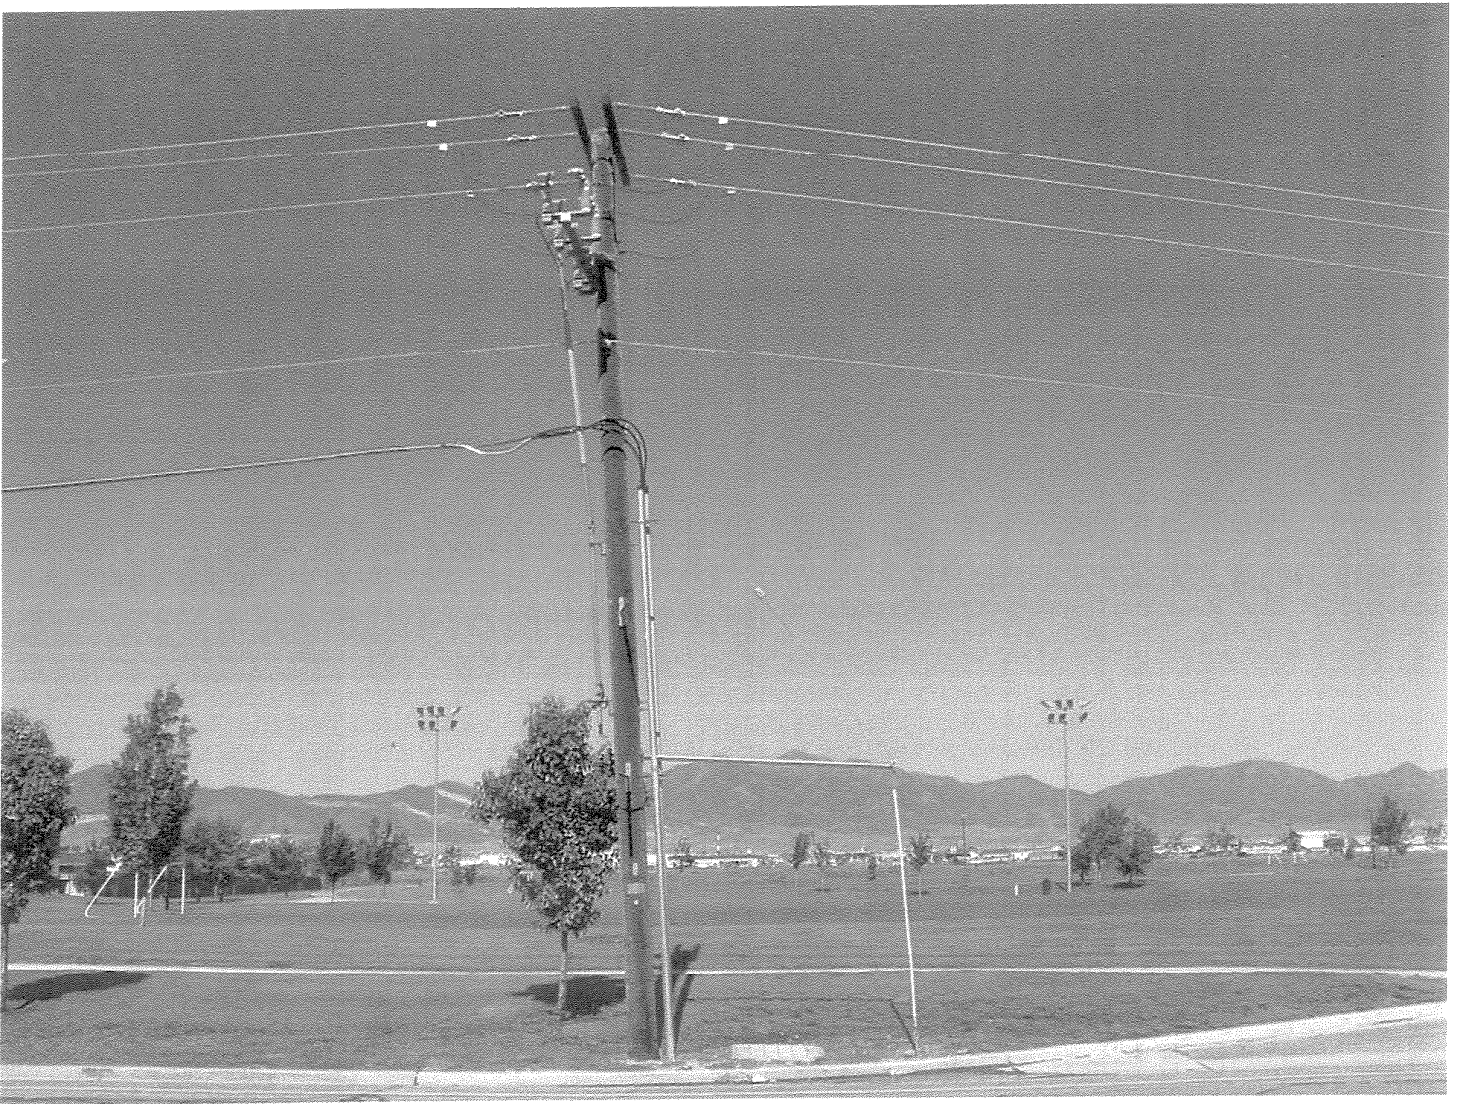
## PHOTO 5

The next two photos show situations in which I believe that PacifiCorp has acted unreasonably with respect to Comcast because PacifiCorp refused to re-sag its lines. It could have done this with minimal expense. It refused, and Comcast was forced to bury its cable underground.

The first photo depicts the Comcast cable, the lowest on the pole, going down metal conduit risers down the pole and underground because the power line sags too low and PacifiCorp was unwilling to re-sag it.

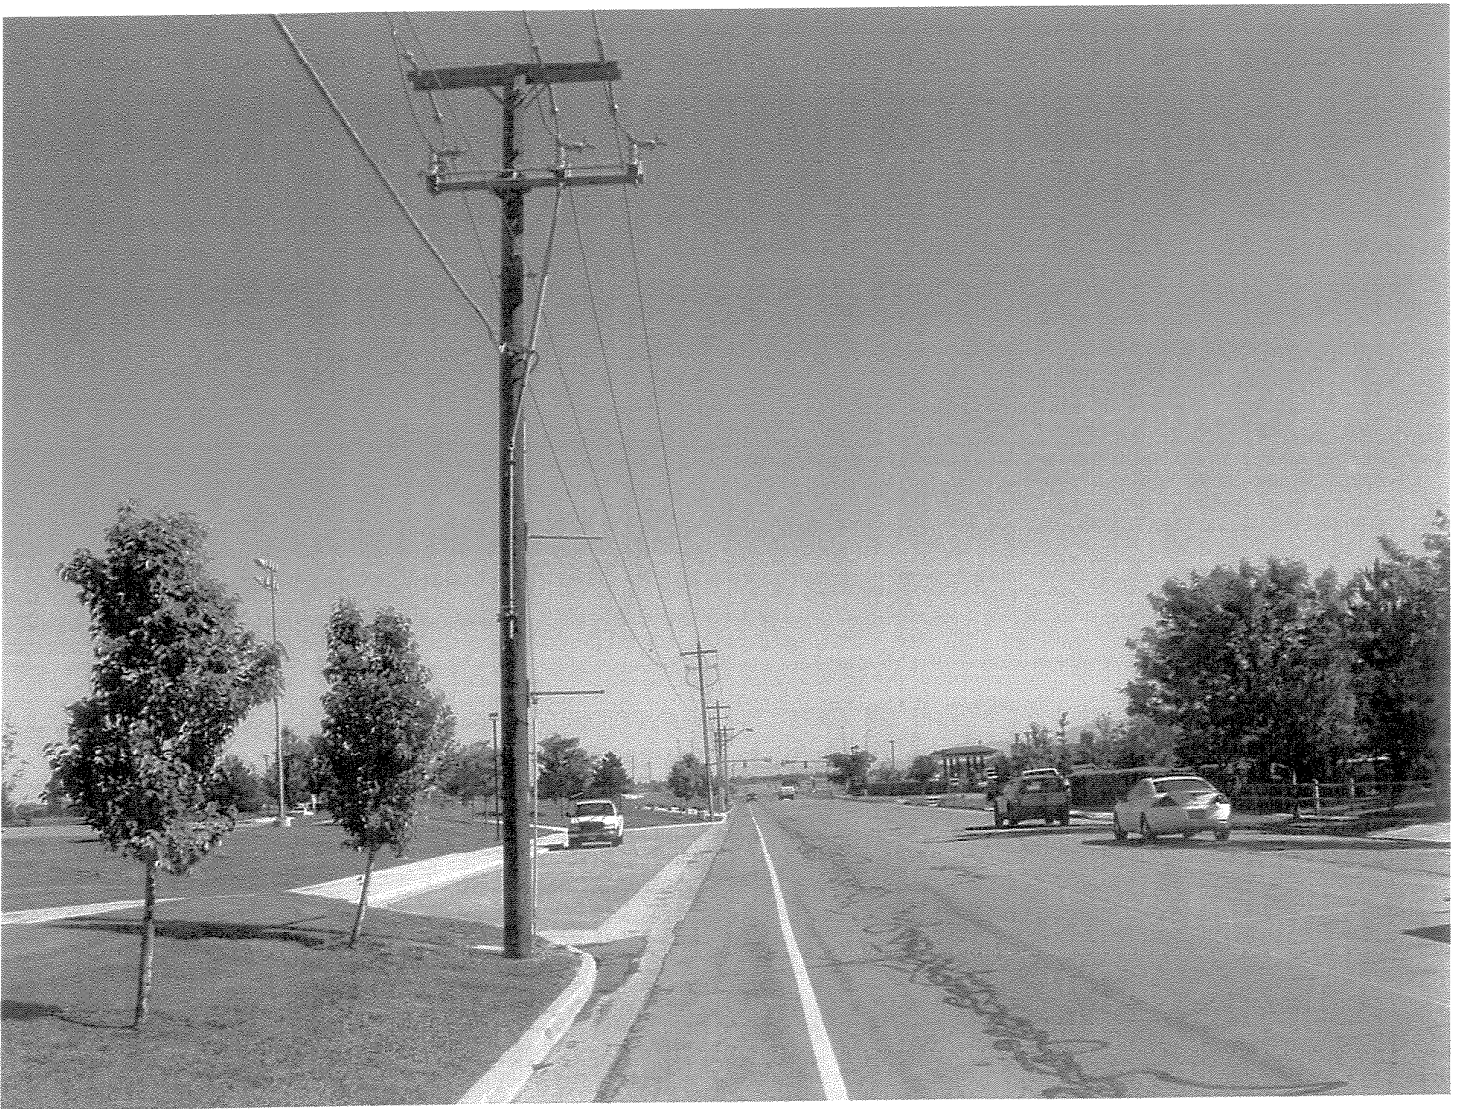
## PHOTO 6

This photo shows the same pole depicted in the previous photo, and shows the deep sag in the electric facilities that the power company was unwilling to fix.

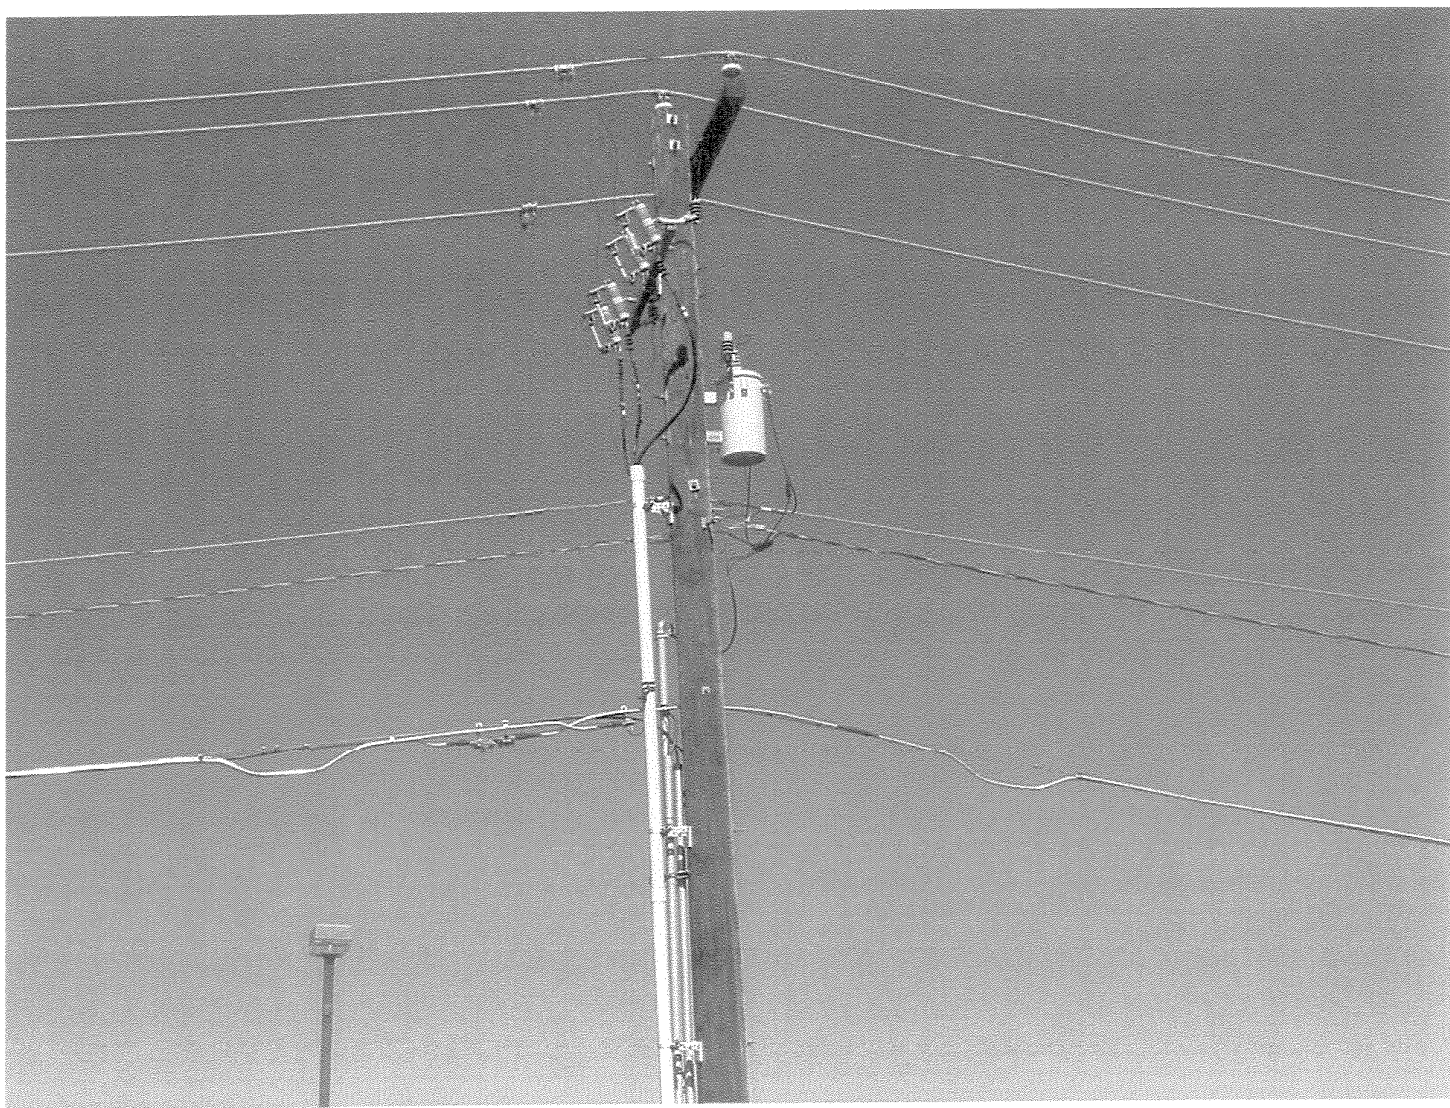
## PHOTO 7

The next two photos show very clearly that the electric utility has a secondary connection to a weather head that is much lower than the required 40" clearance for this sort of configuration. The next photo shows a similar violation.

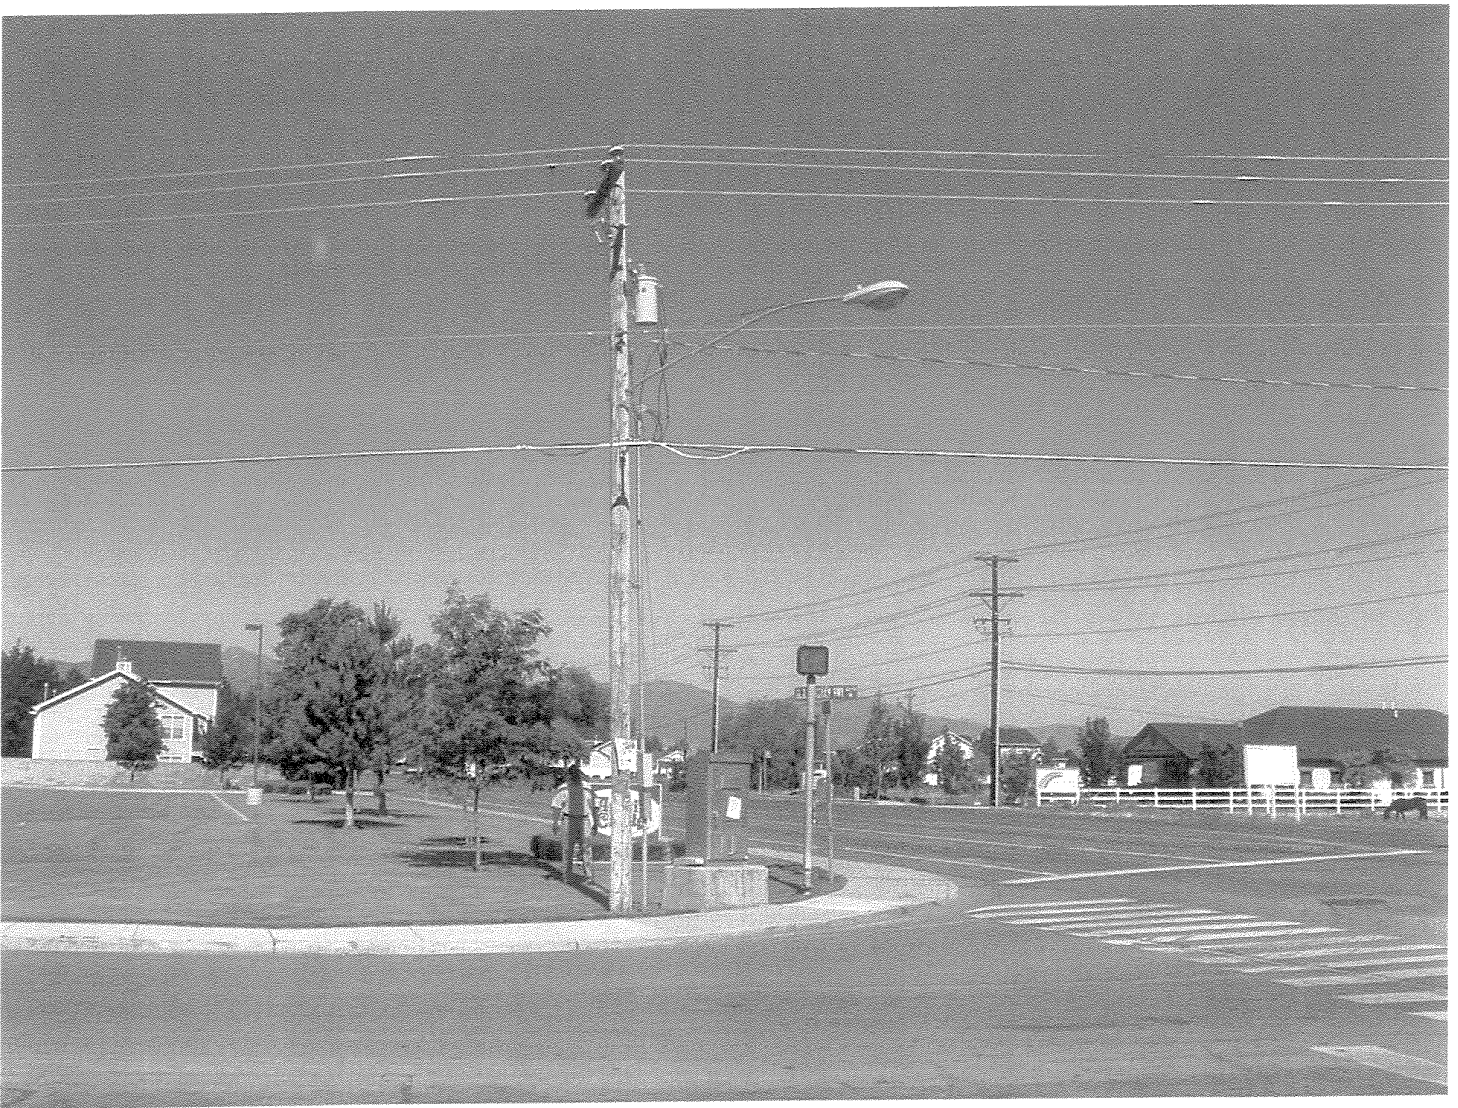
## PHOTO 8

This is another example of another weather head violation of the communications space. Notice that the power loops coming out of the transformer and into the weather head actually dip below the cable tv line at the bottom of the pole. The cable tv facility has been there for years, and the power to the traffic signal controller is relatively new. Comcast's Rodney Bell is very familiar with Comcast's plant and informed me that the cable plant was already in place when the electric line was connected to the weather head.

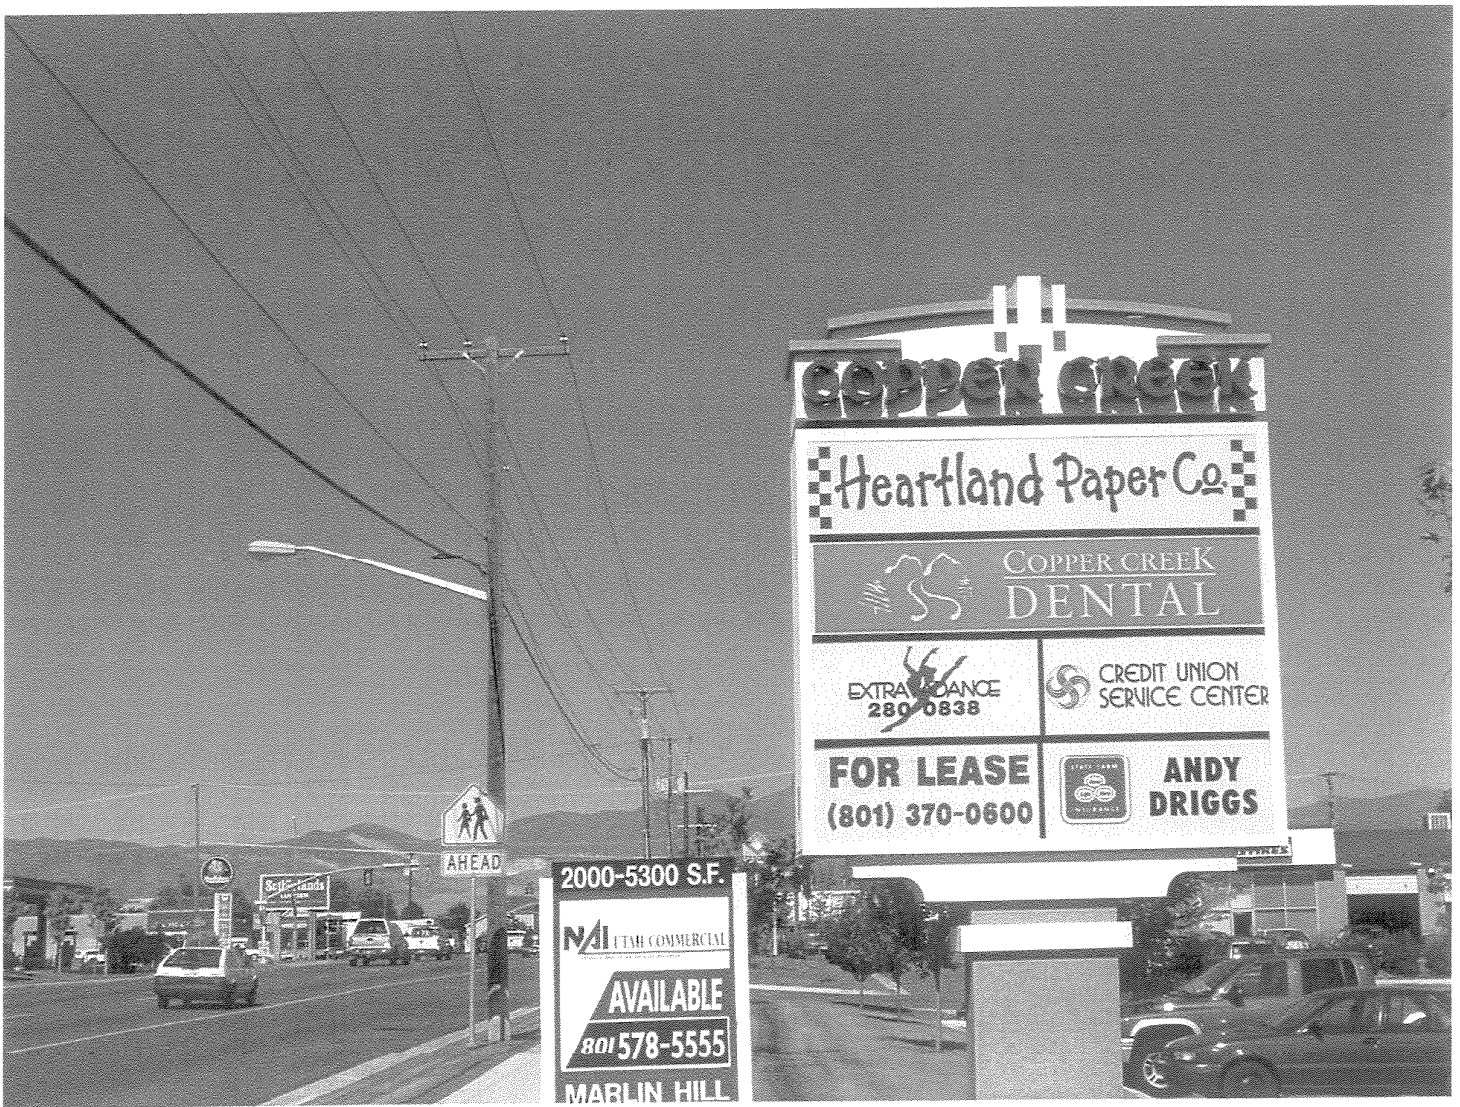
## PHOTO 9

This photo presents an interesting case of an instance in which the electric company has installed the street light just a few inches below communications. This violates NESC rules 238D and 239G, which requires that street light leads be installed 12 inches *above* communications or 72 inches below. These violations could have been avoided if PacifiCorp had simply notified Comcast that it intended to install a street light, and Comcast could have re-worked its attachment to allow the streetlight to be properly installed. It is also clear from this photograph that the street light supply cable coming from the next pole in the run (toward the mountains) sags well below the Comcast cable. The NESC requires 30 inches of separation, and this is yet another example of how easy it is for the power company to clear a violation with proper sagging and tensioning of facilities.

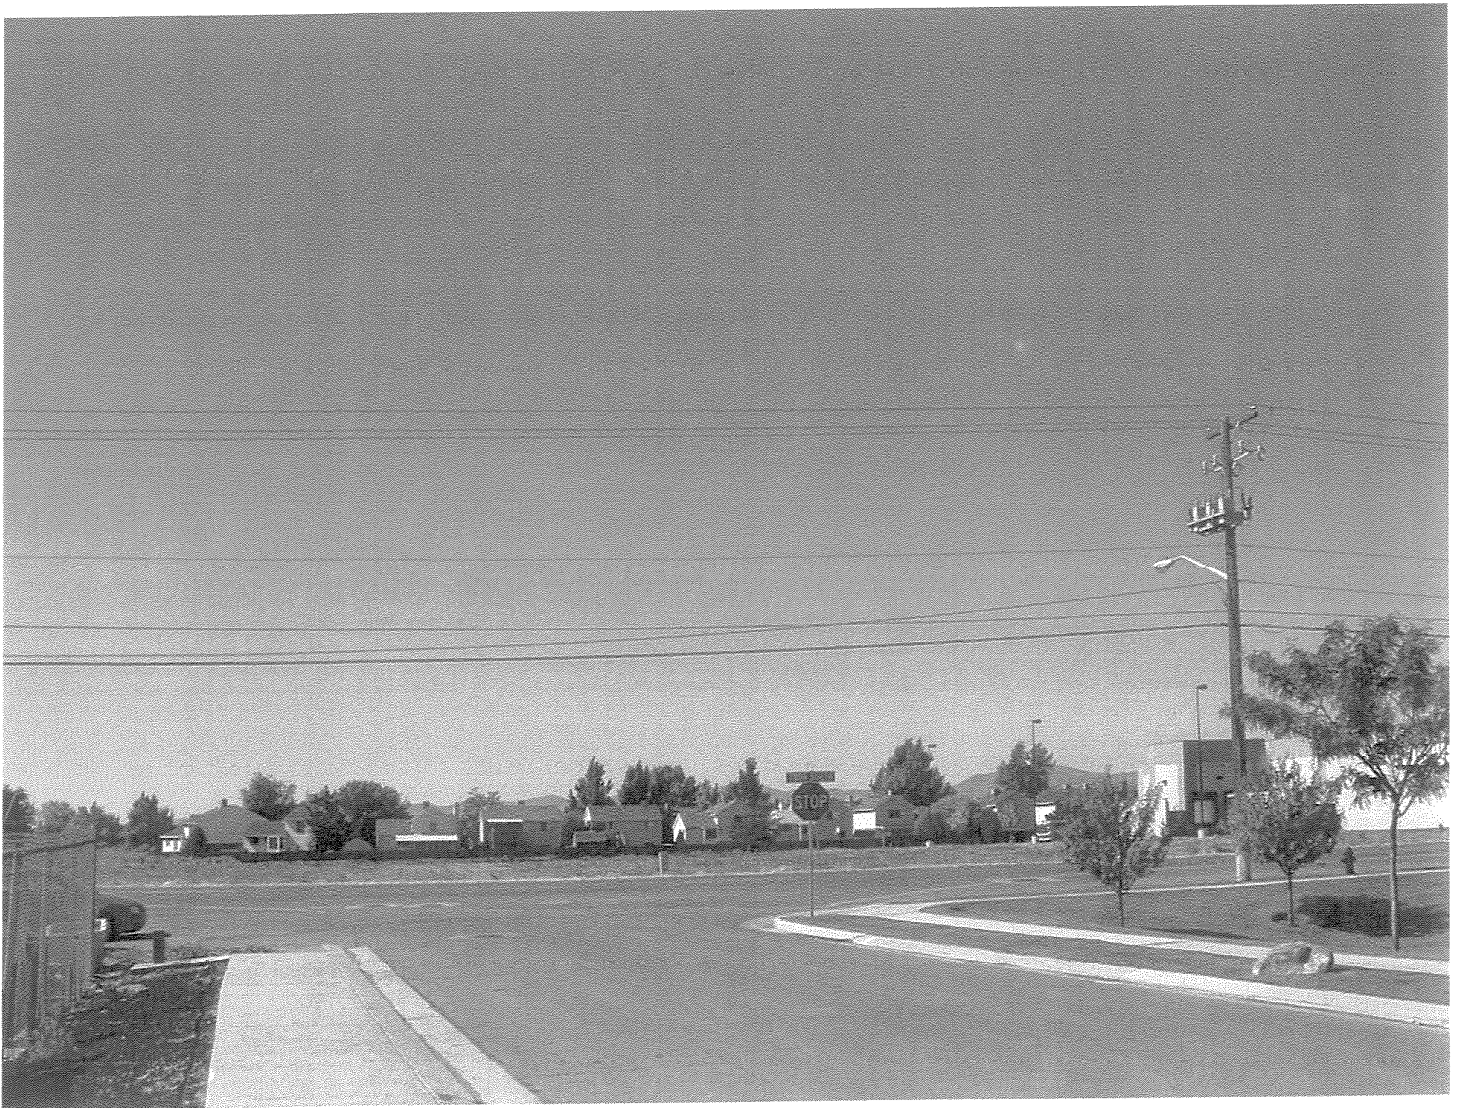
## PHOTO 10

The next photograph is another good example of the widespread occurrence I observed of street light supply cables drooping too close, or even below communications. This, again, often can be cleared up by re-tensioning the electric cable.

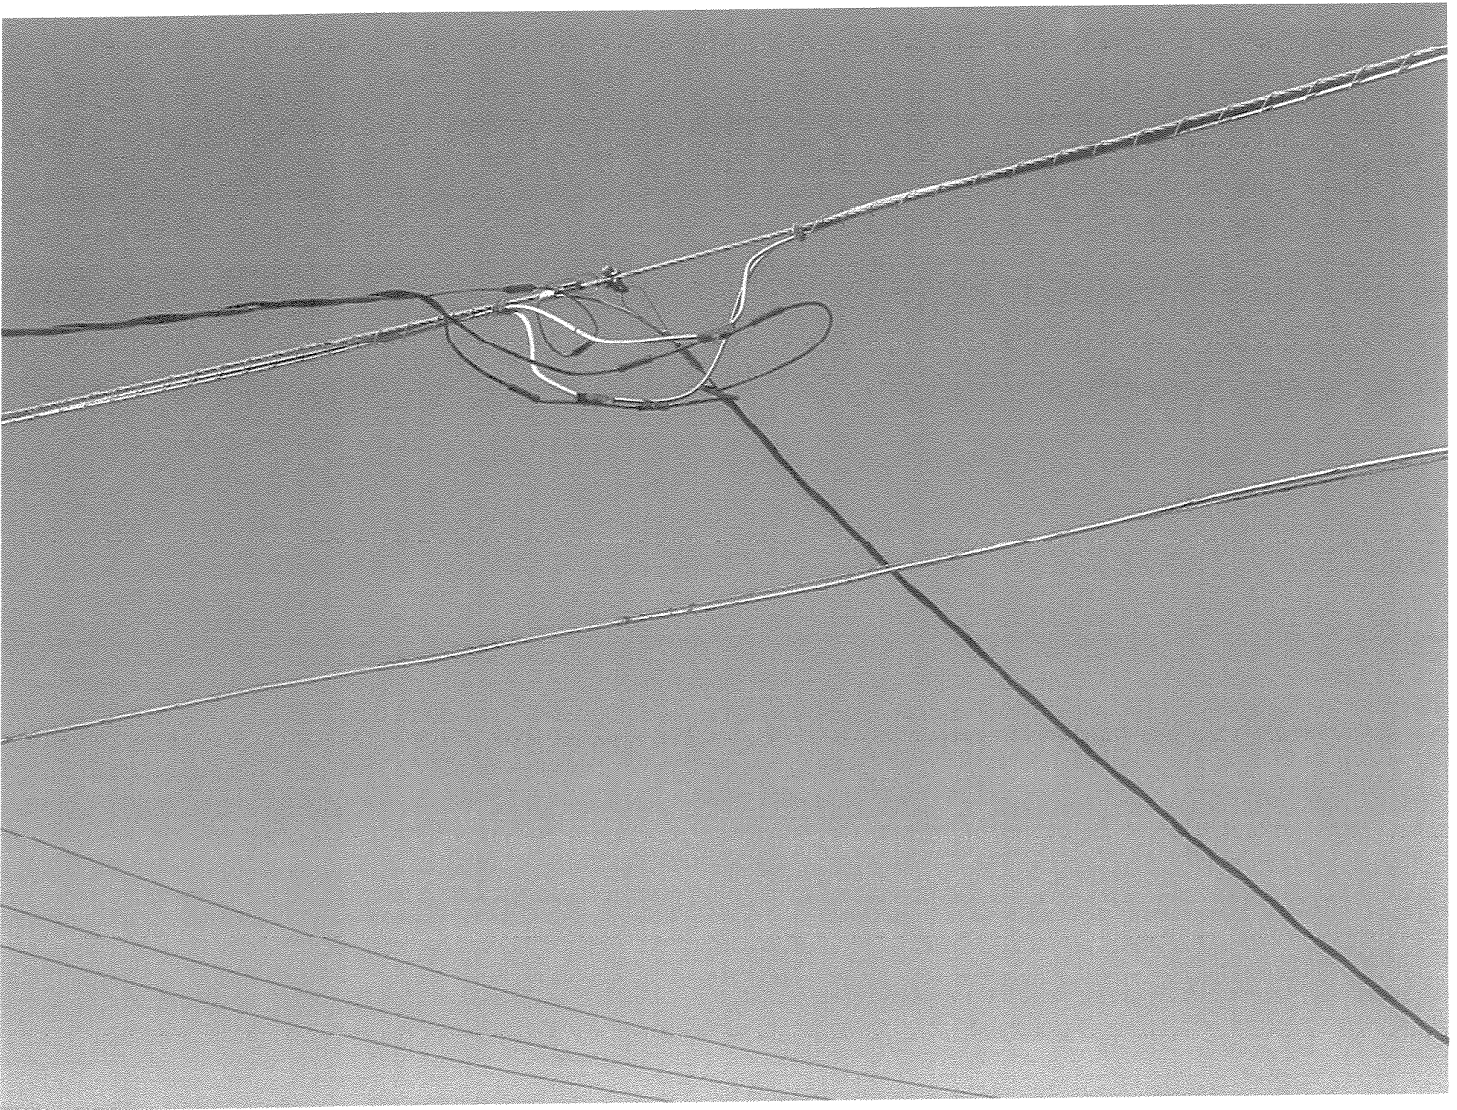
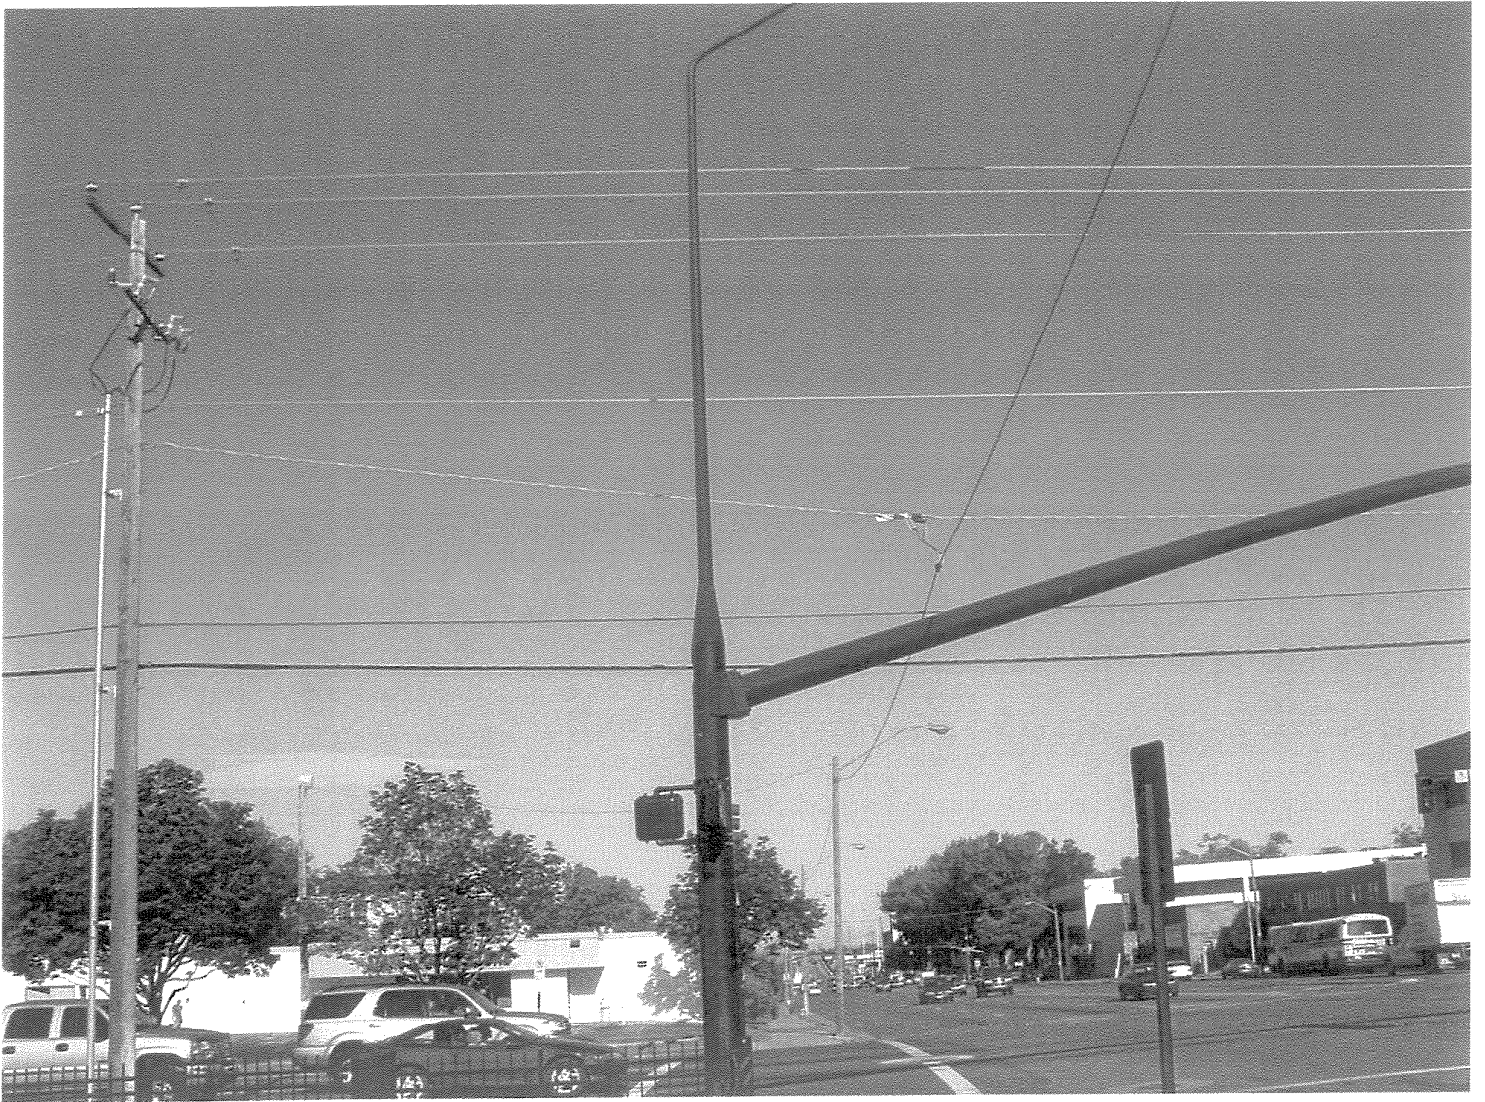
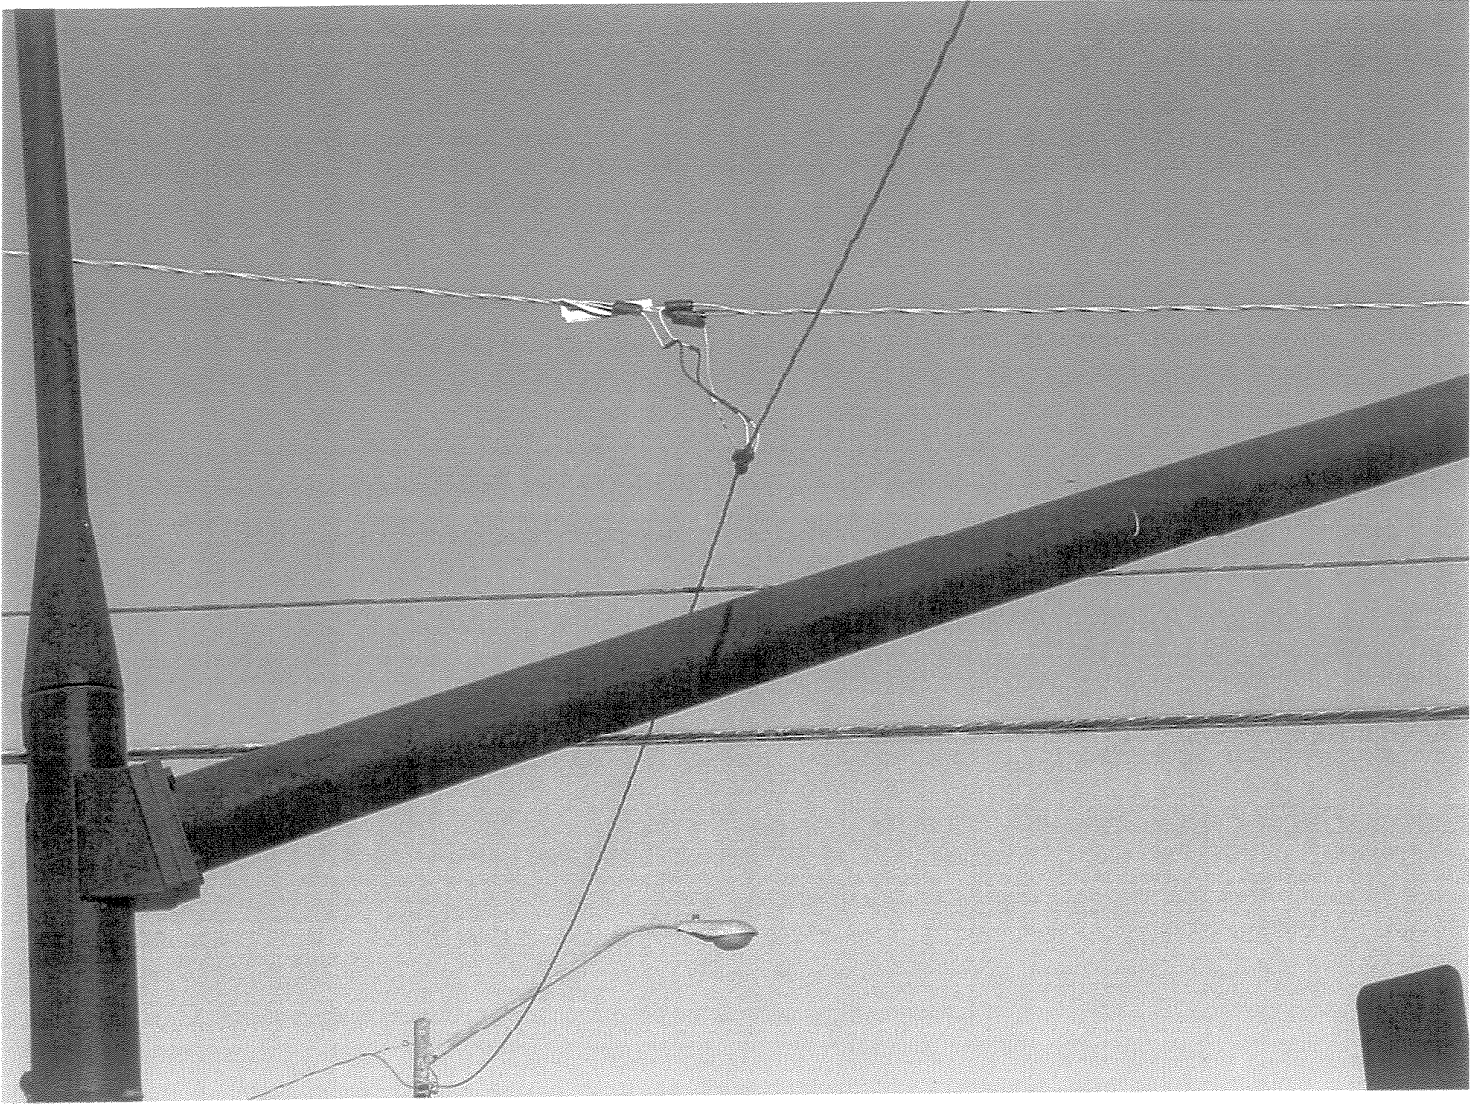
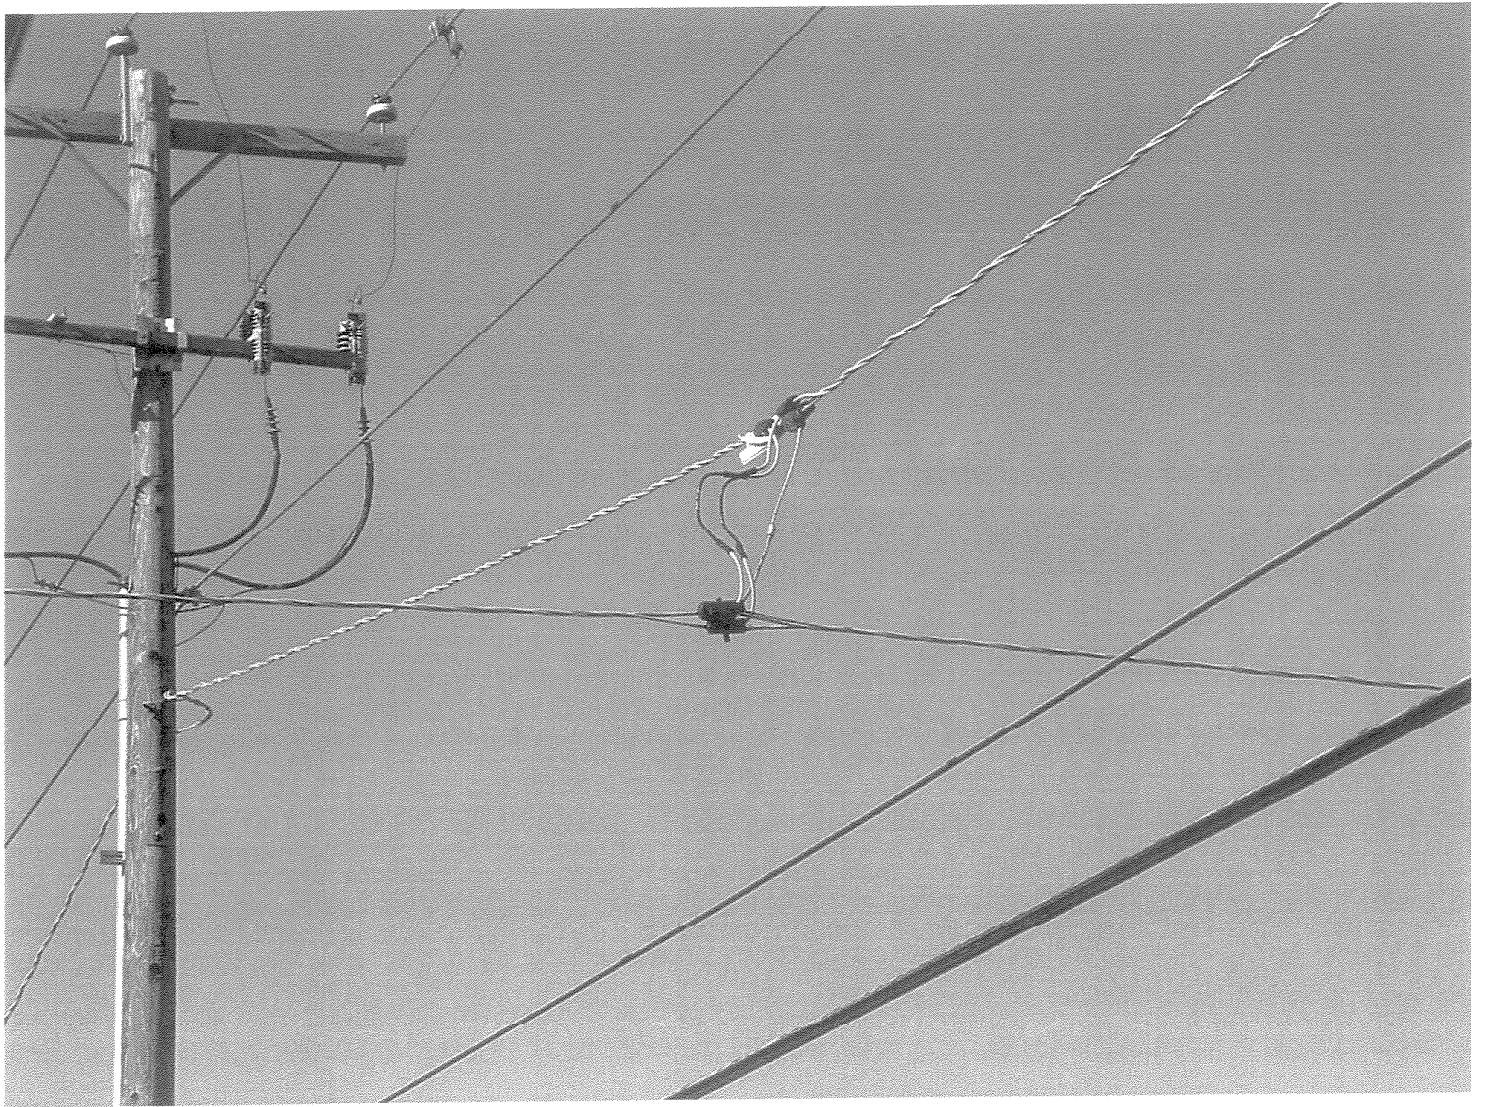
### **PHOTOS 11, 12, 13 and 14**

An example of another type of violation that I saw very often appears in photos 11-14. These are good examples of the common PacifiCorp practice of connecting electric service wires in the span between poles. This creates additional weight on the span and forces the secondary cable into violation with cable because the correct NESC clearances are not maintained. This violates NESC Rule 235C2B. A similar violation can be found in the next three photos, 12, 13 and 14, which, while supplying street lights as opposed to customer services drops, create an identical violation of the 30-inch rule.
