# **APPENDIX 1**

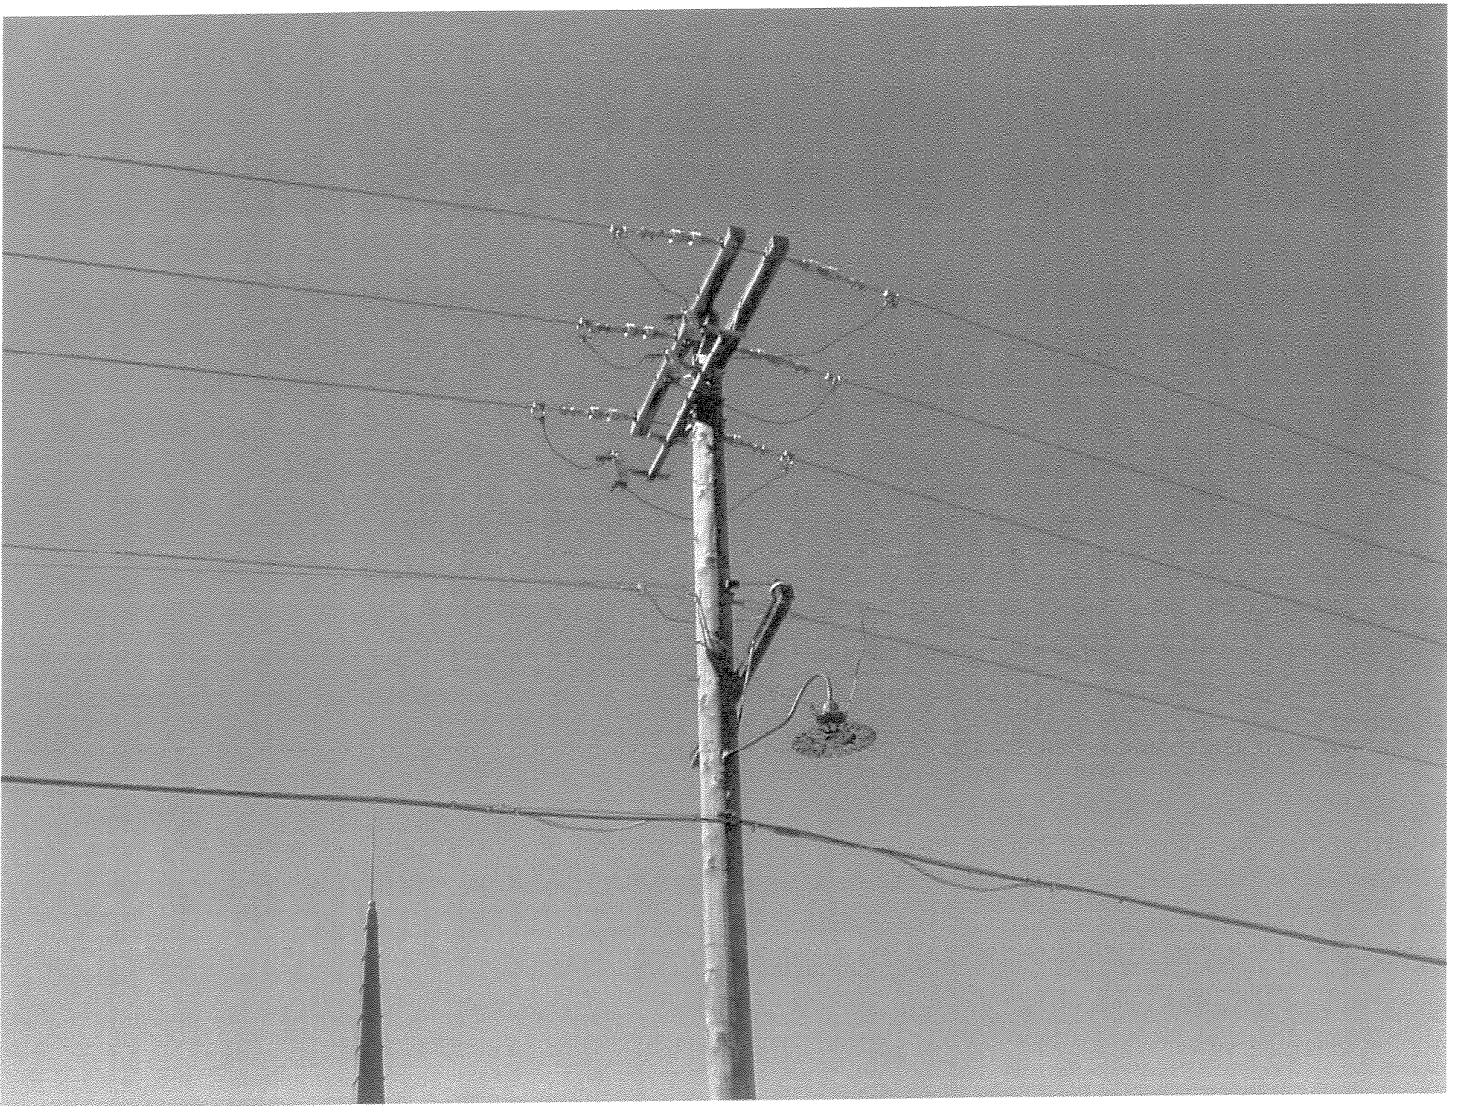
## PHOTO 15

Here you can see a relatively new PacifiCorp pole (I would estimate that it has been in place for only a year or two). While the pole is new, it shows that PacifiCorp has retained an incandescent street light fixture that virtually all power companies phased out between 30 and 50 years ago. I include this because it shows that PacifiCorp is using wiring techniques that are very old. In fact, I would expect that PacifiCorp would be hoping to eliminate this kind of configuration at some point. Notice in this photo how the street light leads go directly from the series circuit down to near the light-bulb socket. This series or arc circuit is on the wood cross arm with the primary voltage conductor on the shorter poles that you will notice in the next (and last) photograph. Its location on the primary arm makes it more hazardous to work on or near.

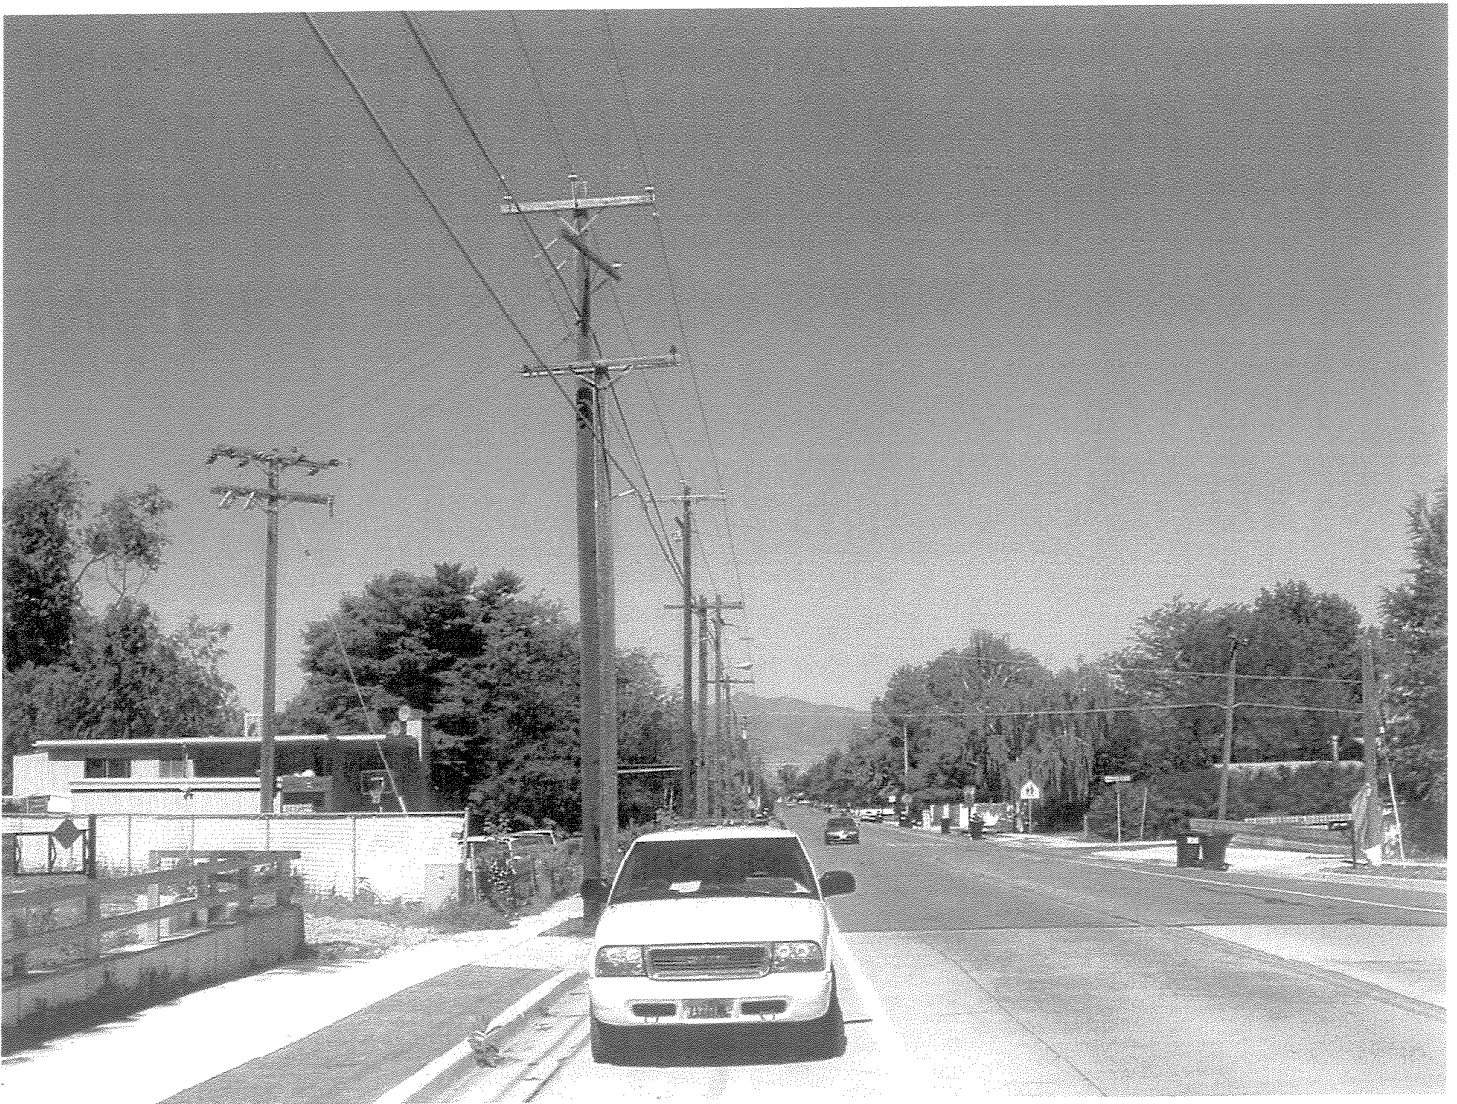
## PHOTO 16

While you cannot tell clearly from this photograph, I personally observed that this series (street light) circuit continued not only for a few poles, but for miles. It is possible for workers to work safely around these circuits, but it is quite a bit trickier than more modern configurations because the low voltage lighting circuit is on the same cross arm as the high-voltage primary conductor. My main purpose in including this level of detail here is to show that PacifiCorp has facilities in place that are obsolete, cumbersome and inefficient by any modern, reasonable standard and which were phased out decades ago by other utilities.
