State of Utah  
Department of Commerce  
Division of Public Utilities

**MEMORANDUM**

Date: September 21, 2004

Re: Docket No. 02-2035-02, and 04-035-01 PacifiCorp's claims to exclude outages attributable to events seven, eight, nine, and ten

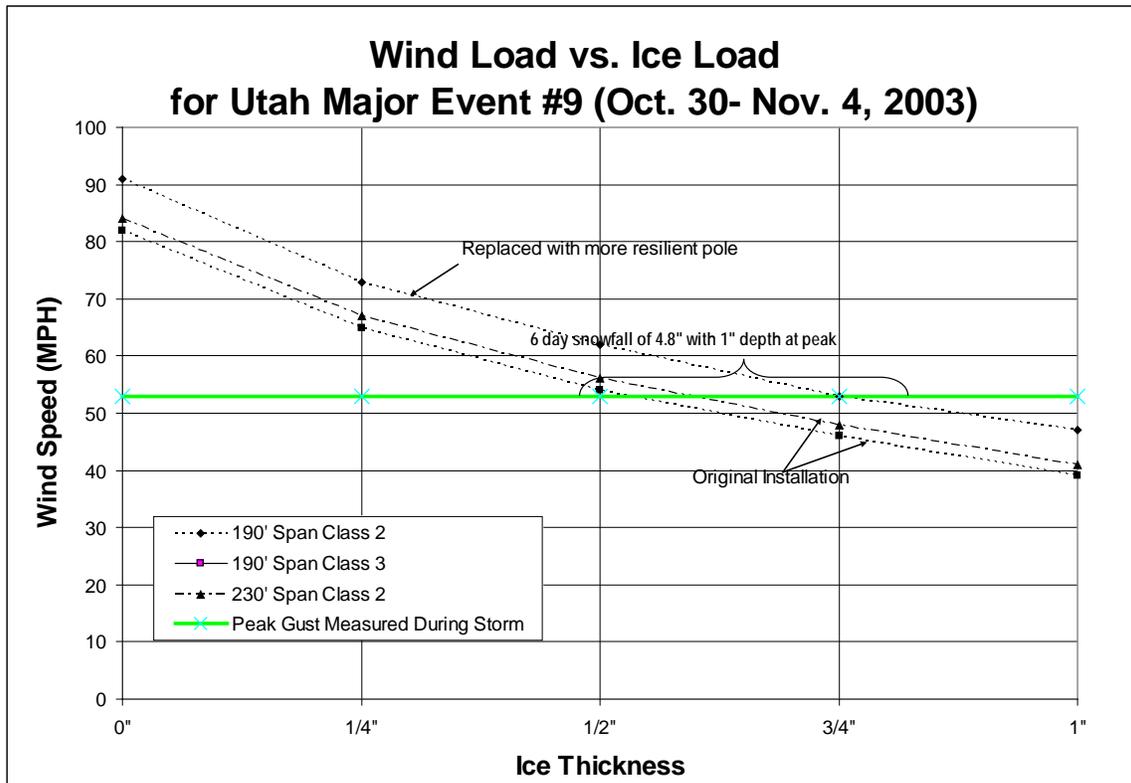
**Figure 1. Calculated Pole Strengths during Event Nine**

According to PacifiCorp, the poles that broke were class 2 poles with 190' span, and were originally installed before 1968. Because of their age, PacifiCorp considers them as having 2/3 of their original strength. These poles were loaded with double-circuit power lines. To determine whether the snow storm and the subsequent winds of October 30 through November 4, 2003 has exceeded the design limit of these poles, one has to determine the maximum combination of wind and ice loads the poles were designed to withstand. Based upon calculations performed by PacifiCorp staff, during this event, in which no allowances were considered for telecommunications or other conductors, the graph shown below was developed. The graph illustrates the combination of ice thickness and wind speed that the poles were constructed and maintained to withstand.

The horizontal axis of the graph is the ice thickness (inches) and the vertical axis of the graph is the wind speed (mph). The horizontal curve represents the peak wind gust at the time of the storm. The three curves labeled as 190ft span class 2, 190ft span class 3, and 230ft span class 2 are the allowable pole strengths for the respective designs to withstand certain combinations of wind speed and ice thickness. For instance, if the installed pole were 190 inches span class 2 and the ice thickness were  $\frac{3}{4}$  of an inch, then the maximum wind speed that the pole can withstand is 53 mph. Any wind speed over 53 mph would break the pole.

The snowstorm of October 30 through November 4, 2003 and the subsequent wind resulted in a combination of 1 inch thick ice around the conductors and a wind gust of 53 mph. For a 190ft span class 2 pole with conductors covered by a 1 inch thick ice, the maximum tolerable wind speed is less than 50 mph. This indicates that the 53 mph wind speed exceeded the design limit of the poles. This resulted in a breakage of 5 distribution

poles, 25 crossarms, 3 braces, a transformer, and 12,083ft conductor and 159 blown fuses (as a result of broken trees and branches).

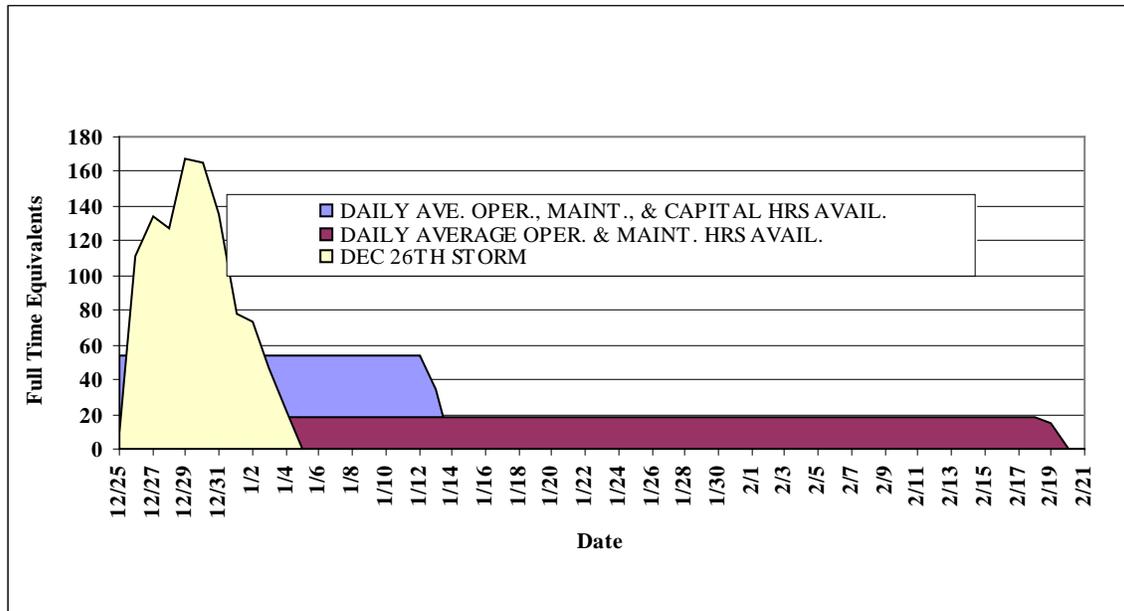
**Figure 2. Length of Restoration Time: Actual Versus Two-Year Average Daily Full Time Equivalents of Internal staff and Contractors.**

The December power outage affected customers in six operating areas, Jordan Valley, Layton, Ogden, Park City, Salt Lake City Metro, and Tooele (As stated above American Fork customer outages and staffing are being excluded from the event). The average daily available wrench turners<sup>2</sup> (in terms of FTE) in these operating areas were about 55. This consisted of about 18 and 25 FTE of Company employees doing normal operations and maintenance (normal maintenance includes, among other things, outage restoration, overhead and underground line maintenance, inspections, customer field orders, and miscellaneous operations) and capital work, respectively, and about 1 and 11 FTE of contract employees doing normal operations and maintenance work and capital work, respectively. However, the Company used 1,069 FTE to restore power. This allowed the

Figure 2 shows that if the Company had to use only its local Company and Contract employees doing the normal operations and maintenance work to restore the power, it would restore power fully by February 19, 2004. If the Company had to use, in addition to the aforementioned employees, local Company and contract employees doing capital work, it would restore power by January 13, 04. Hence, because both of these cases would keep many customers out of power for unnecessarily long time, the Company was forced to call in outside resources. Therefore, since the Company had to use more resources, about 1,069 FTE, than was available, about 55 FTE, the operational limit has been exceeded.

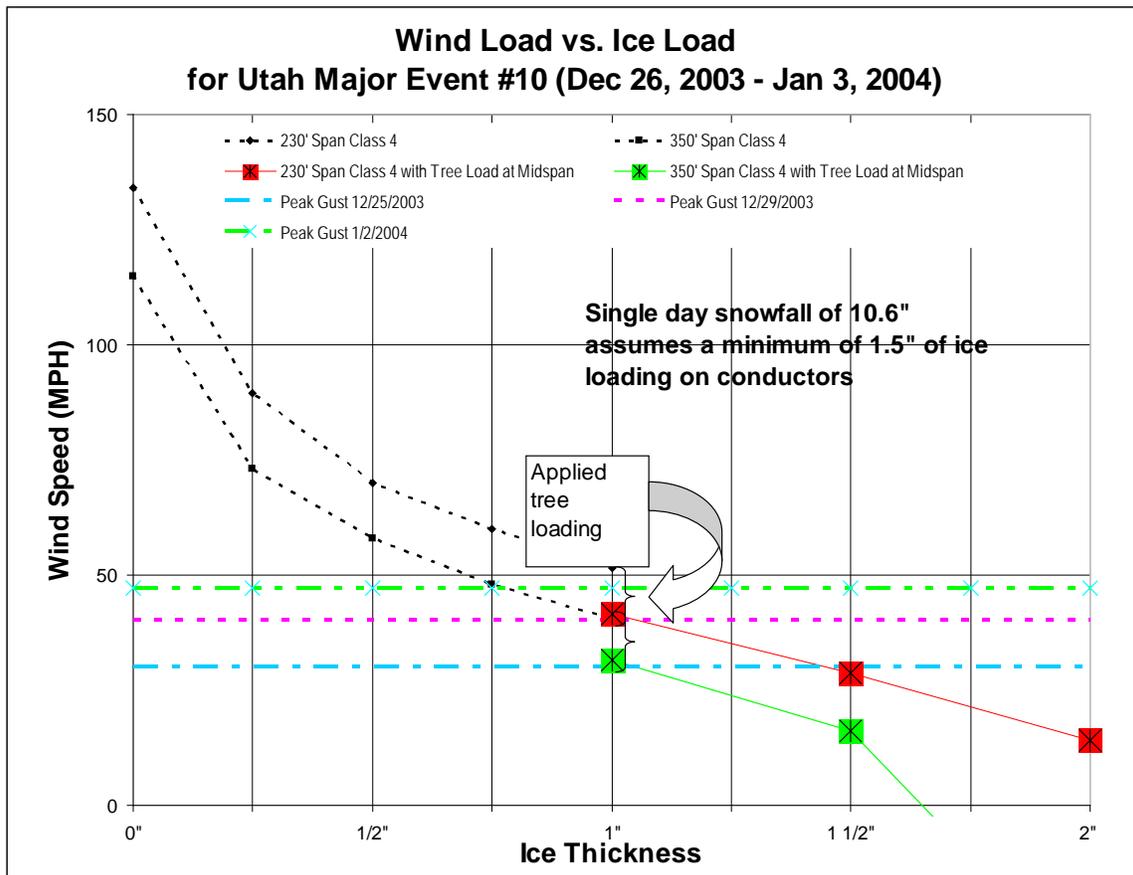
**Figure 3: Calculated Pole Strengths during Event Ten**

According to PacifiCorp, the poles that failed were class 4 with 230ft and 350ft span. These poles were originally installed before 1986, hence are considered as having 2/3 of their original strength. Based upon calculations performed by PacifiCorp staff, during the wind and snow event of December 25, 2003 through January 3, 2004, in which no allowance was taken for telecommunications or other attached conductors (even though these would have reduced the pole's tolerance to ice, wind and tree impacts), the graph shown below was developed (Figure 3). Figure 3 illustrates the combination of ice thickness, wind speed and tree impact that the poles were constructed and maintained to withstand.

The horizontal axis of the graph is the ice thickness (inches) and the vertical axis is the wind speed (mph). The three horizontal curves represent the peak gust wind gust at three different days. The top one is for January 2, 2004, the middle one is for December 29, 2003, and the bottom one is for December 25, 2003. The two downward slopping curves are the allowable pole strengths for the respective designs to withstand certain combinations of wind speed, ice thickness and tree impact. The top one is for class 4 pole with a span of 230ft. The bottom one is for class 4 pole with a span of 350ft. The portion of these graphs to the left of 1 inch ice thickness shows the combination of wind speed and ice thickness that the poles are designed to tolerate. After the 1 inch ice thickness level, the tree impact is imposed resulting in a downward shift of the curves.

Figure 3 shows that the 230ft span, class 4 and the 350ft span, class 4 poles that failed would have been able to withstand wind speeds of about 16 and 28 mph, respectively, when stressed with 1.5 inches of ice load and the load of the fallen trees. Therefore, the conditions that occurred during the December 25, 2003 through January 3, 2004 event exceeded the design limits of the facilities.
