Appendix 1
Incident Report
Fault on 46 kV Power System near the Boeing Facility

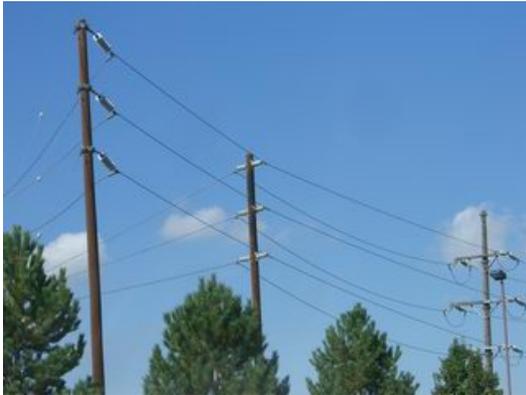
The fault occurred on the center pole shown in the photo on the left. The fault was witnessed by persons at Boeing, and appeared to be lightning-caused. It caused some surface blackening of the pole and damage to the insulators. This blackening and damage are shown in the closeup of the insulators in the second photo below. In this second photo the damage to the insulators is evident in the brown discoloration at the base of the upper two insulators.
