**ROCKY MOUNTAIN  
POWER**  
A DIVISION OF PACIFICORP

Re: Utah Docket No. 06-035-148  
Formal Complaint of Tim Vetere

**OREM OFFICE**  
287 EAST 950 SOUTH  
OREM, UTAH 84058  
PHONE: (801) 404-5336  
FAX: (801) 404-5337  
www.hansenallenluce.com

RE: Tim Vetere Pump Evaluation

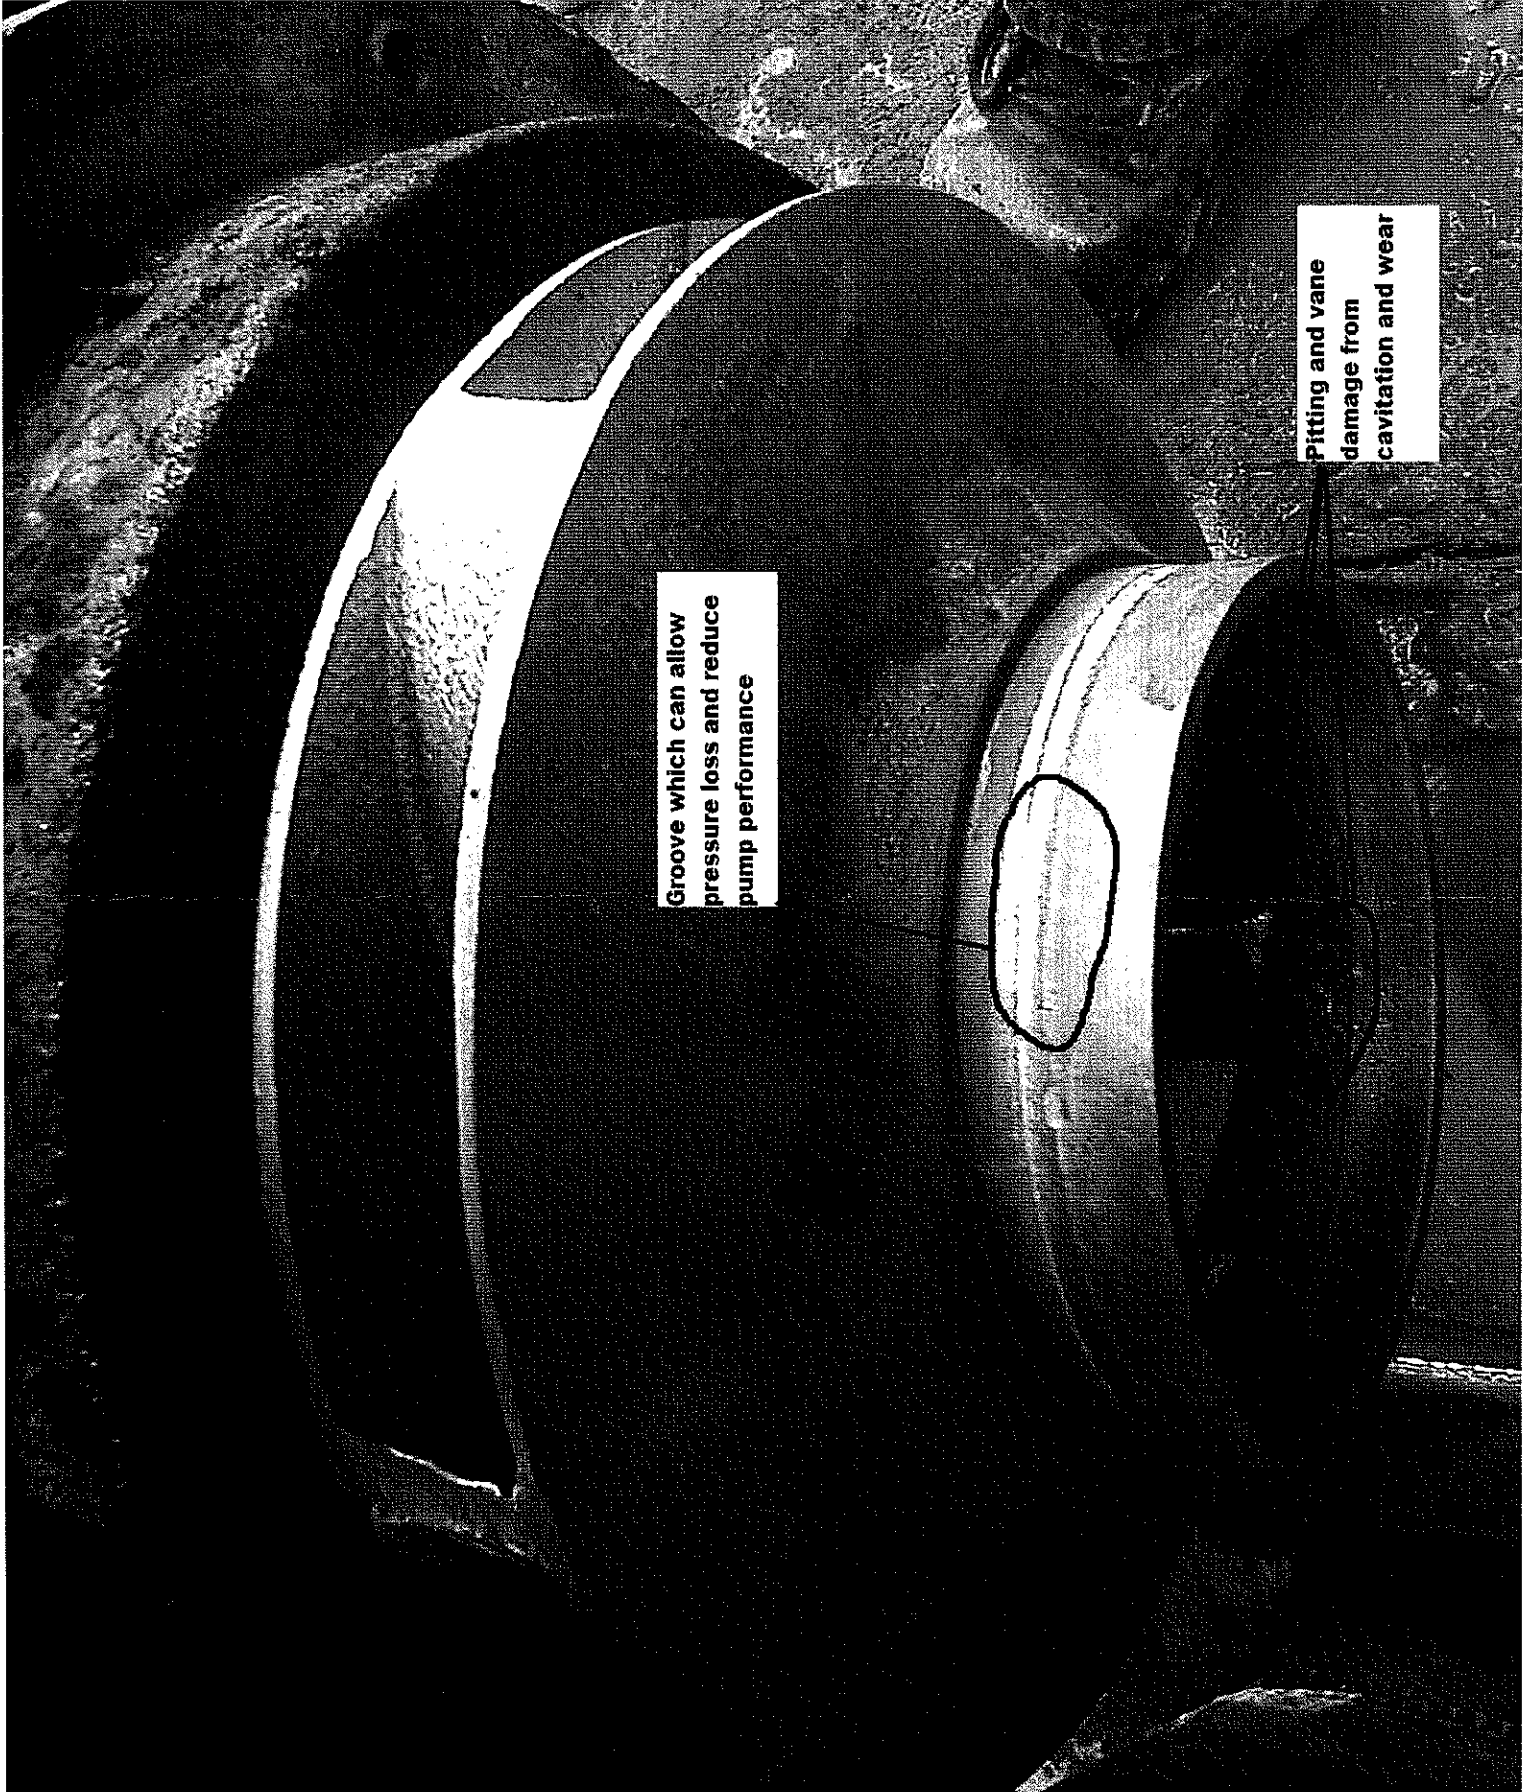
Based on the information previously reviewed, the Booster Pump is operating at approximately 60% efficiency. The pump should be operating above 80% efficiency at its design head. Inspection of the impeller shows two causes of concern. One is a groove around smaller brass ring. This will allow water to leak around the impeller vanes. There are also indications of pitting and cavitation damage around the vanes of the impeller. Both of these conditions will reduce the efficiency of the pump.

Groove which can allow pressure loss and reduce pump performance
