September 2, 2020

RE: **Docket No. 20-035-24**  
In the Matter of the Formal Complaint of Scott Macdonald against Rocky Mountain  
Power  
*Response to Request for Supplemental Information*

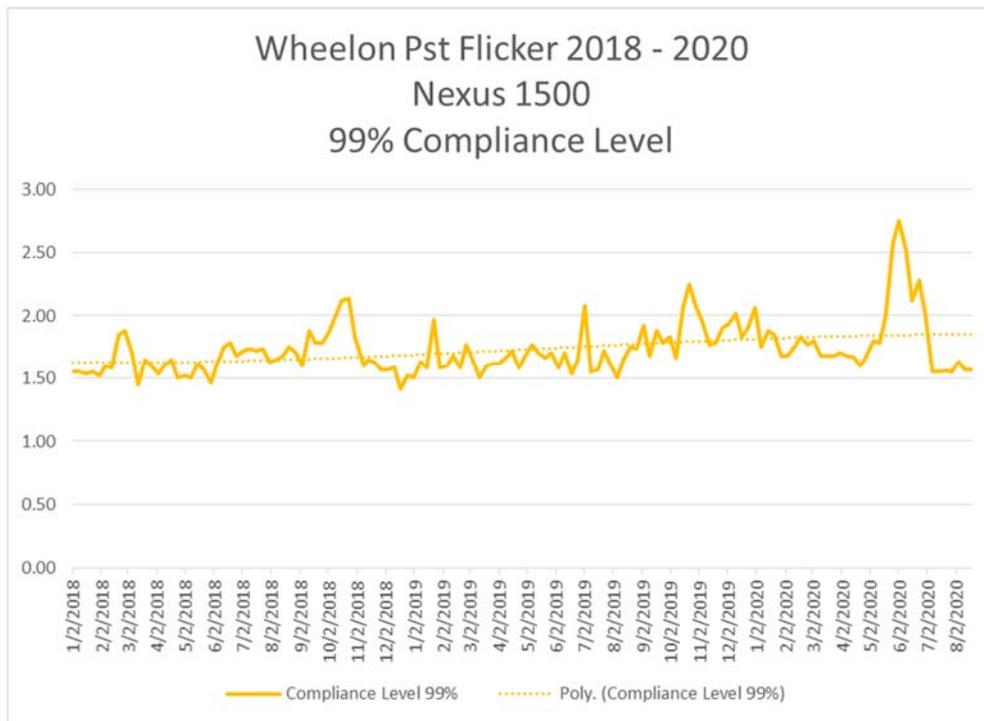
Figure 1 -  $P_{st}$  Level at Wheelon Substation

Rocky Mountain Power has been monitoring flicker at a substation that is considered the point of common coupling for a large fluctuating load [REDACTED] in the area (“Large Customer”). Rocky Mountain Power has been working with the Large Customer to bring the amount of light flicker caused by their operations to within levels compliant with IEEE 1453. The flicker values have been recorded by a Nexus 1500 power quality monitor that determines  $P_{st}$  using the IEEE 1453 computation method (see figures 1 and 2.)

Yes. The Large Customer in the vicinity of the Complainant's area has fluctuating load that has been identified as the primary cause of the elevated flicker levels. The source of the elevated flicker levels has been proven repeatedly by correlating the Large Customer's plant shutdowns with observed flicker measurements.

There has been extensive communication, including conference calls and in-person meetings and email between the Large Customer and Rocky Mountain Power, held for the sole purpose of improving the complainant's flicker levels. Rocky Mountain Power sent formal communications to the Large Customer requesting the customer provide Rocky Mountain Power a written strategy and timeline to bring down its flicker levels. A copy of that letter is provided as Attachment 1. A copy of the response from the Large Customer is also provided as Attachment 2.

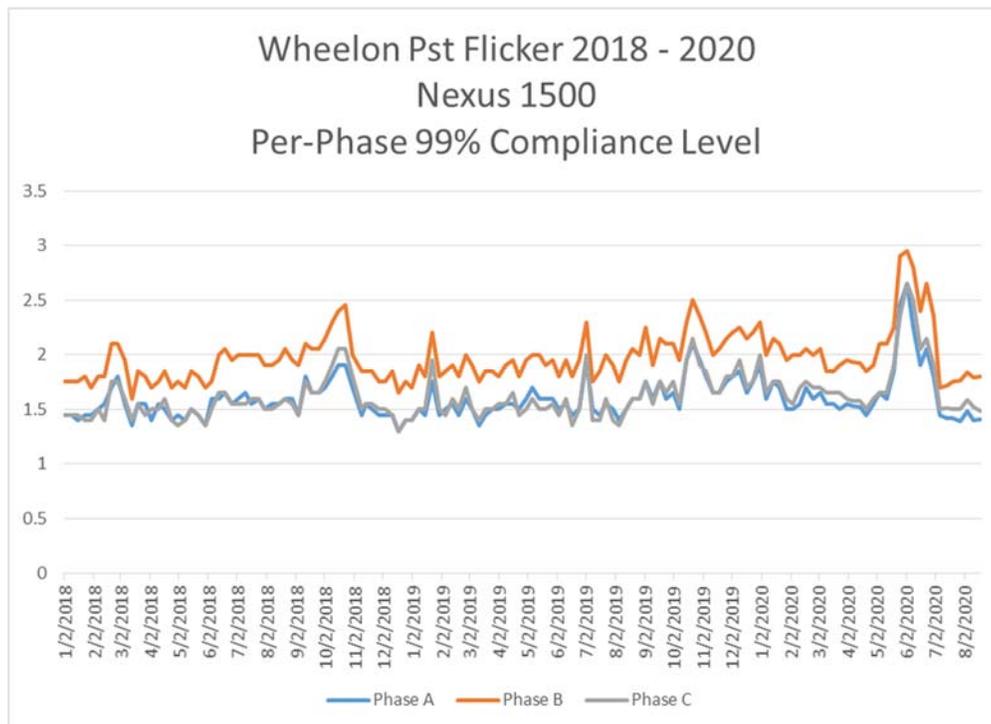
Figure 2 – Three Phase  $P_{st}$  Levels at Wheelon Substation

In addition to working with the Large Customer on its flicker levels, power quality monitoring identified the  $P_{st}$  on Complainant's phase (B phase) to be 23% higher than the other phases. The Complainant was re-fed to the (A) phase in April 2020 in attempts to provide an immediate improvement.
