February 17, 2021

RE: **Docket No. 20-035-24**  
In the Matter of the Formal Complaint of Scott Macdonald against Rocky Mountain  
Power  
*Rocky Mountain Power's Status Report*

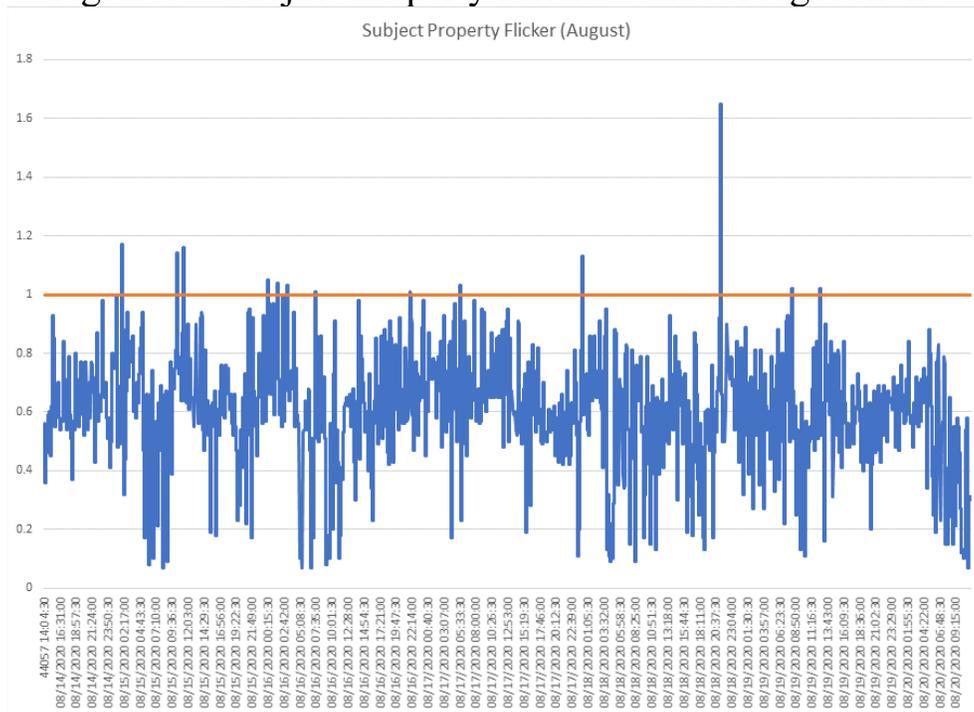
**Figure 1 – Subject Property Flicker Values August 2020**

$P_{st}$  is defined as perceptible flicker in the short term (10-minute interval). Flicker is considered acceptable in IEEE methodology and PacifiCorp's standards if the maximum of the 10-minute interval values over 7 days is less than one, excluding the highest one percent of values. The reported value for a week is considered the weekly  $P_{st}$  value and is used to track the Large Customer's compliance with their contracted  $P_{st}$  values and analyze acceptable levels at the Subject Property. An Eagle 440 monitor was placed at the Subject Property from 08/14/2020 14:04 - 08/20/2020 11:28. The monitor recorded in standard 10-minute intervals to capture the 1.03  $P_{st}$  value at the property (see Figure 1).

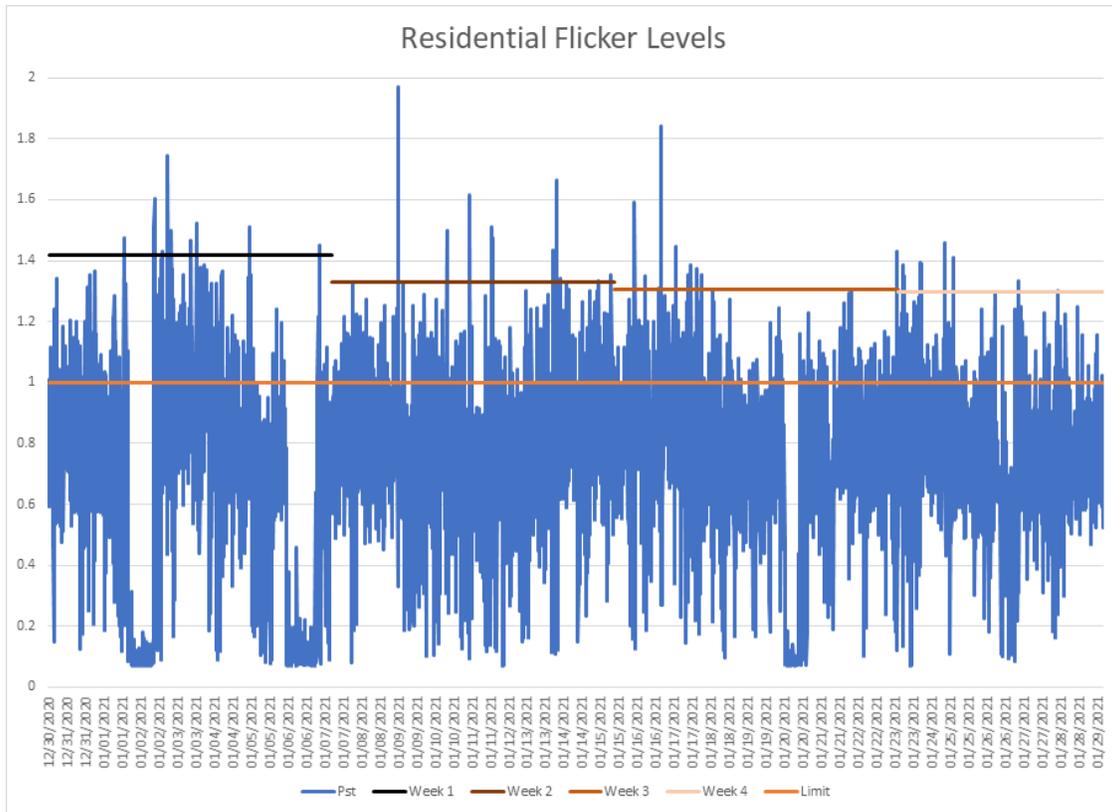
Figure 2 - P<sub>st</sub> Level at Subject Property Monitor January 2021

On December 30, 2020, a monitor was placed at the Subject Property. Over a 30-day period, the monitor recorded an average weekly flicker value of 1.35 (Figure 2), a 31% increase in  $P_{st}$  levels from the previously reported value in August 2020 of 1.03. The measured amounts from December 30, 2020 through January 29, 2021, exceeded the recommended IEEE standard of 1.0  $P_{st}$  for each weekly testing period.

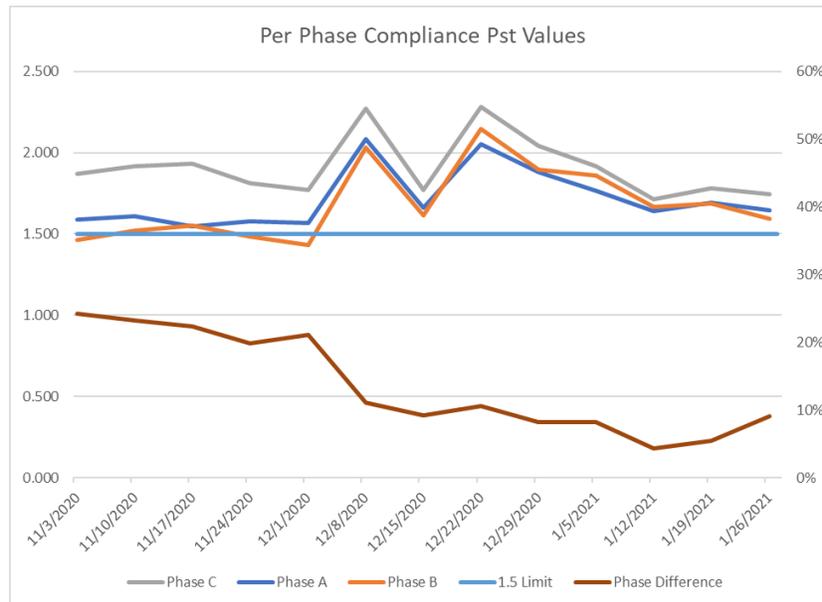
Figure 3 – Per Phase Transmission Flicker

Two factors have been identified as contributors to the increase of  $P_{st}$  values observed in August 2020 compared to the recent values. First, the utility electrical system is made up of three wires, also known as phases (referred to as phases A, B and C). Prior to December 2020, the Company had consistently measured  $P_{st}$  values 23 percent higher on the highest phase over the other two phases as shown in Figure 3.

The Subject Property was moved from the highest phase to the lowest phase on April 14, 2020. The exchange of phases alleviated the flicker at the Subject Property and contributed to the improved 1.03  $P_{st}$  level observed in the August 2020 measurement. However, recent changes in the Large Customer’s manufacturing process have reduced the amount of flicker on the elevated phase resulting in an average 6.8% difference between phases, compared to the previous average difference of 23%. The improvement for customers on the elevated phase was not extended to the other two phases however, and the two other phases have risen from 1.49 to 1.59 (see Figure 4). The Subject Property resides on the lowest of these other two phases. The Large Customer’s processes have recently changed such that the difference in flicker values between the phases has lessened, thus decreasing the effectiveness of changing the phases.

As previously explained, in April 2020, the Company moved the Subject Property to the lowest phase to capitalize on the discrepancy in phase values, which provided an improvement in flicker. However, as noted, recent changes in the Large Customer’s processes have reduced the effectiveness of these efforts.

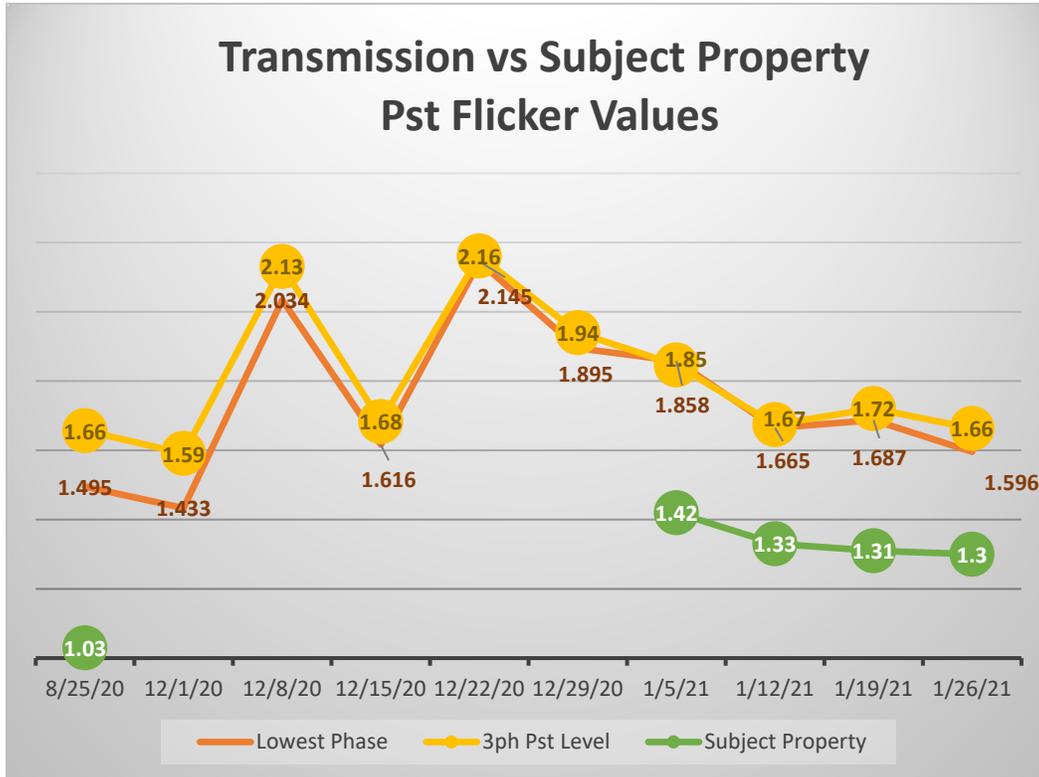
Figure 4 – Flicker Comparison of Transmission & Subject Property

The transmission weekly P<sub>st</sub> values (depicted in orange and yellow) are derived from a flicker monitor located at Wheelon substation near the Large Customer. This monitor measures the Large Customer’s P<sub>st</sub> levels. The composite flicker level at Wheelon substation attributable to the Large Customer’s fluctuating load is determined by finding the 99<sup>th</sup> percentile of each of three phases for a 7-day period, and the average of the three phase 99<sup>th</sup> percentile values is used to calculate the amount shown in yellow in figure 3. The darker orange trace reflects the flicker value of the phase shared with the Subject Property. The comparison of the Subject Property flicker values to the shared transmission phase demonstrates that the Subject Property flicker follows the lowest transmission phase opposed to the overall customer compliance evaluation.

RMP continues to work with the Large Customer in attempts to reduce the flicker introduced into the system as a result of the Large Customer’s fluctuating load. In these last few months, efforts have been primarily focused on addressing a spike in measured flicker (shown in Figure 4),
