RE: Docket No. 17-035-01 – Application of Rocky Mountain Power to Decrease the Deferred EBA Rate through the Energy Balancing Account Mechanism – Response Testimony

Docket No. 17-035-01

Response Testimony of Michael G. Wilding

December 2017

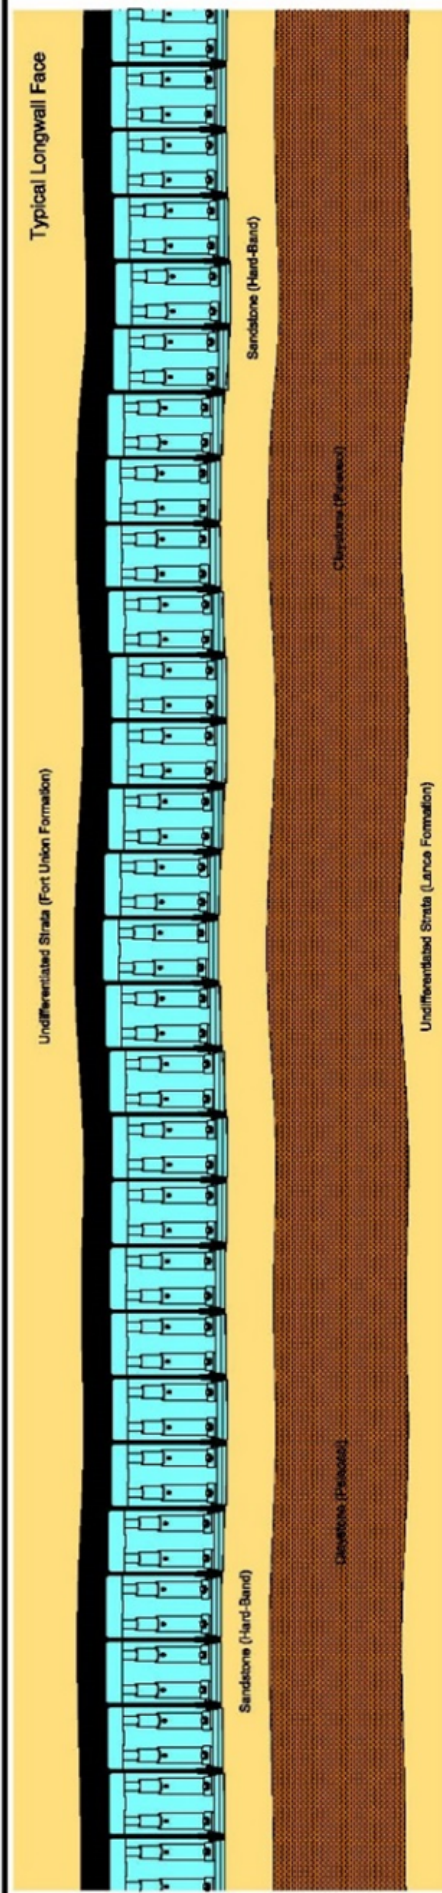
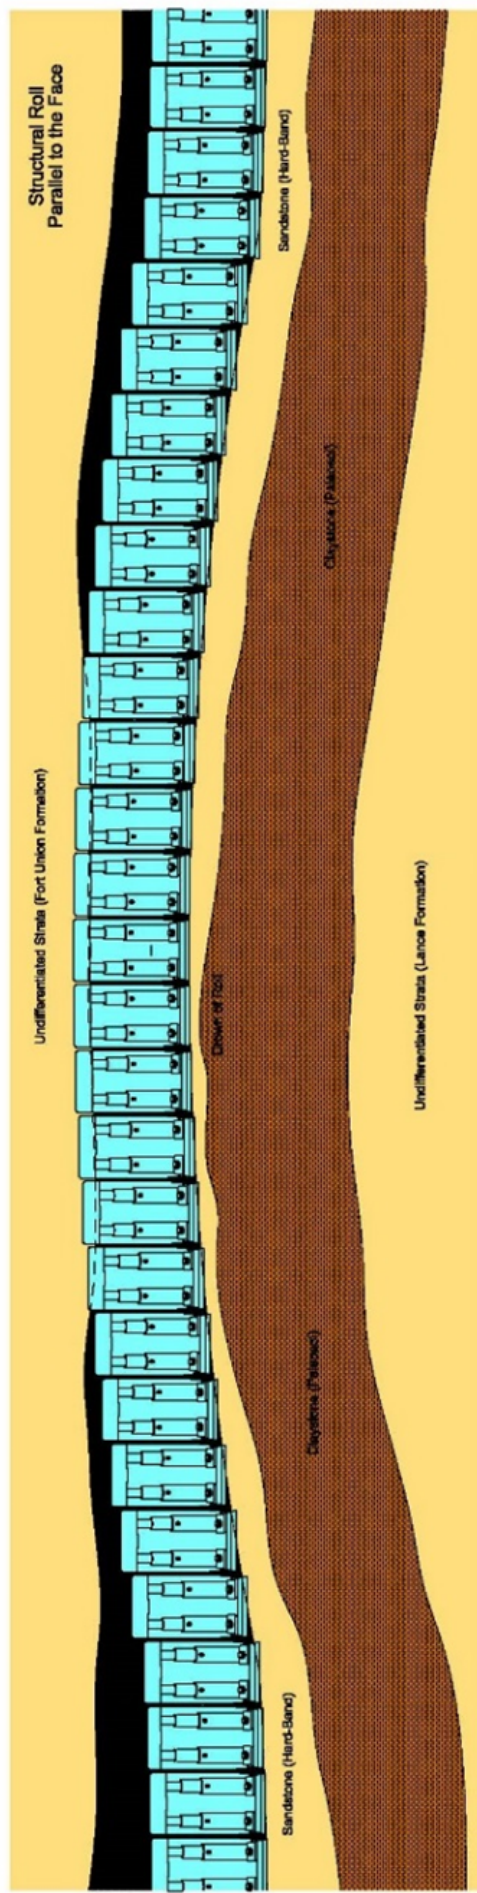
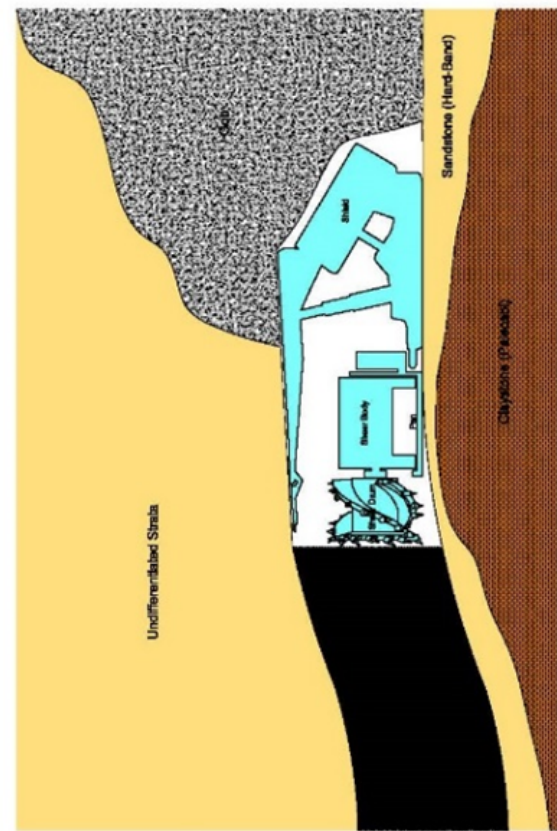
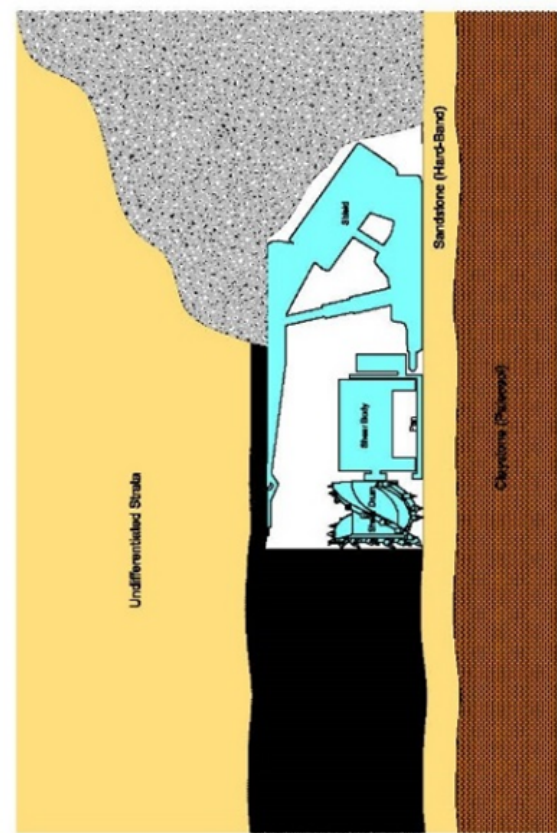
14th Right Longwall Structural Rolls

192 The structural rolls were both parallel and perpendicular to the face. In addition, the
193 hard sandstone floor, normally approximately two feet thick, thinned at the crowns of
194 the structural rolls to less than one foot thick. The combination of the thinning coal
195 seam, thinning sandstone floor, and severity of the structural rolls exceeded the
196 capacity of the shearer to maneuver through the coal face without trimming into the
197 hard sandstone floor and the roof. As the crews struggled to navigate through these
198 difficult conditions, the hard sandstone crown was cut, which exposed the incompetent
199 paleosol or claystone under the hard sandstone floor.

202 A. Crews attempted to alter the longwall mining horizon by changing the cutting angle of
203 the shearer to overcome the structural rolls. Longwall crews continuously evaluate
204 mining conditions encountered (coal seam thickness trends and structural features)
205 along the face and attempt corrective measures to mitigate the changing mining
206 environment. At times during mid-December, longwall crews were able to alter the
207 mining horizon to effectively stay within the coal seam and limit incidental contact
208 with the hard sandstone floor.

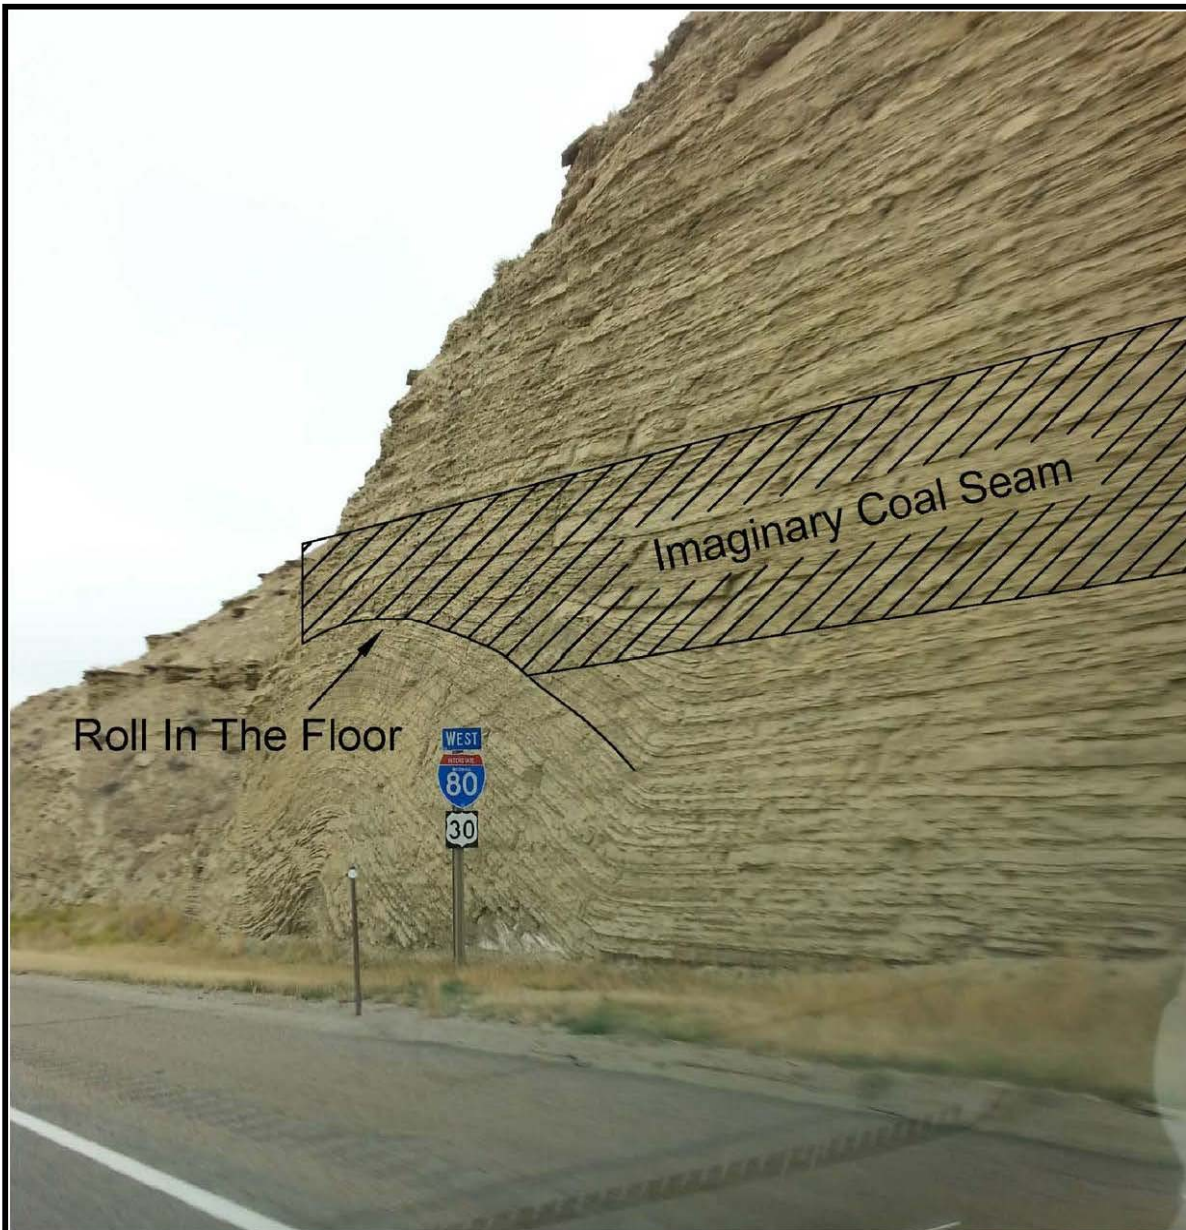
**Example of a Structural Roll in the Floor –
Near Bridger Coal Co., Point of Rocks, Wyoming**

Example of a Structural Roll in the Floor
