Feeder Line Replacement Refresher

Questar Gas Company
Meeting with Utah PSC
March 27, 2013

Vintage Large Diameter IHP Main Replacement Program

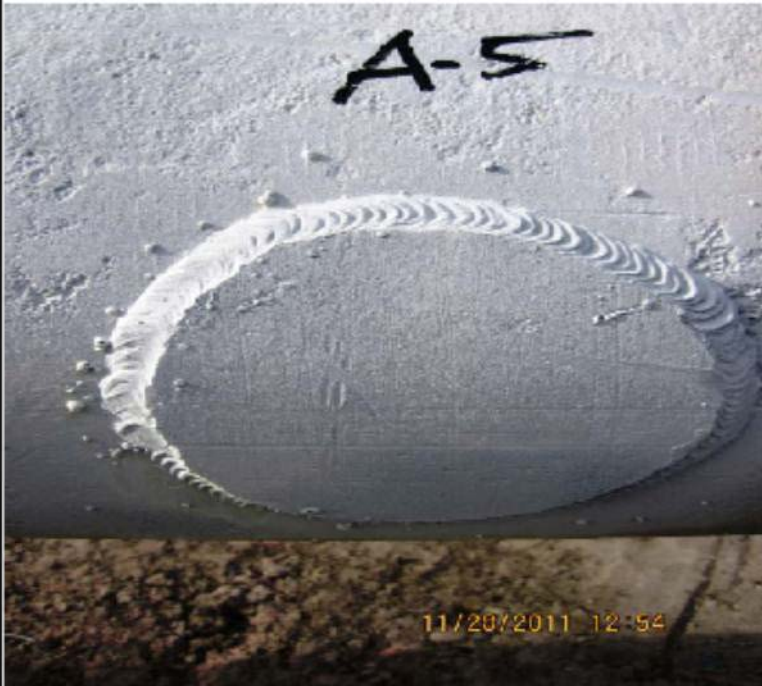
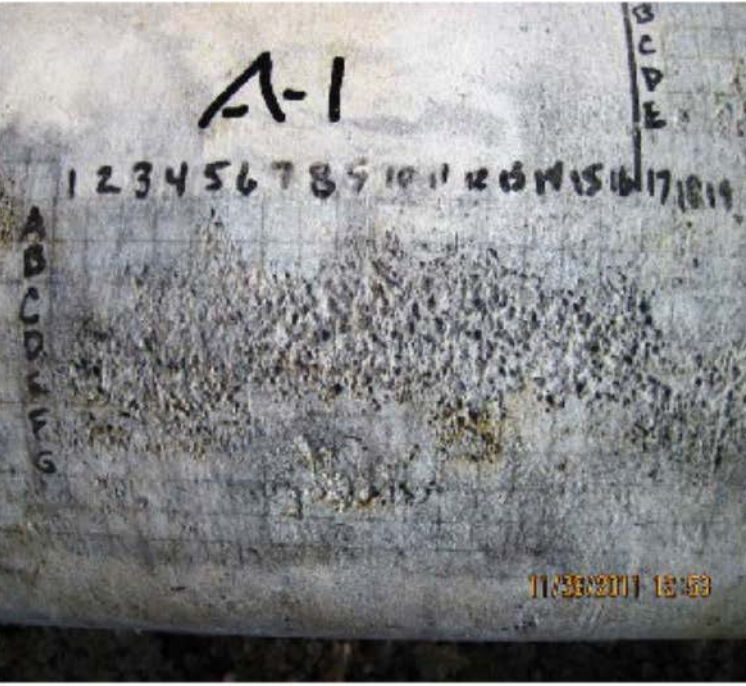
Line: IHP Dig ID: 800 S 7th E and 9th E SLC

patch weld	A1 Pit Corrosion through out the whole section of pipe. Pick the deepest area to examine of 240' that was available removed from the ground.

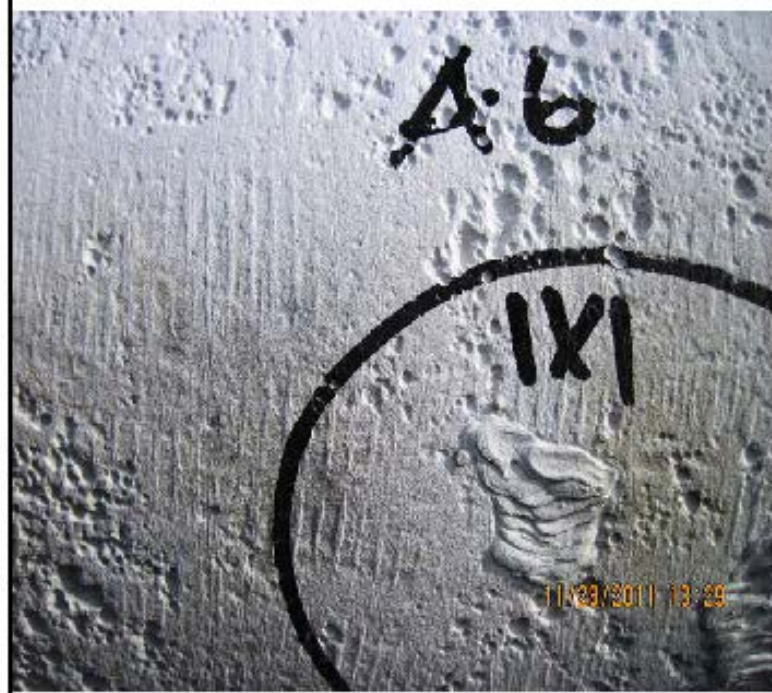
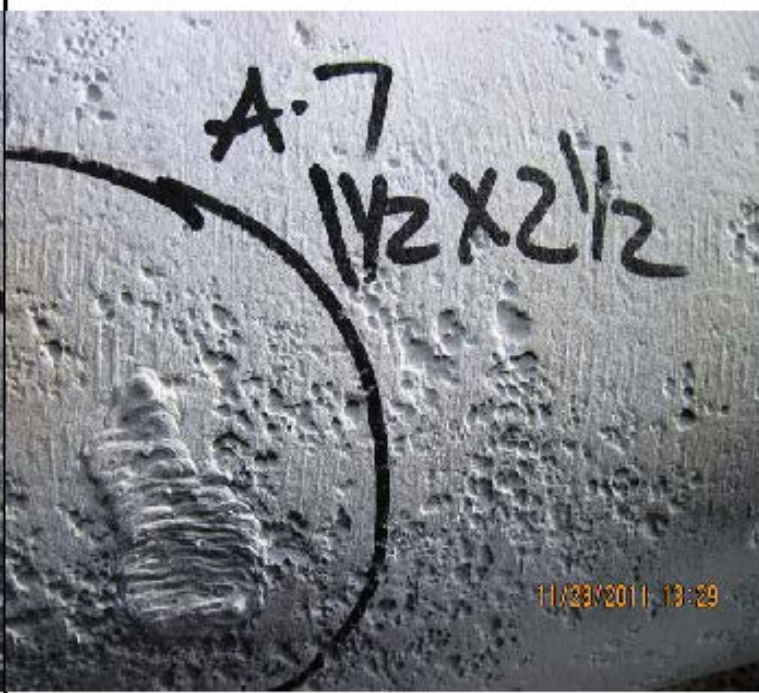
Dig ID: 800 S 7th E and 9th E SLC

A6 Puddle Welds over general corrosion, Magnetic Particle no linear indications found.	A7 Puddle Welds over general corrosion, Magnetic Particle no linear indications found.

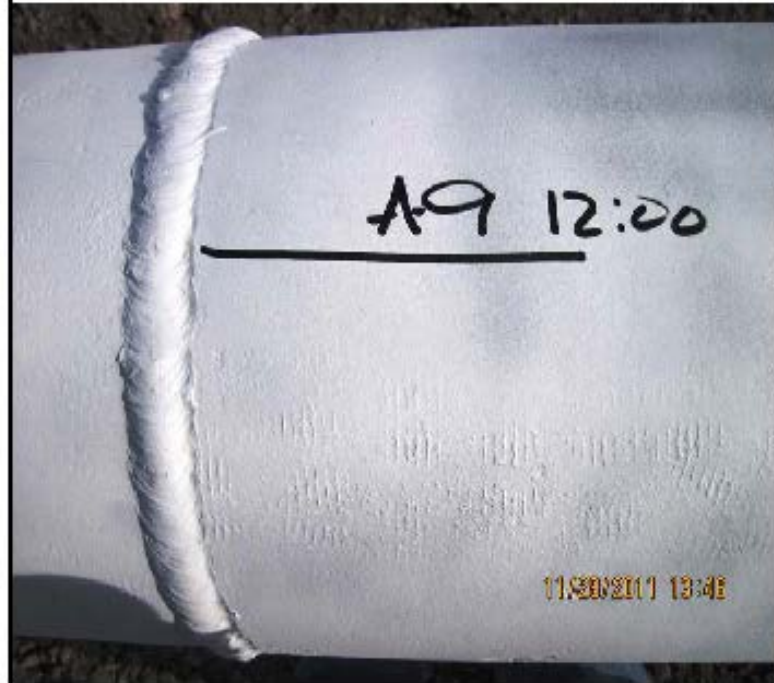
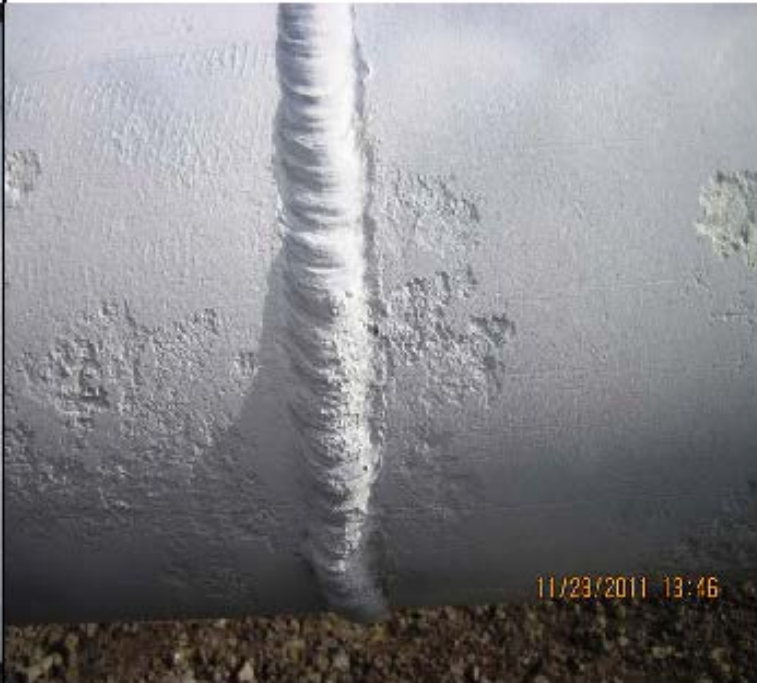
Dig ID: 800 S 7th E and 9th E SLC

A-9 Acetylene Weld	A-9 Acetylene Weld
