Landmark Installations HDD, LLC

Rebuttals to 5 Claims Made by Taylorsville Bennion Presented by Tokio Marine HCC - Public Risk Group Grundy Utilities Program

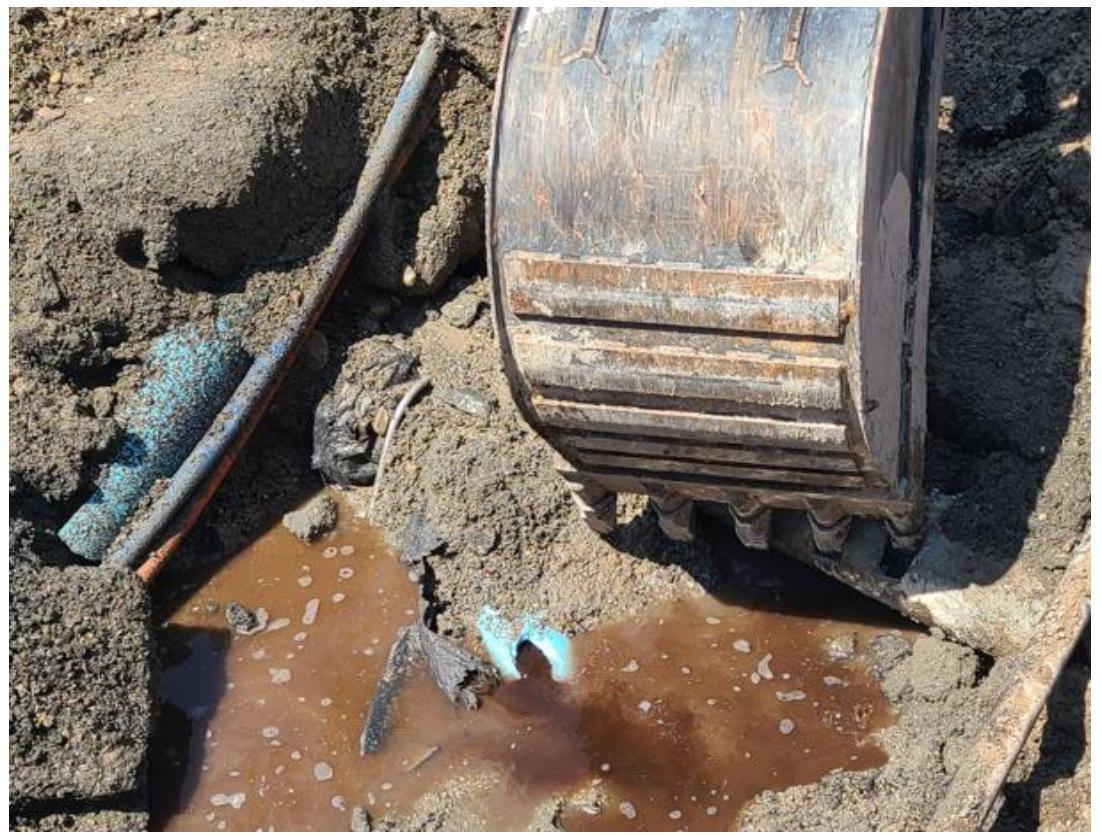
- Taylorsville Bennion owned the utility line regardless of whether it is active or abandoned. This line should be marked according to law.
- The abandoned line was within 24 inches of the marking on the ground

- CGA Guideline 4.11 Abandoned Facilities states an abandoned line should be treated as an active line
- The abandoned line was more shallow than the active line, making the abandoned line more likely to locate than the active line in the pothole.

- Landmark had every right to assume this line was the active line Per CGA Guidelines
- The image below shows the abandoned line within 24" of the active line. The images also show the line is at a shallower depth than the active line, making it more likely to be located than the active line when potholing.

- Please provide Taylorsville Bennion's reasoning behind destroying this abandoned line before measurements could be taken. What was the purpose of this?

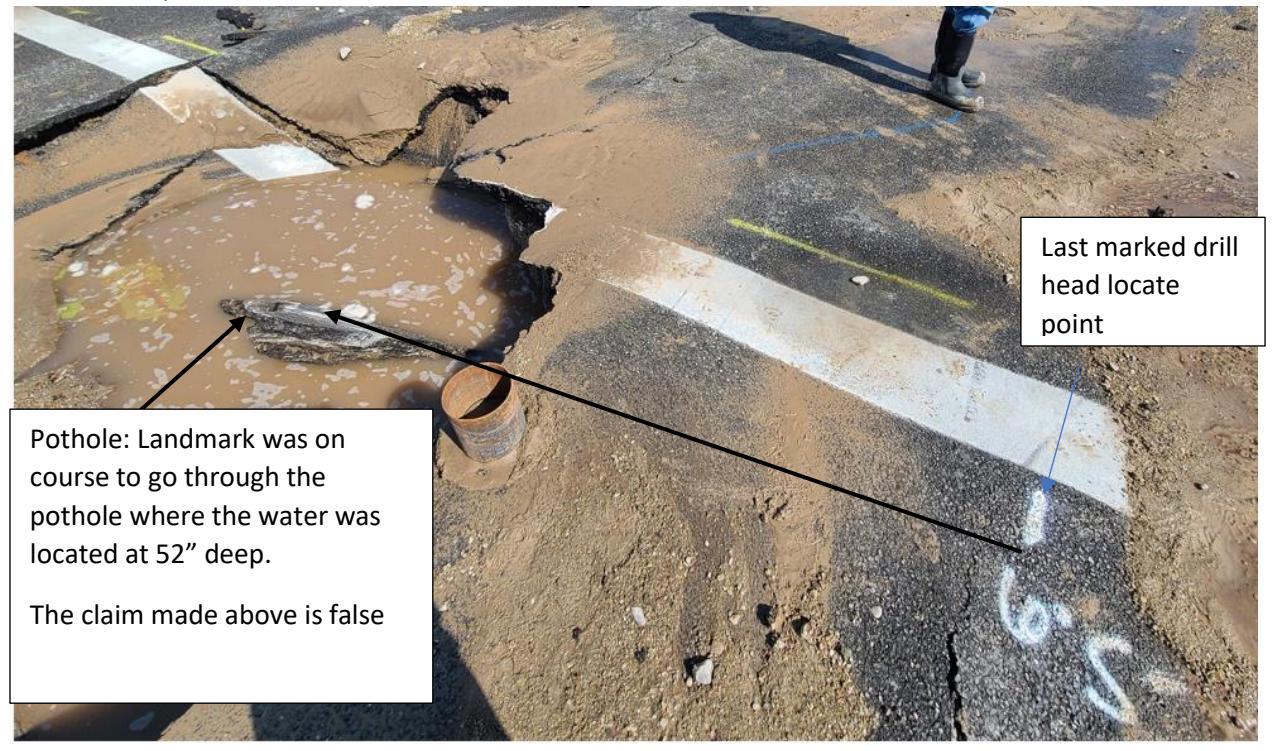
• See image below: Landmarks pothole was well with in the 24" s of our running line.

This is a photo showing the above statement is false. The pothole is well within range to bore directly beneath the potholed line

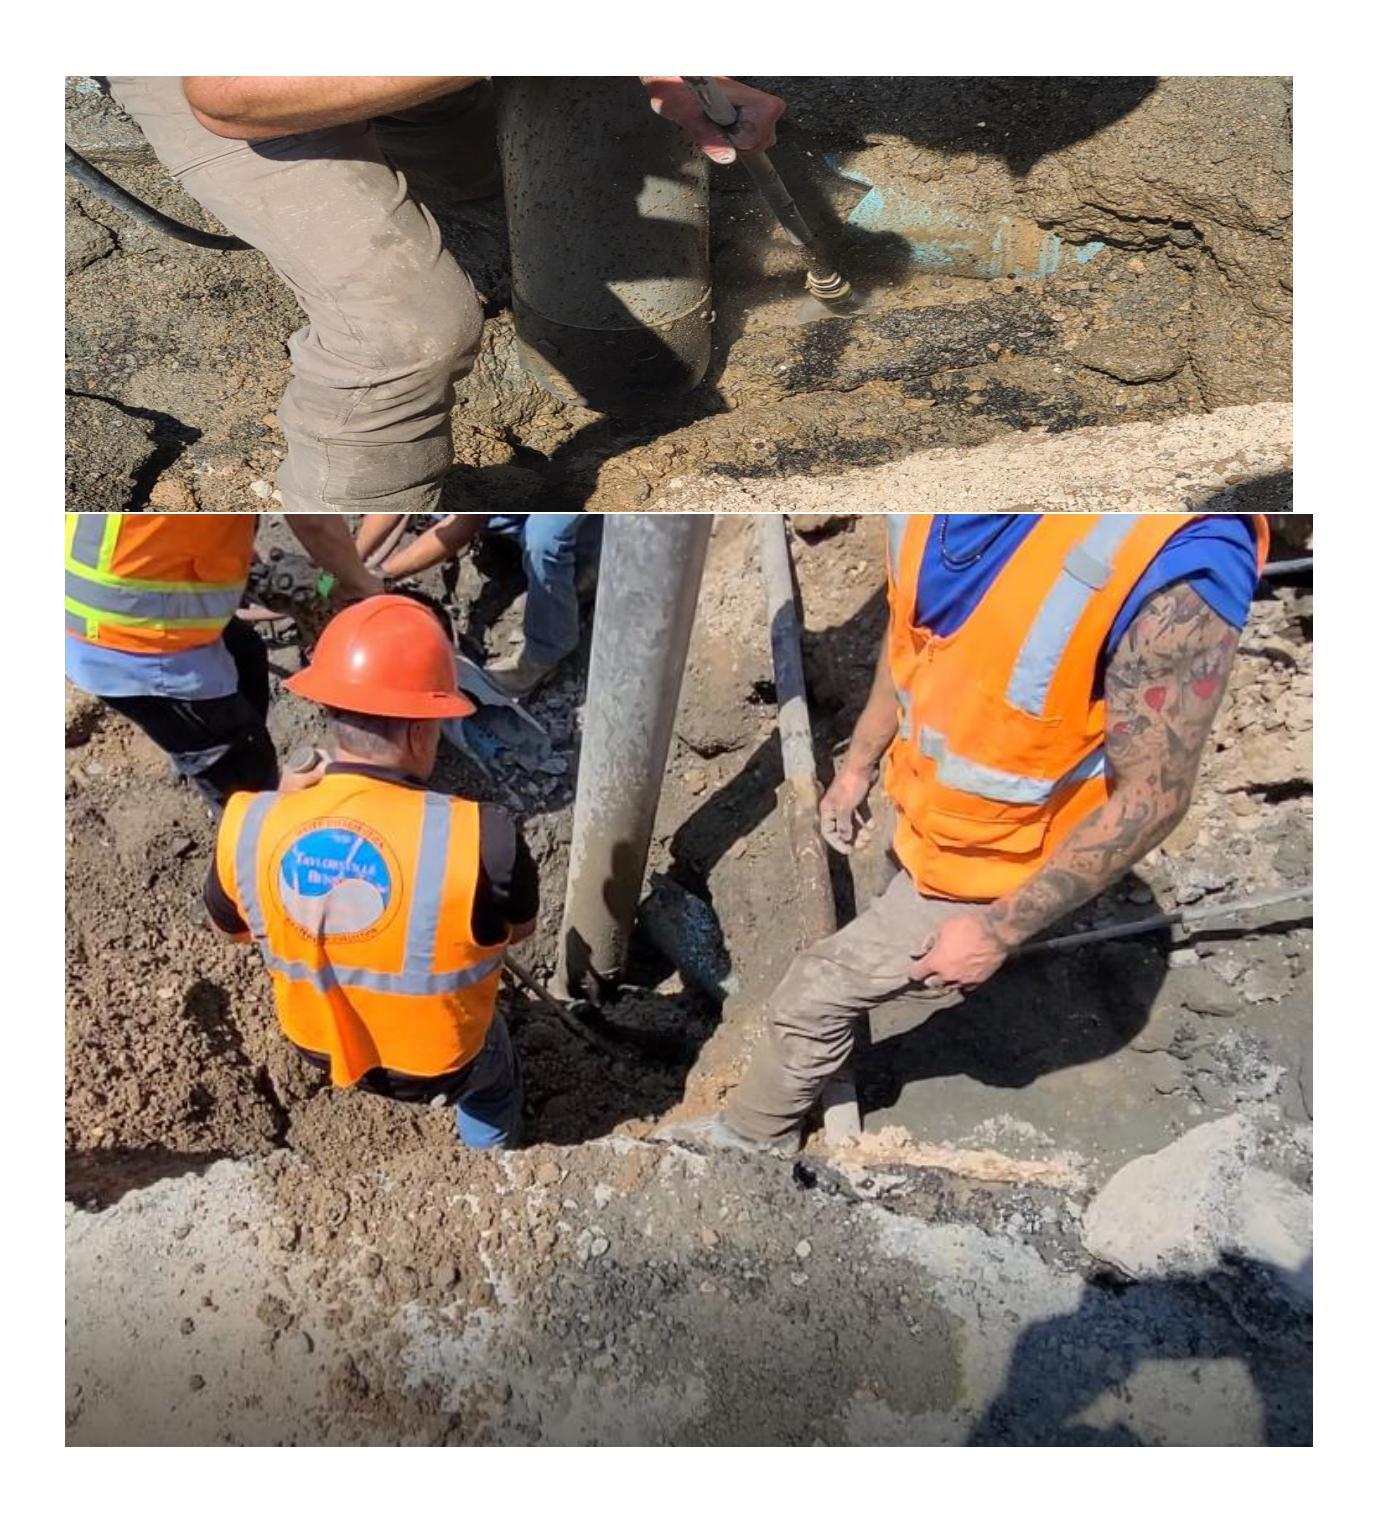
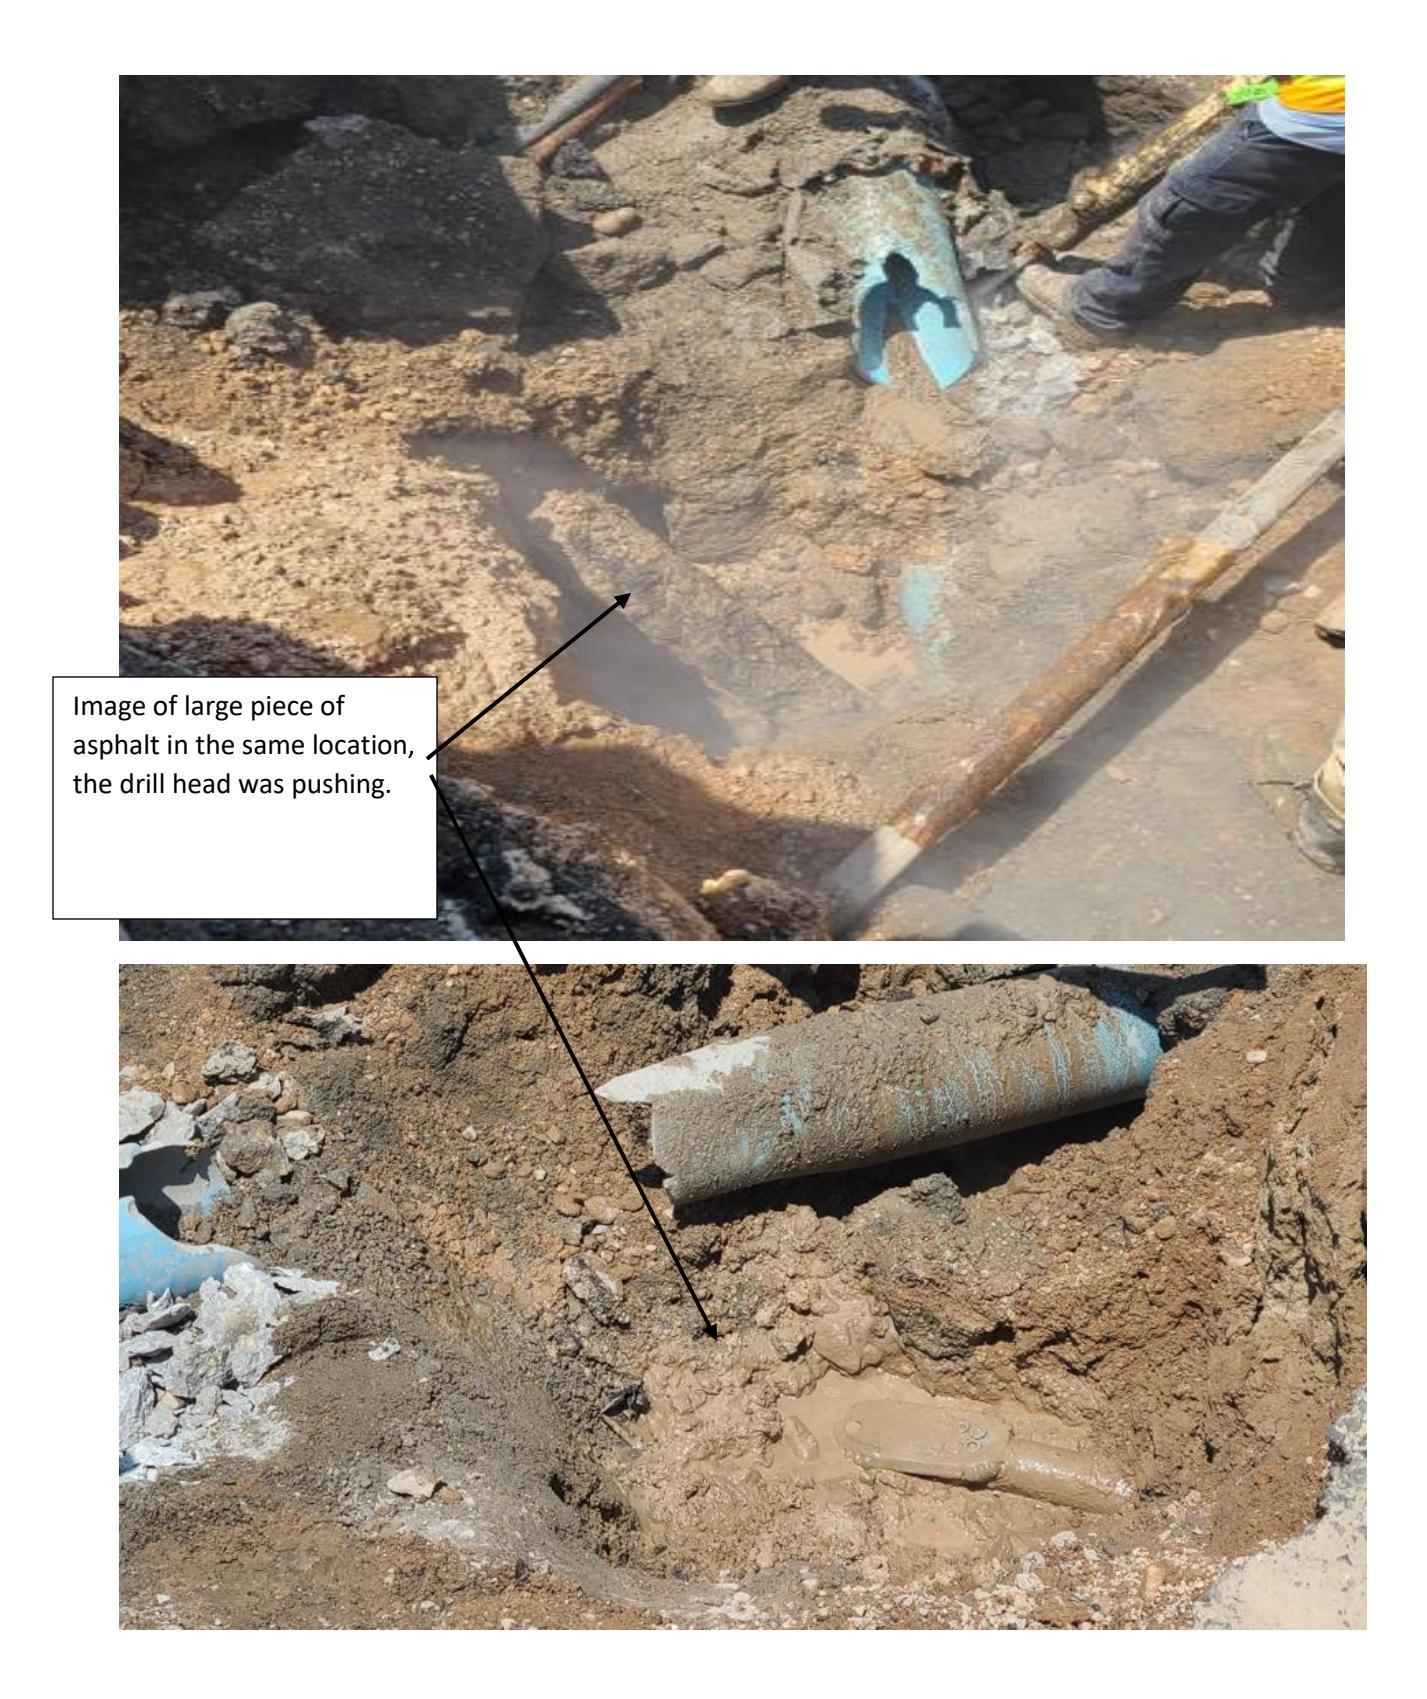
- This is an indication of hard materials in the ground. It also indicates that the material was large enough to bend a drill rod that requires thousands of pounds of force to bend the rod.
- Below are photos, of Taylorsville Bennion, excavated large pieces of asphalt using a hydro-vac. As you can see these pieces were buried long before the incident an image also shows the drill head pushed out the same location of the large piece of asphalt
- Please address the improper installation of the thrust block

This asphalt piece was resting beneath/next to the abandoned line see prior image of abandoned line Image of the area before asphalt was excavated. All existing and surrounding asphalt had already been removed from the area to repair a coating on a gas line.

Below are images of Taylorsville Bennion removing the buried asphalt discovered after the asphalt from the road had already been removed. If video evidence is needed we can send it over.
