Action Request Response

Re: **Docket No. 23-035-23**, Formal Complaint of Glenn Mickelson against Rocky Mountain Power

Recommendation (No Action)

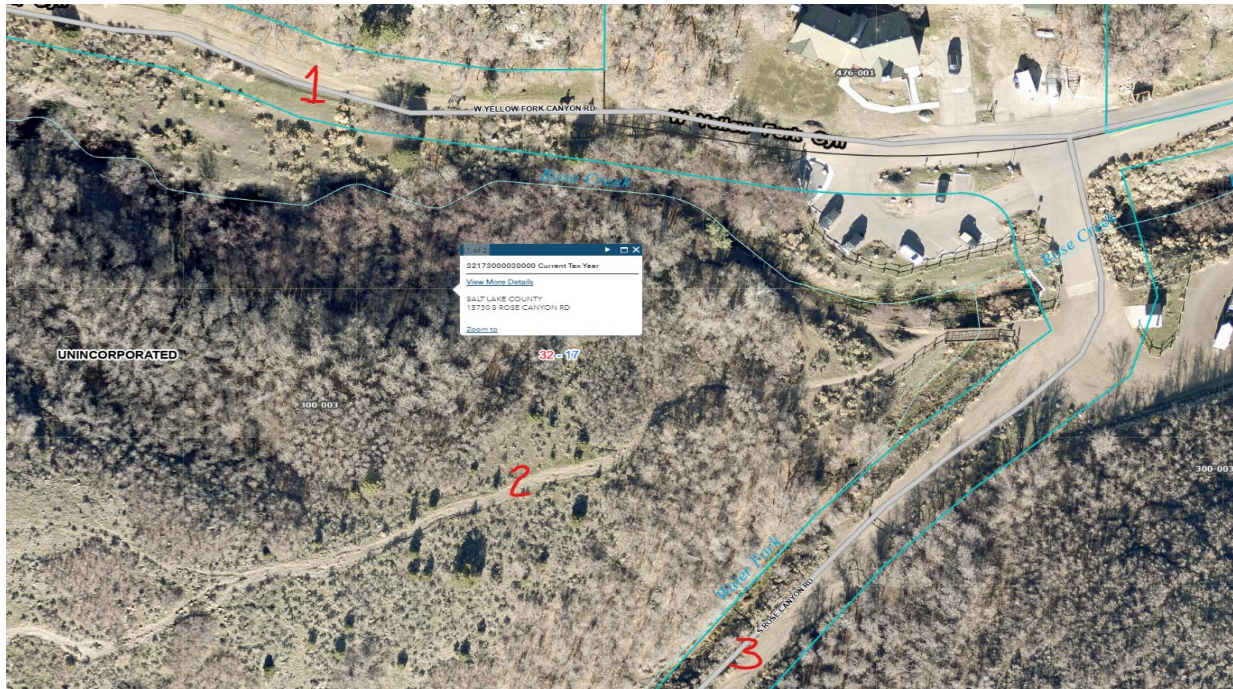
Exhibit #1: Plat map of trailhead area per SL County Assessor's Office:

The Division reviewed recorded Salt Lake County Assessor plat map plots surrounding the area in question and the review showed that the County owns most of the land surrounding the trailhead parking lot area except for the roads. It appears that the Yellow Fork Canyon and S. Rose Canyon roads are not part of any plat, which would be consistent with it being a public right of way. There is another trail that is fully within the County's plat adjacent to the trailhead (#2 on Exhibit 1).

- 1 – Yellow Fork Canyon Road
- 2 – Trail within SL County owned plat
- 3 – S. Rose Canyon Road / Water Fork Road

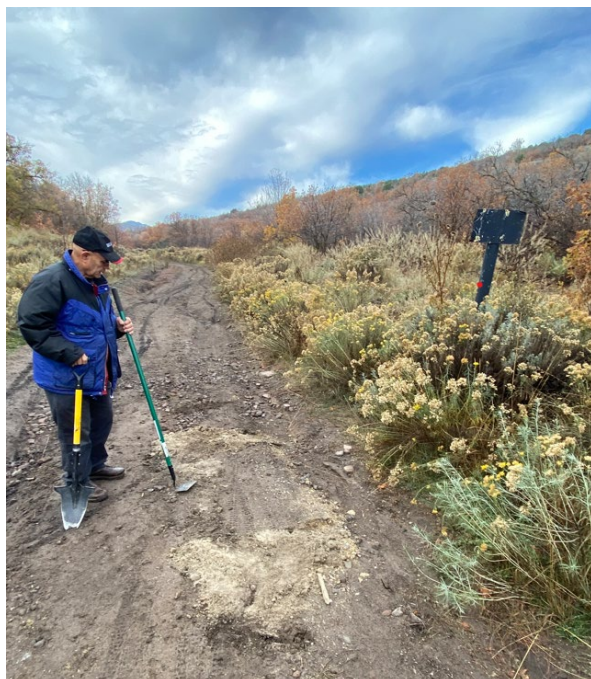
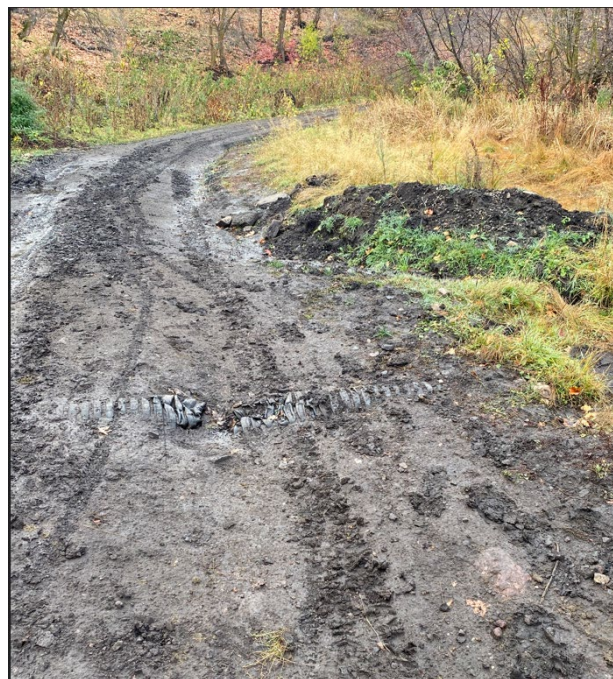
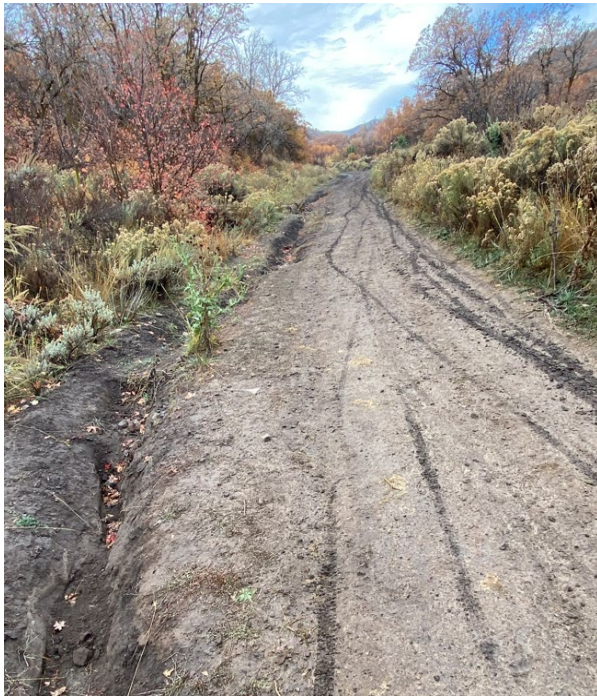
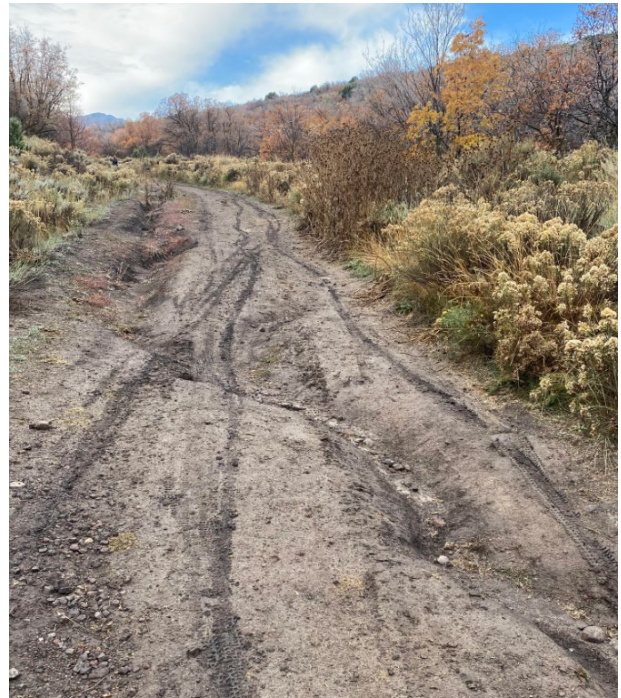
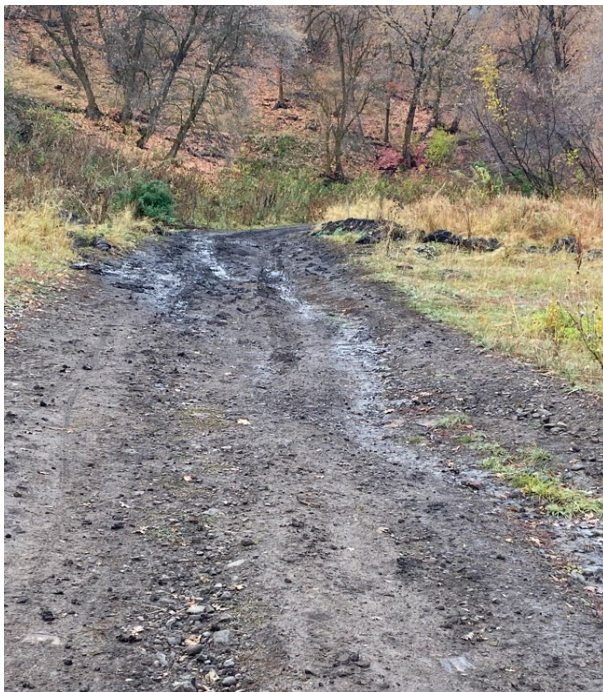
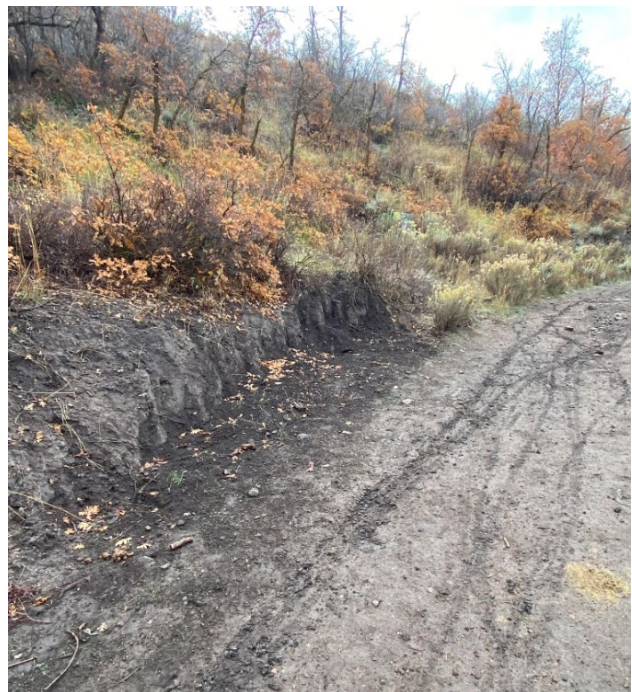
Additional photos of the S. Rose Canyon Road / Water Fork Road (3):

significant distance up the road to the playground and rest area and noted what appeared to be vehicle tracks and semi-recently laid road base on various sections of the road. There were signs of runoff carved into various sections on the side and in middle of the road. No exposed cable sections were noted nor any extraordinary concerns other than what appears to be continual erosion.

Division staff hiked up a significant length of this road and noted runoff channels present in the middle and on the side of the road in various sections but no exposed electrical cables. Based on the Complainant's photo, Division staff believed, but could not positively determine, that they found the location of the exposed electrical cables shown in the photo. This was determined from approximately matching the stated distance from the gate and comparing the landscape against the complainant's photo. The Division staff also noted fresh dirt on the side of the road that appeared to cover a runoff trench. However, since the landscape is similar in nature, the Division could not positively ascertain that the location was correct. And due to the lack of cellular data service in the area, the Division could not positively determine if this was the exact coordinates mentioned in the Complaint but felt confident that there was no exposed electrical cable nor risk to the public on the road. Division staff left the site convinced that no cables were exposed nor was there any imminent threat to the public under ordinary conditions.

Again, the Division could not visually see exposed electrical cable during the site visit. Thus, the Division cannot positively confirm the location, the depth, or whether the cable is buried

The Division cannot, at the present time, find any exposed high voltage electrical cable that poses any imminent risk to the public as stated in the Complainant's Request for Review and/or Rehearing. The Division is concerned about the possible shallow depth of the buried cable and recommends that RMP better protect and ensure burial of the cable is to NEC standard, if it has not done so already. The Division also recommends that RMP report to the Commission regarding its long-term solution so that this issue does not recur. The Division suggests that RMP and the County coordinate and maintain the road to a higher standard.
