February 1, 2017
Questar Gas
IRP Workshop

IRP 2017 Schedule

Agenda

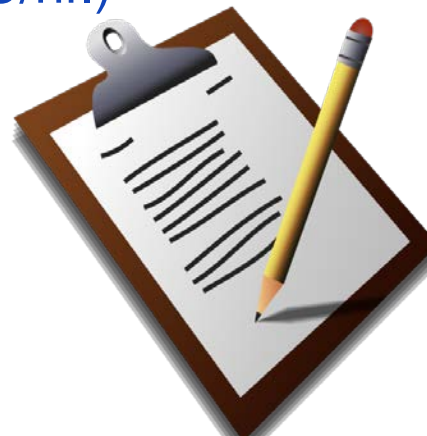
■ Appliance information

- Type, manufacturer, model, serial no.
- Installation date
- Date of last service
- Green Sticker (Y/N)
- Nameplate rating (BTU/hr.)
- Air shutter position (if present)

■ Performance data

- Gas flow rate (clock meter)
- Gas manifold pressure
- Flue gas O₂ and CO concentrations
- AGA flame code (flame characteristics)
- Gas composition

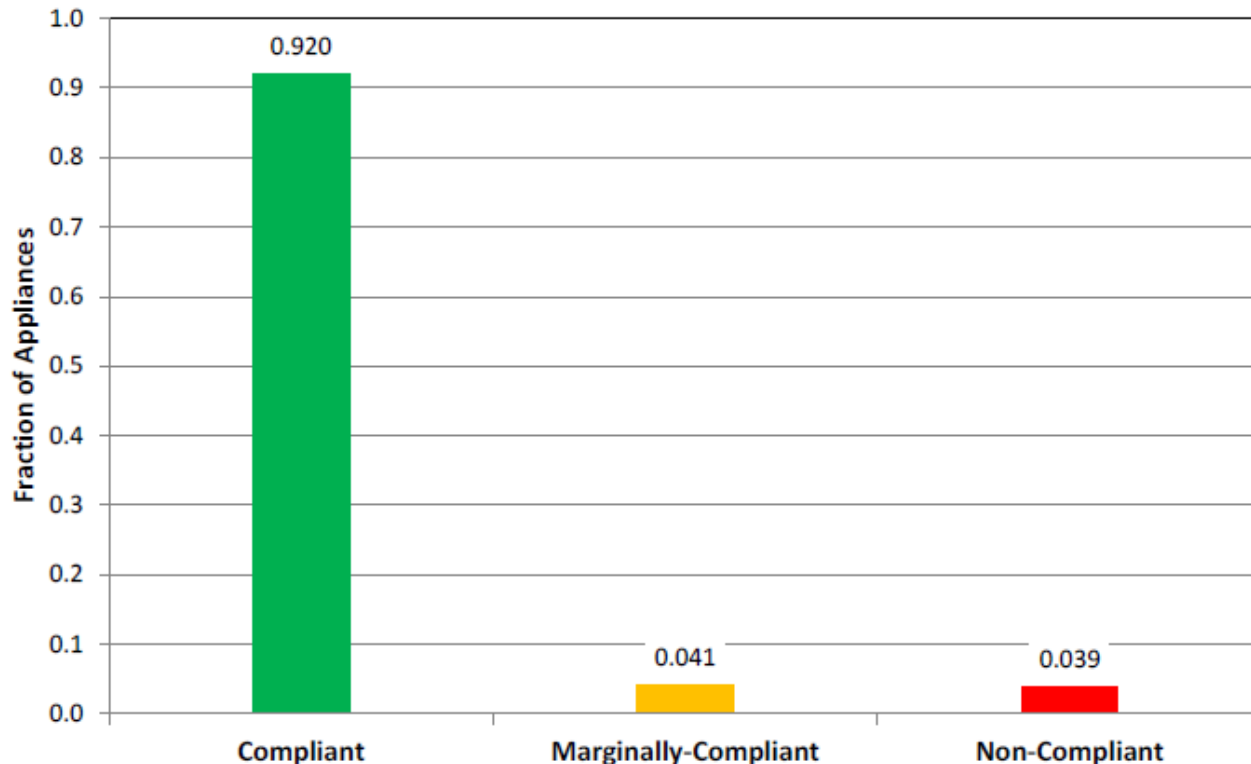
Utah Compliance with CO Limits

A high percentage of appliances exhibited low CO emissions. Only 3.9% had non-compliant CO emissions. This level is well below the limit (6%) established by the NYSEARCH interchangeability project team

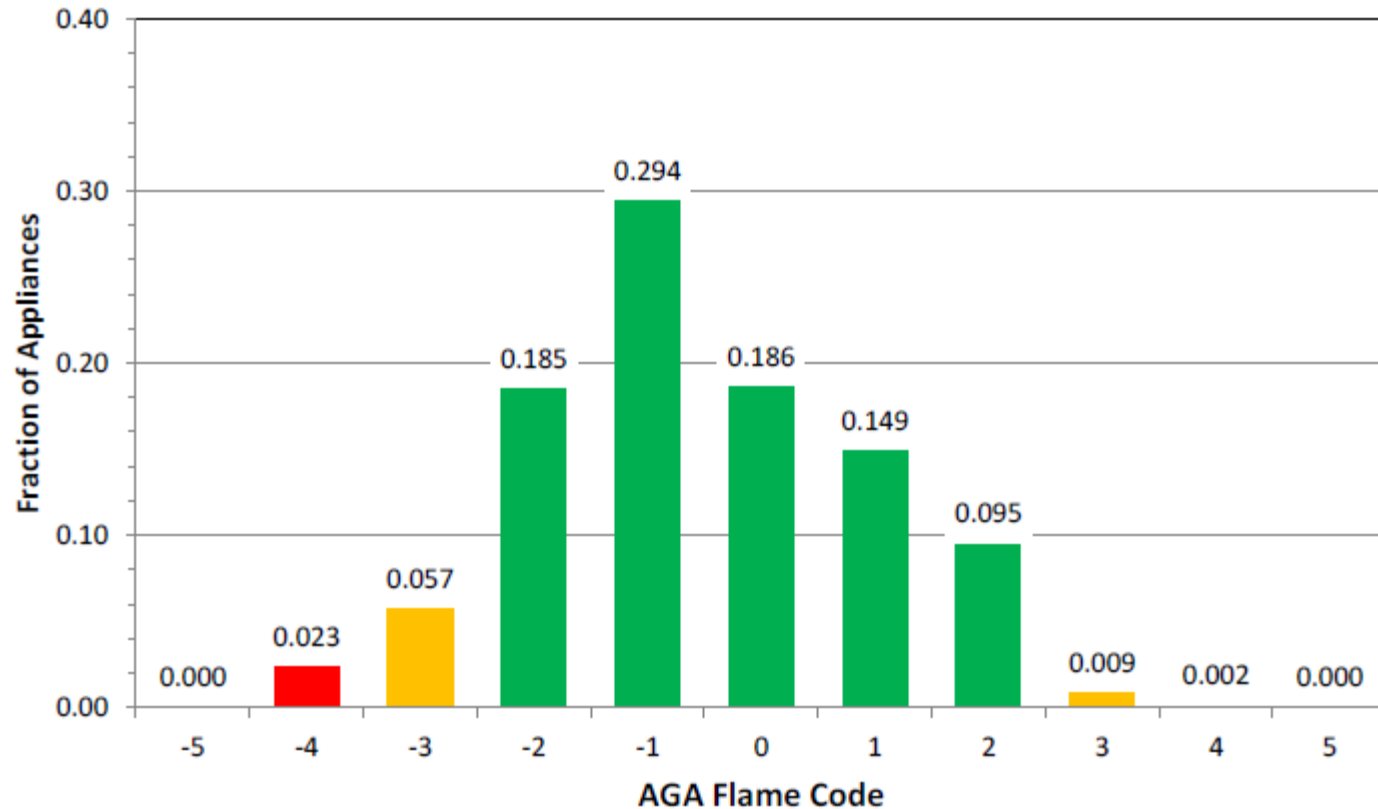
Utah AGA Flame Code

For appliances other than fireplaces, yellow tipping was experienced in 2.3% of the units tested. This level is well below the limit (5%) established by the NYSEARCH team

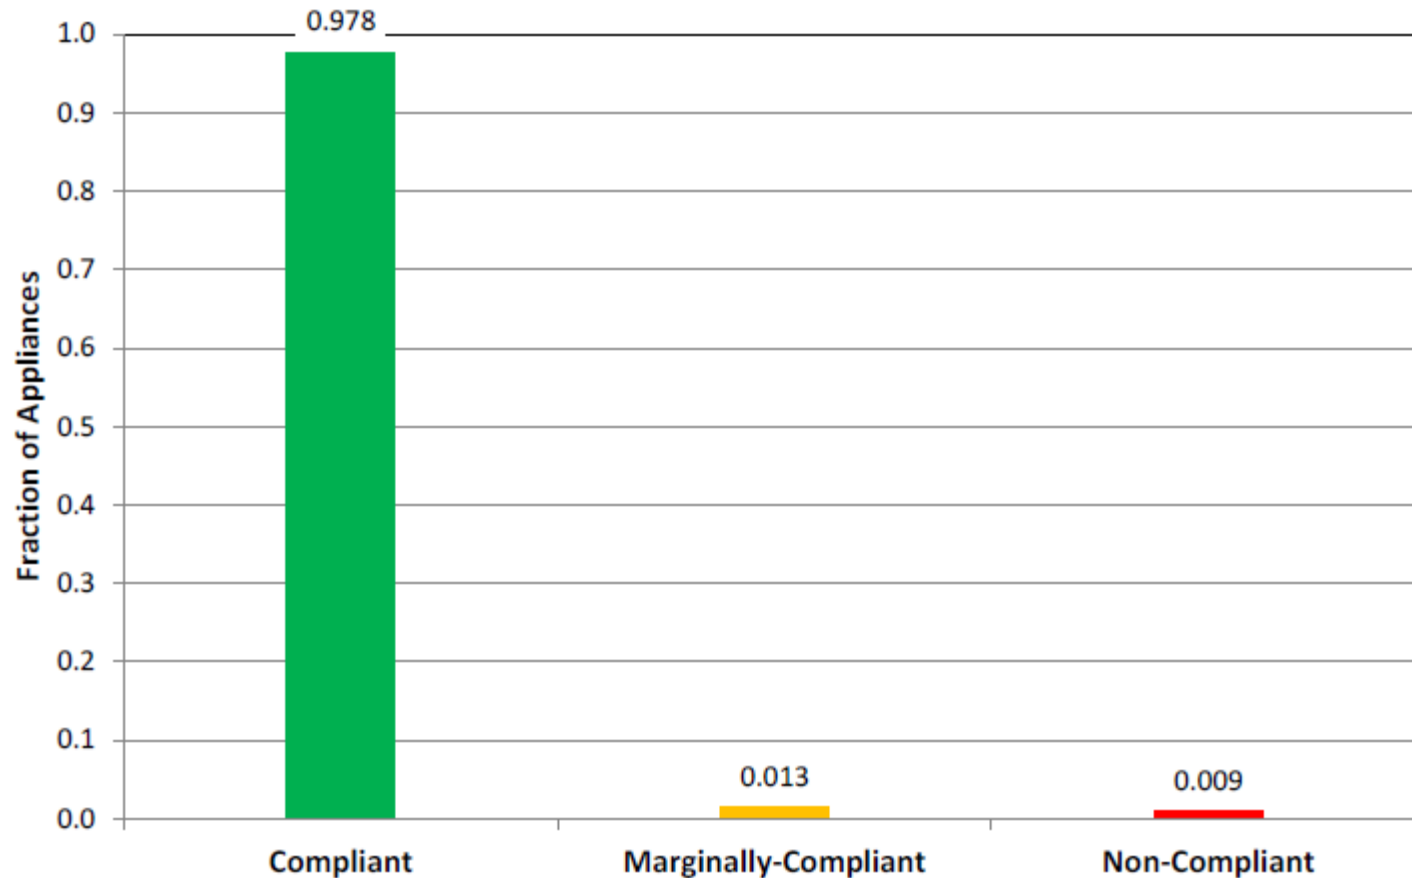
Eagle Mountain Compliance with CO Limits

An extraordinarily high percentage of appliances exhibited low CO emissions. Only about 1% had non-compliant CO emissions

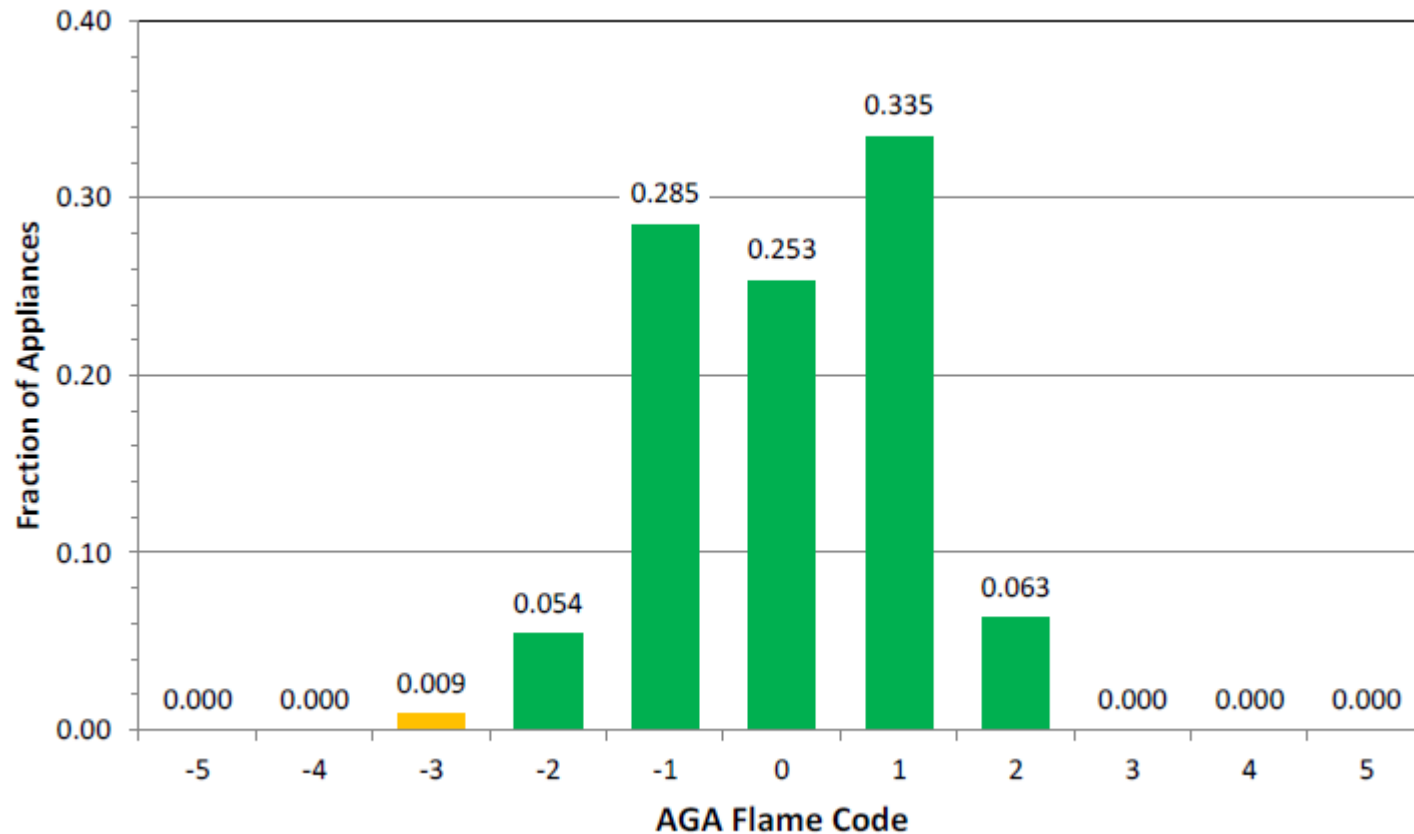
Eagle Mountain AGA Flame Code

In the Eagle Mountain zone, none of the appliances tested exhibited either lifting or yellow tipping

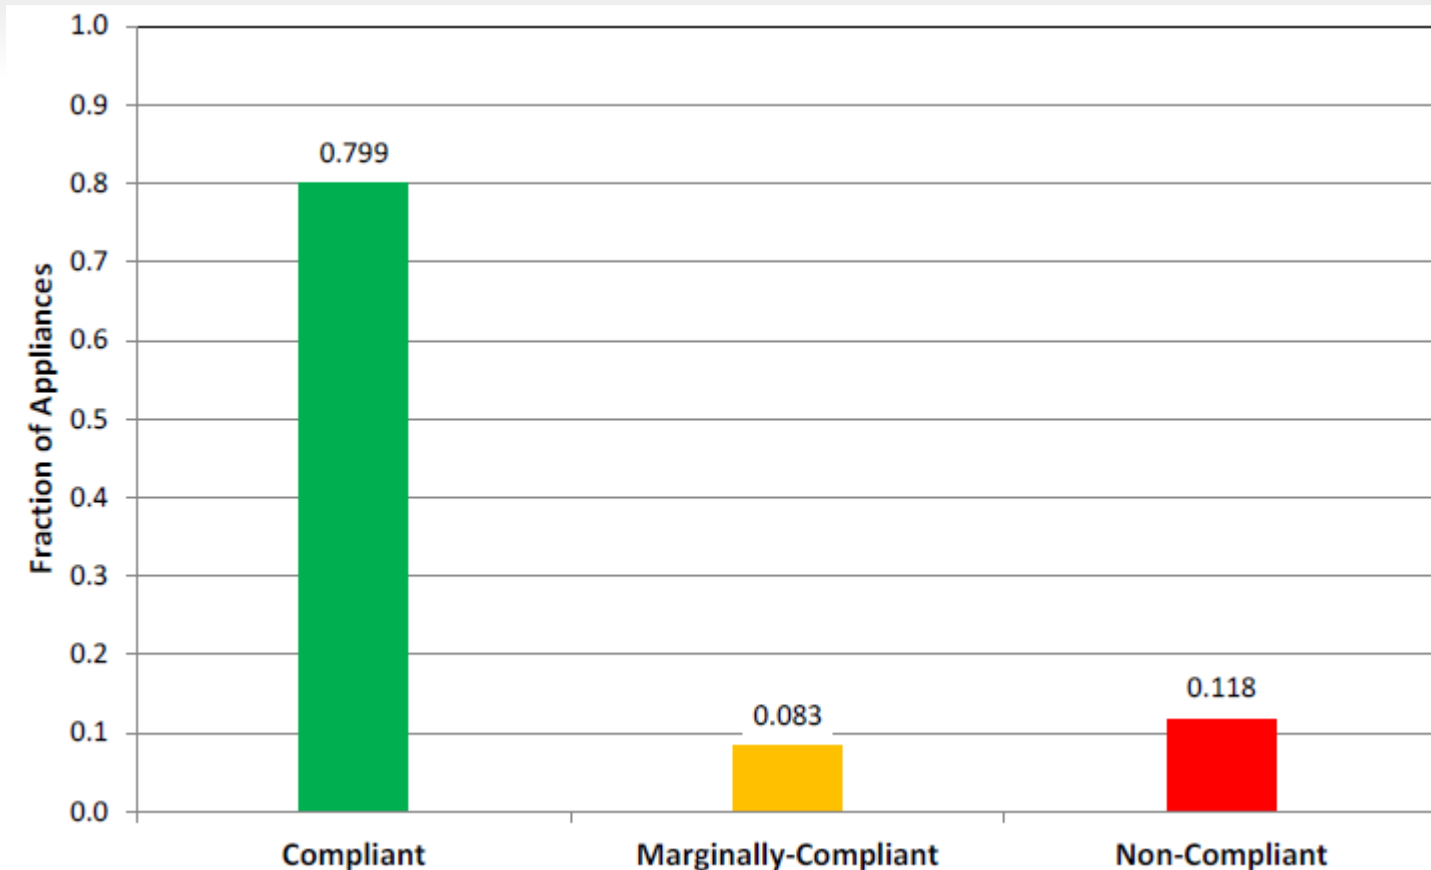
Idaho Compliance with CO Limits

About 12% of the appliances tested had non-compliant CO emissions. This level exceeds the limit established by the NYSEARCH Team

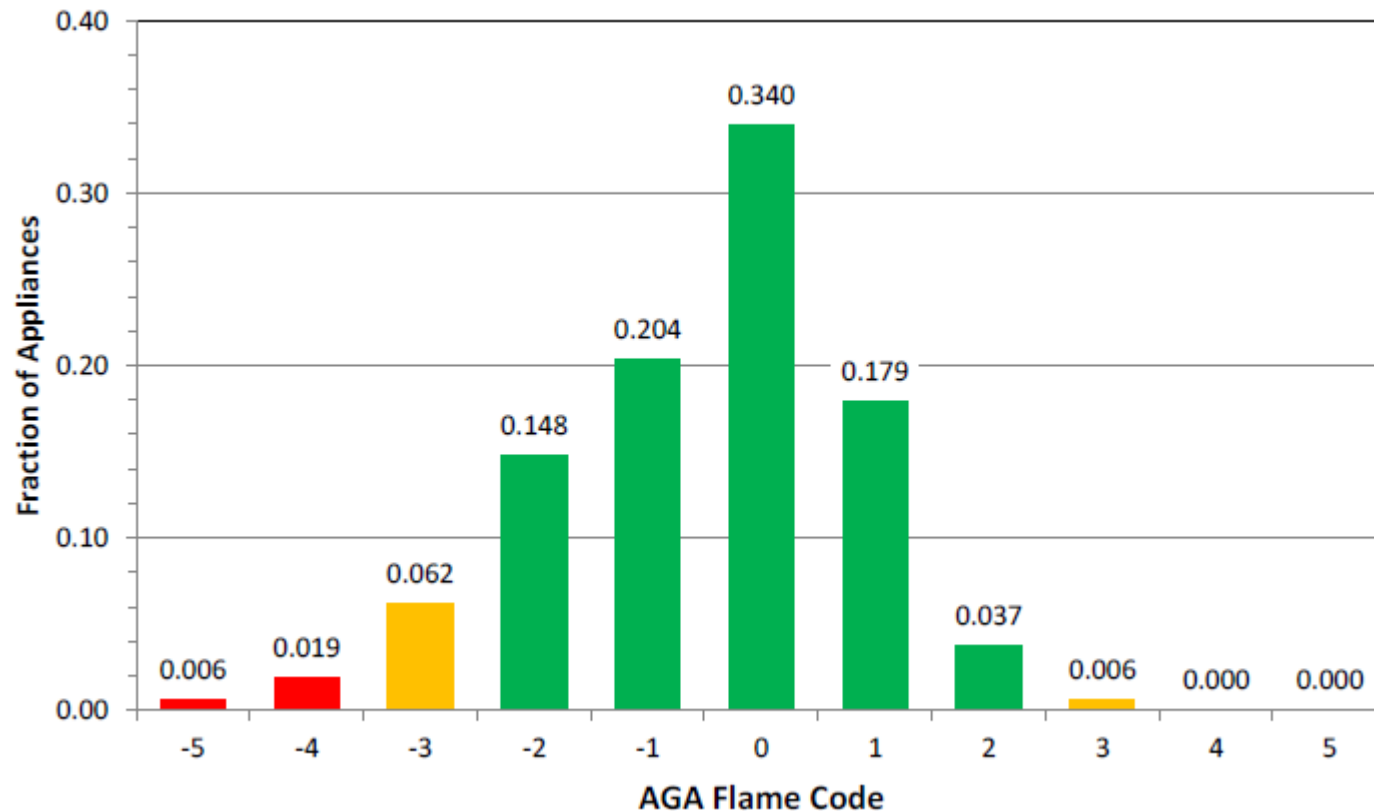
Idaho AGA Flame Code

Without fireplaces the percentage experiencing yellow tipping is 3.4%, well below the 5% limit established by the NYSEARCH Team

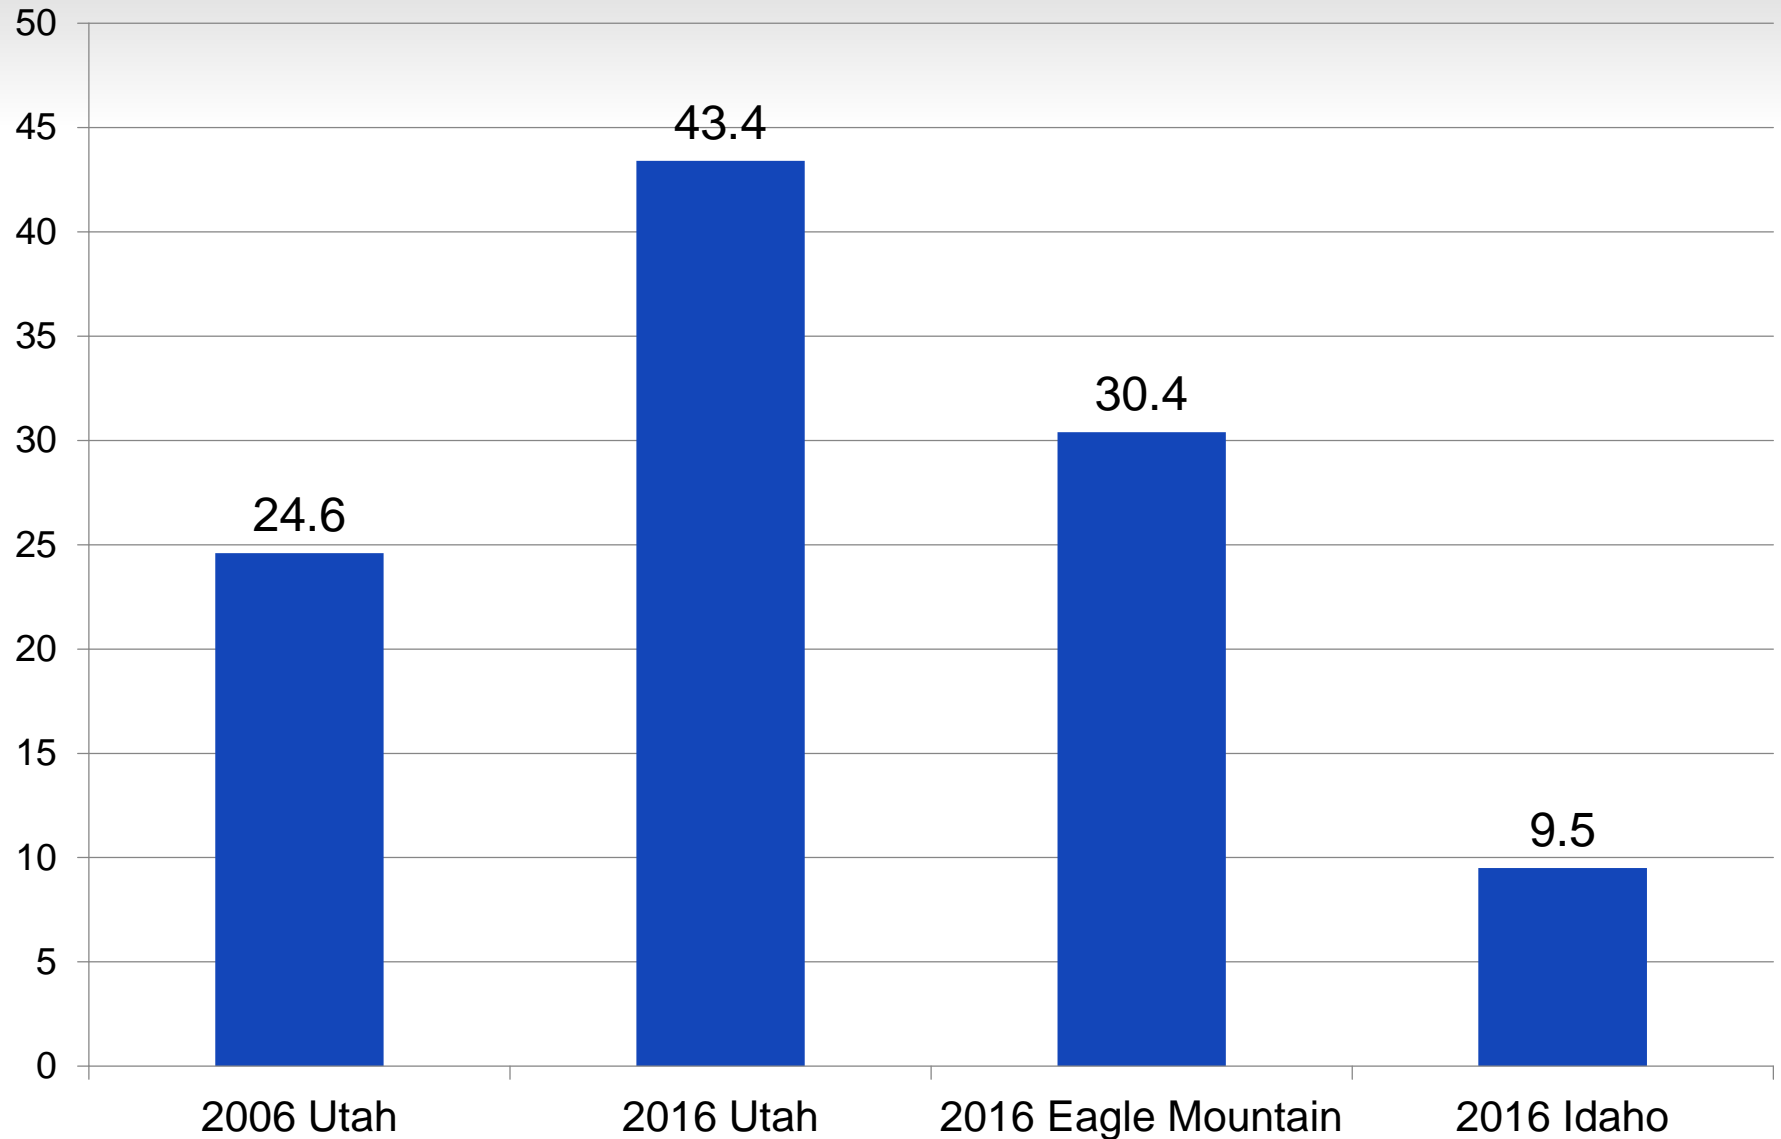
Percentage of Appliances with Green Sticker

- Nearly 12% of appliances were non-compliant
- Service technician notes indicate that overfiring is the primary cause of elevated CO emissions
- Overfiring is often caused by improper adjustment
 - Incorrect orifice size
 - High gas manifold pressure
