Gross Negligence of Taylorsville Bennion when installing new water line.

Accounts of water line strike on 07-15-2021

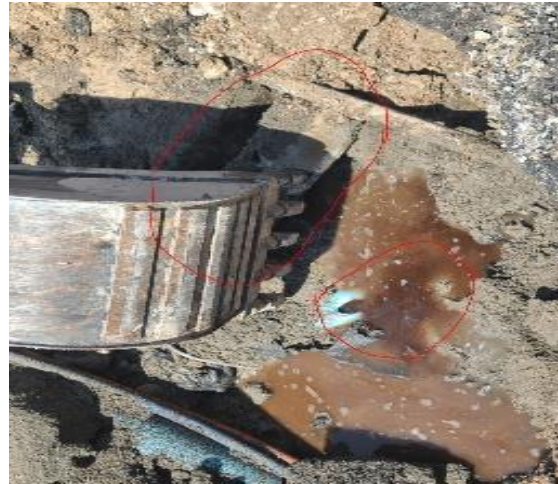
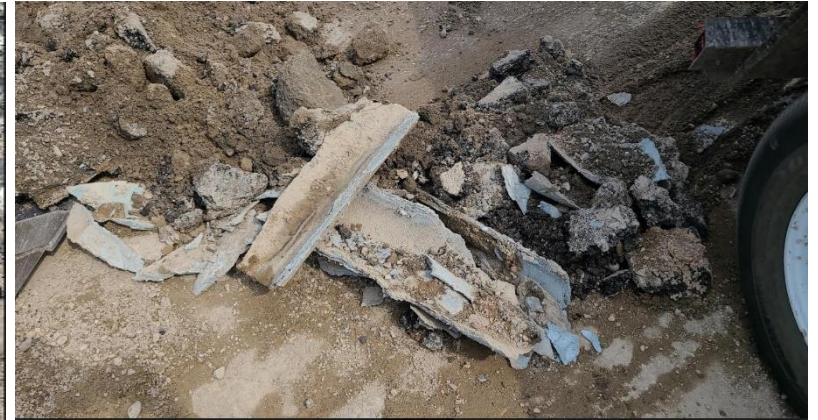
Buried and left abandoned line right above active line. Abandoned line was located above active line within 2' making it more likely to find the abandoned line than active line when potholing the water utility marks. See photo below (Note: When Bennion Taylorsville discovered this line an employee by the name of Karl removed the abandoned line from the damaged area then crushed it immediately with an excavator,

Abandoned Water line located above and just slightly west of active water line. (Note we believe this was the line located during our potholing.)

Old water line was removed from damaged area by Taylorsville Bennion and placed behind excavated material. This line was repeatedly smashed by the excavator destroying the old line before any measurement could be taken.

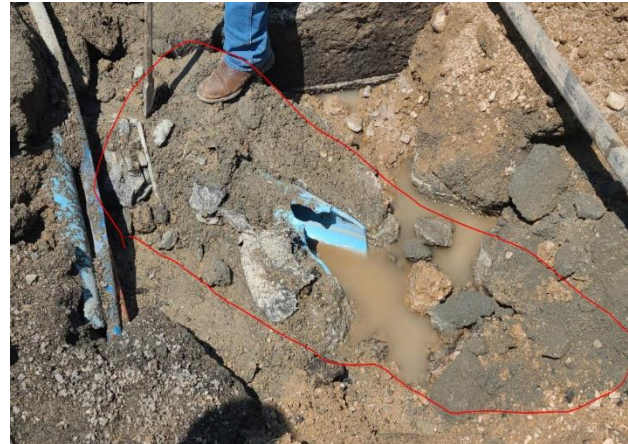
Thrust block encased an 8ft+ area of pipe encasing a large portion of the line with concrete makes the line far more brittle and susceptible to break when any additional utility is to be installed in the area See photo below of specifications of Udot roads and what was installed: Additional pictures and videos are available

Taylorsville Bennion begins removing Concrete poured all around waterline. This concrete was poured to act as a thrust block when the line was installed. This is not the proper way to install a thrust block. This concrete pouring surrounded the entire base of the line. Concrete surrounding this large section of pipe make the pipe brittle and subject to break when pressure is near by. This along with the asphalt pieces in the ground is what ended up causing the line to break as our bore head was passing beneath the line. The installation of this line was installed improperly in every way and does not meet the proper specs. Below are photos of the poured thrust block and submitted plans to install thrust blocks in Utah city's. We also have video of Taylorsville Bennion removing the surrounding concrete.

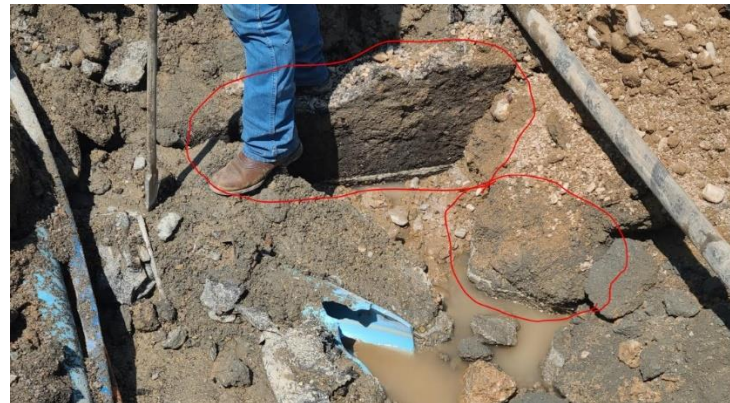
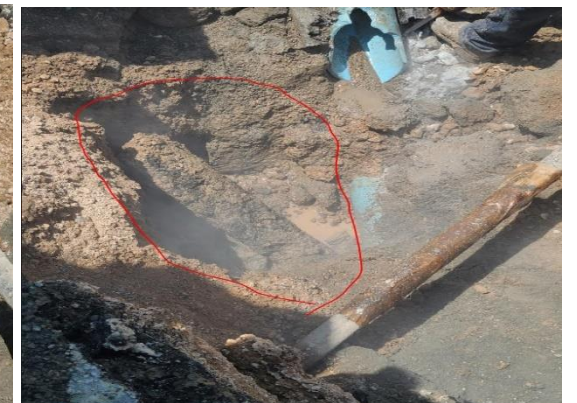
When Taylorsville Bennion updated there line, the excavated road was then buried along with new line. Leaving extremely large pieces of asphalt much larger than the line itself surrounding the line on both sides. This makes it extremely likely to damage this line for any company going below this line. See pictures of asphalt discovered during excavation. Additional pictures and videos are available.

Taylorsville Bennion begins the processe of removing large asphalt materials that were buried around the line and below the line. We believe when the active line was being installed the old road pieces were just tossed in the hole and buried surrounding the active line, rather than being properly disposed of. We believe this also played a major role of the damaged line. The pictures below is large pieces of asphalt that are sitting near and below the line on both sides. Installing any utility in this intersection would cause this line to have a extremely high risk of damage.

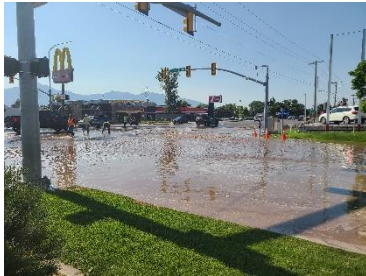
drill operator mentioned to locator he was running into a rough, rocky area just before the potholed water line.

Locator stops operator to verify depth of potholed utility (52") and debt of bore head (77").

Water line burst

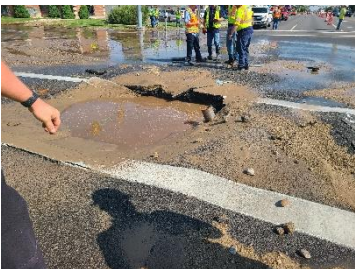
Barricades Services was called for an emergency, barricades to be placed blocking 3 southbound lanes on Redwood Rd and merging the 3 northbound lanes to allow southbound traffic to continue through. Along with barricades to close of west bound traffic completely on 4200 south

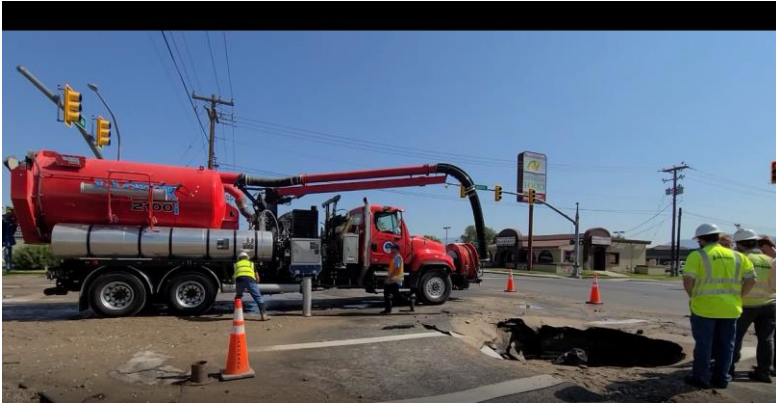
Taylorsville Bennion's Hydrovacc arrives onsite to remove water

Taylorsville Bennion's Excavator arrives onsite to remove material to see damaged area.

Dominion Energy is called to shut off Gas line running near the damaged area for precaution while removing damaged road.

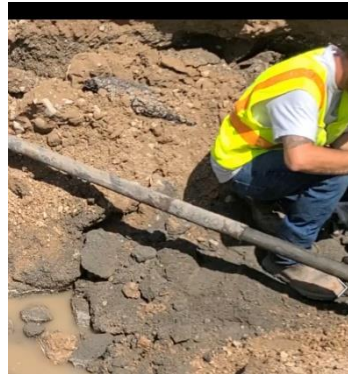
Outer coating of gas line is damaged by Taylorsville Bennions excavator operator.

Outer coating is repaired on gas line

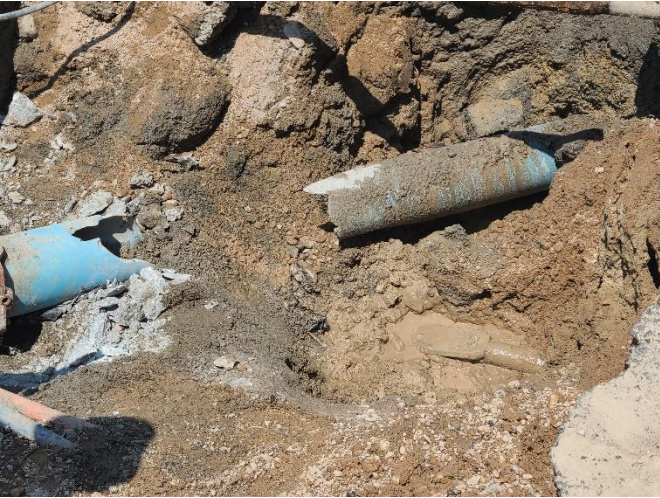
Bore head is located.

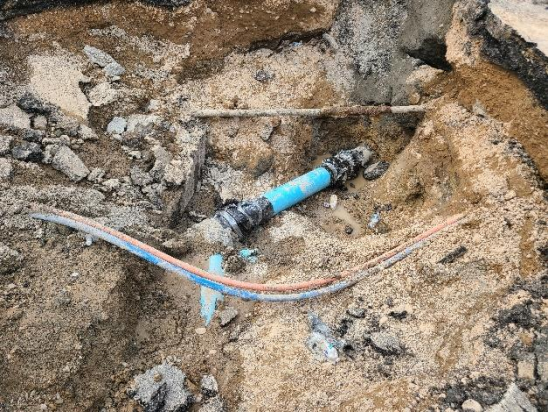
Water line is repaired, Taylorsville Bennion Leaves site claiming no responsibility

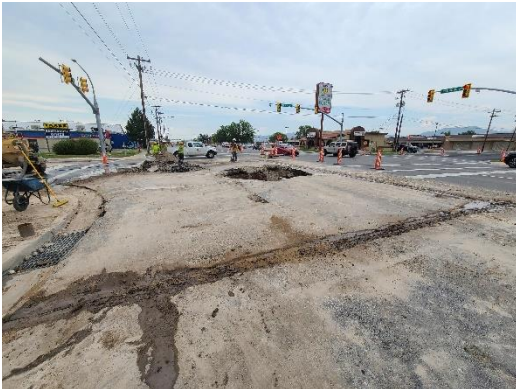
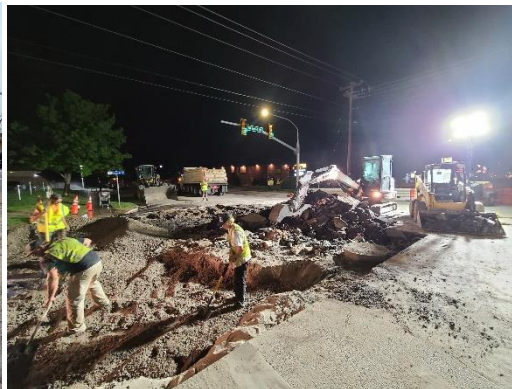
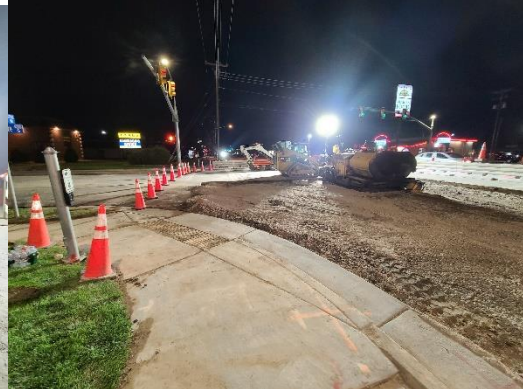
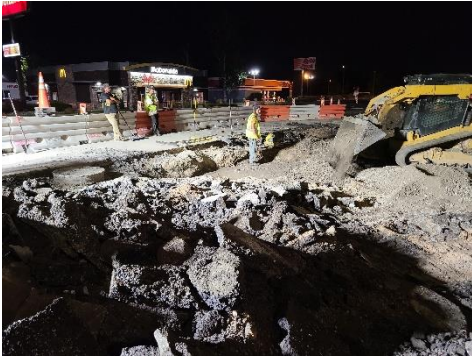
40' by 50' section of asphalt is cut

Asphalt portion is torn out

Utilities are buried with sand

Road based is used to fill up the hole, Tamped down every 6 inches

Asphalt removed from site
