Docket 07-035-08
Review of Dr. Richard Drake Complaint
against Rocky Mountain Power
Final Report

September 4, 2007

WCI *Williams Consulting, Inc.*

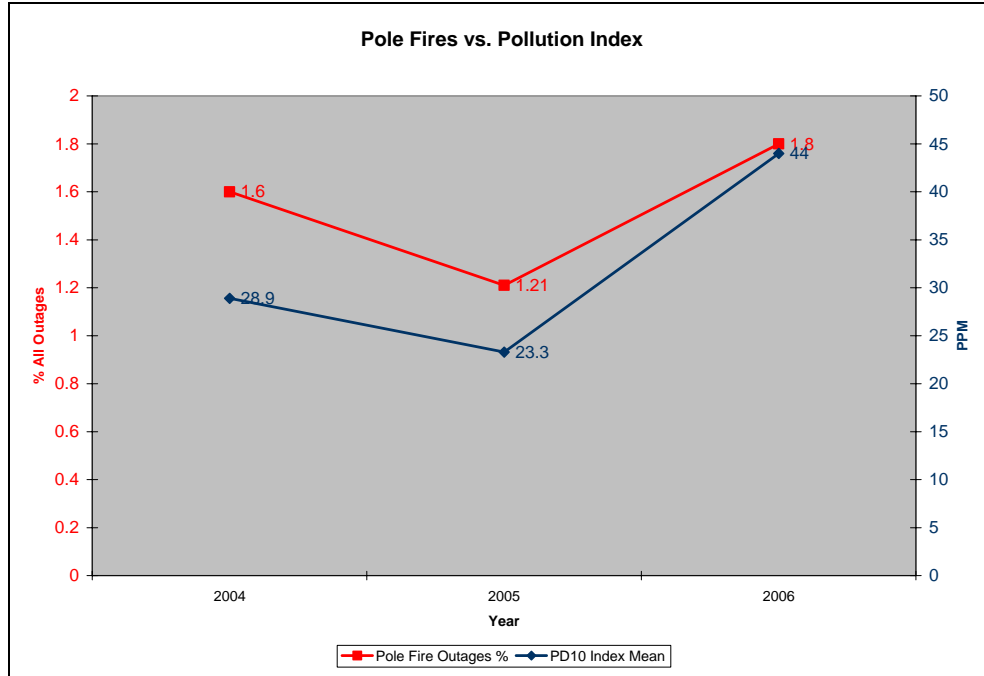
Source: Outage data: RMP, Pollution data: Utah EPA

Utah EPA statistics clearly show a similar trend in particulates below 10 micrometers (PD10) in size (combustion - motor vehicles, power plants, wood burning, etc., some industrial processes, crushing or grinding operations, and dust from paved or unpaved roads). As shown in the chart below, there appears to be a strong correlation between the pollution index and pole fire incidence. However, without a specific analysis that tracks each pole fire incident with atmospheric pollution and precipitation surrounding the date and time of the outage, it is not possible to draw conclusive findings. Nonetheless, the pattern of pollution and pole fires is consistent and supports RMP's conclusion as to the cause of some pole fires.

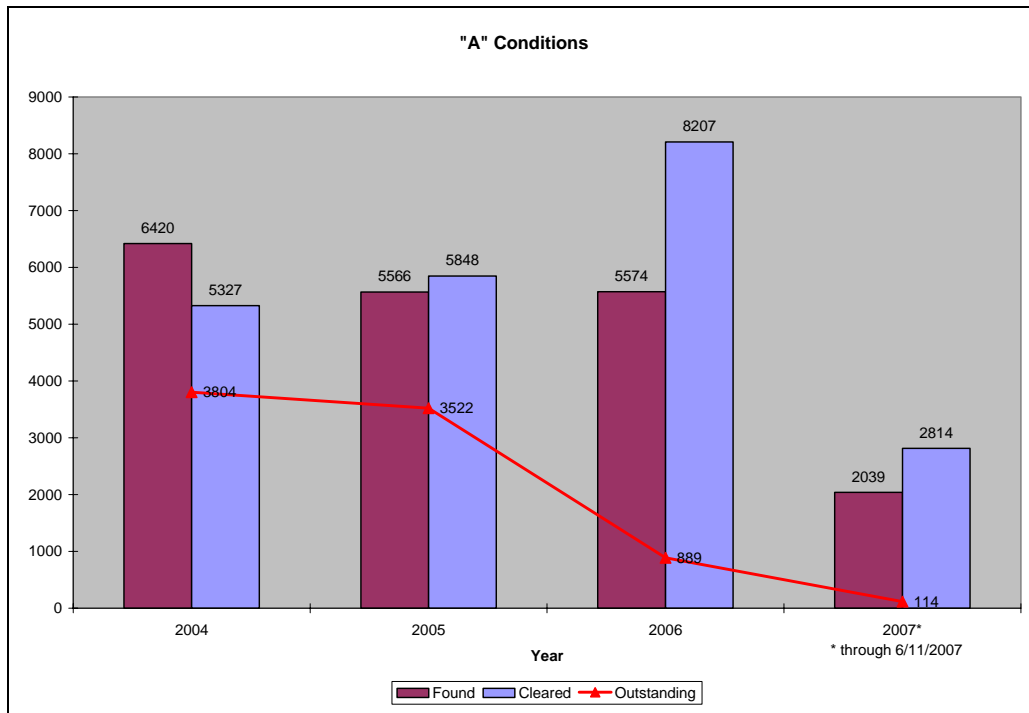
RMP has put substantial effort into correcting "A" conditions found as a result of its inspections, outage responses and other reporting means. "A" conditions have been reduced from 3,804 in 2004 to less than 114 through 6/11/2007 in 2007, as depicted on the following chart.

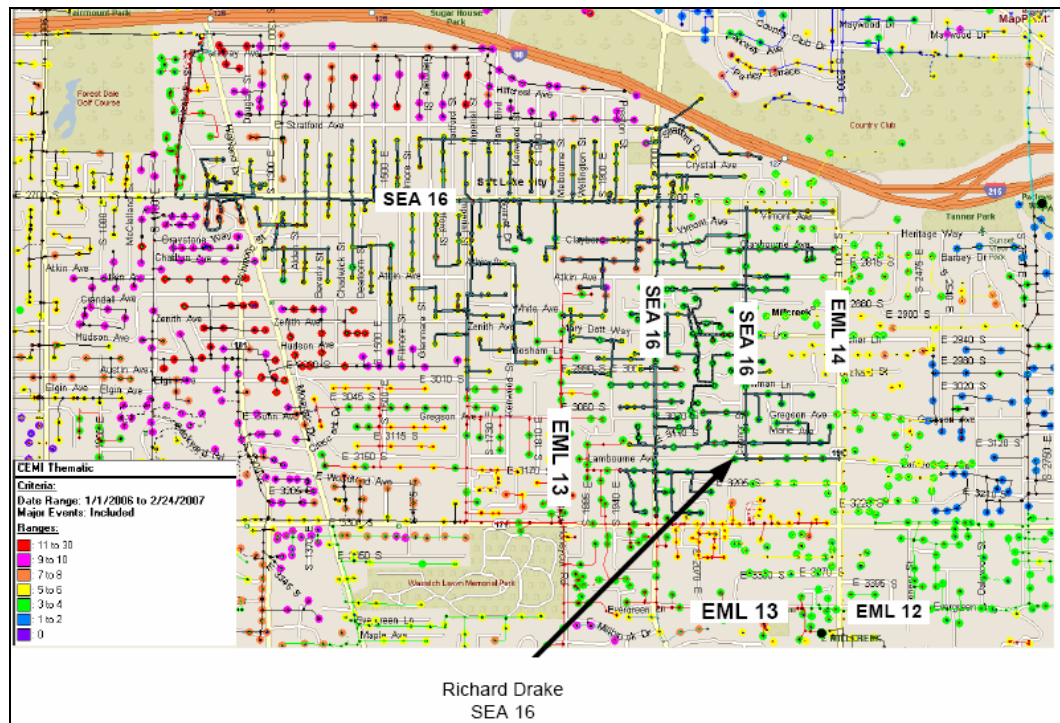
We analyzed the CEMI Thematic shown in the following graphic:

From this it is clear that East Millcreek #13 is not currently part of on-going Reliability Work Plans, nor is it scheduled for cycled inspections. East Millcreek #13 generally experienced 3-4 outages during the 1/1/2006 through 2/24/2007 period, compared to other feeders that had a substantially higher number of outages (in the range of 7 to 10 outages) during the same period. These feeders are currently under RWPs. If RMP were to divert resources to conduct a detailed inspection of this feeder (East Millcreek #13), it would require deferring on-going work in areas defined under RWPs, which by definition are areas of poorer performance than the area served by East Millcreek #13.
