259 Matterhorn Way

PSC DOCKET NO. 21-057-03
Looking East from DEU EXHIBIT B, page 4 of 10
SW side of 259.

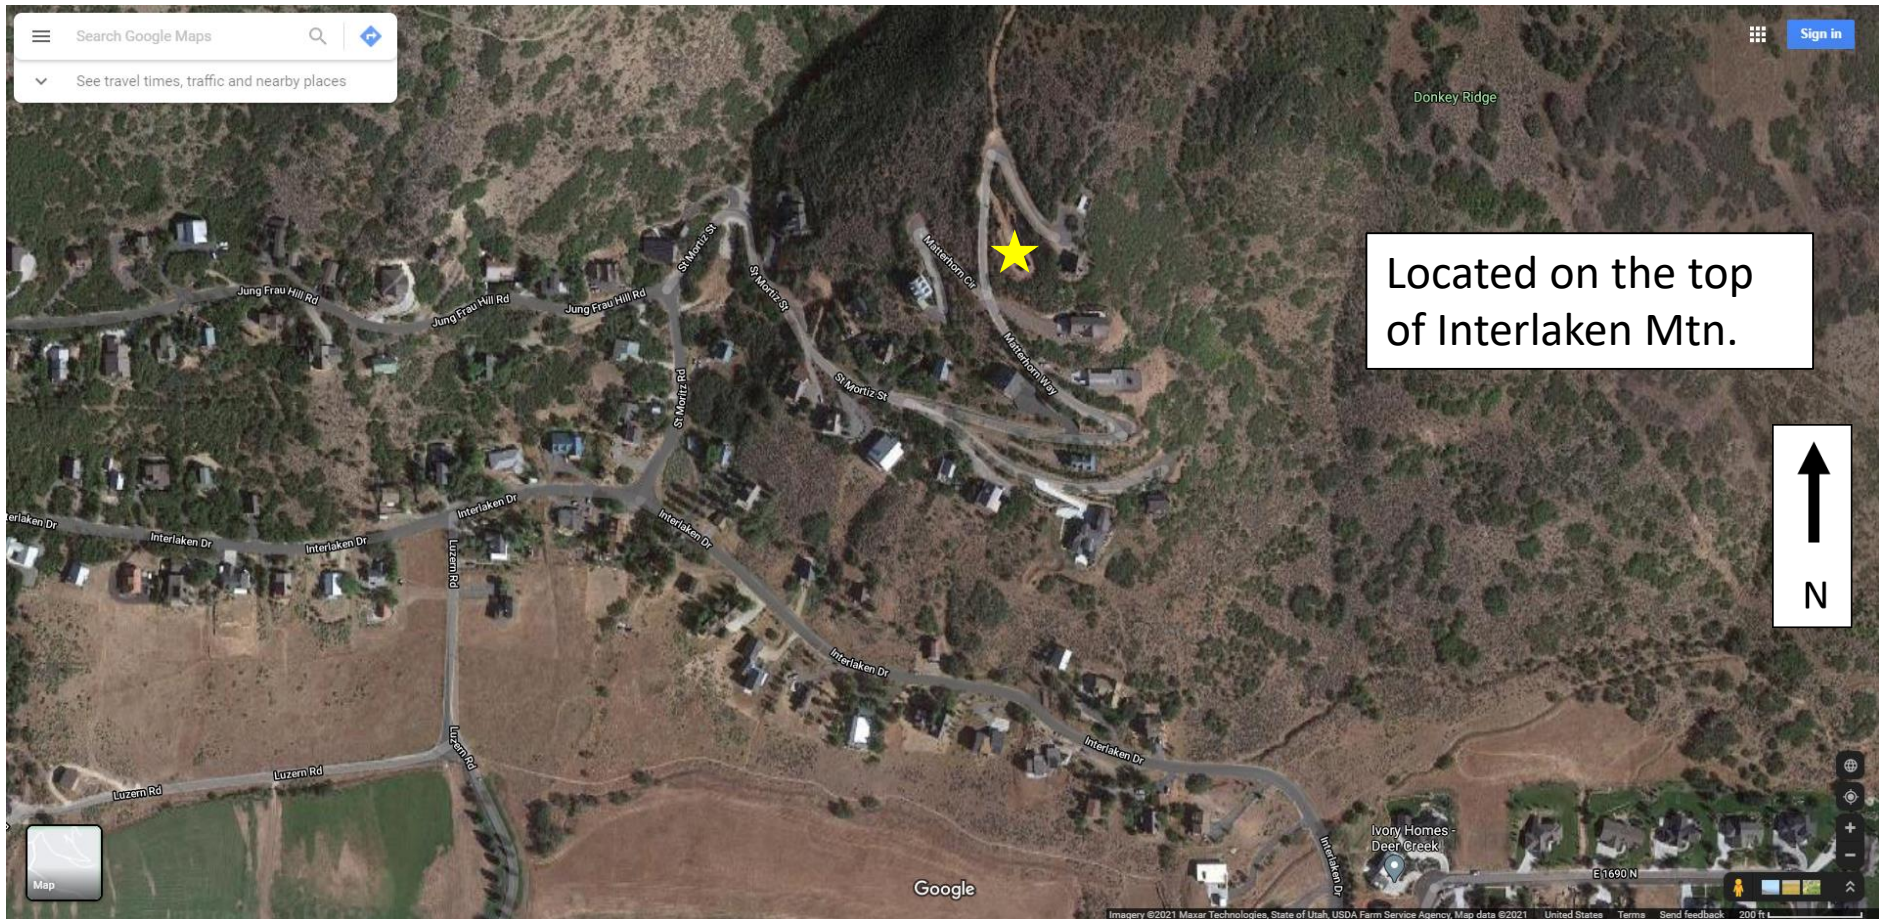
259 Matterhorn Way

Please note site is extensively graded into hillside. The only access is from the driveway. The “Front” of structure should be considered garage side.

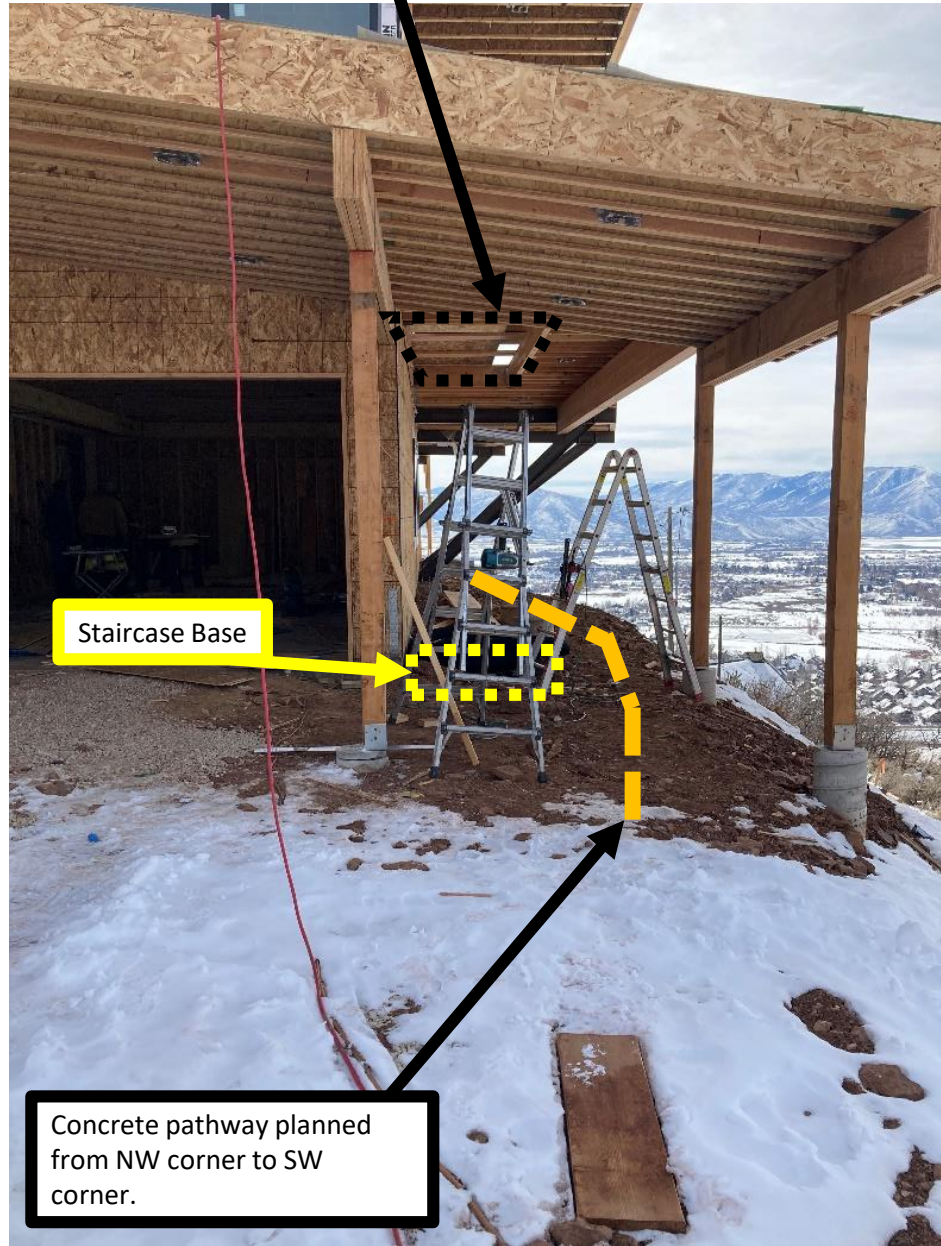
Staircase opening.

Staircase Base

Concrete pathway planned from NW corner to SW corner.

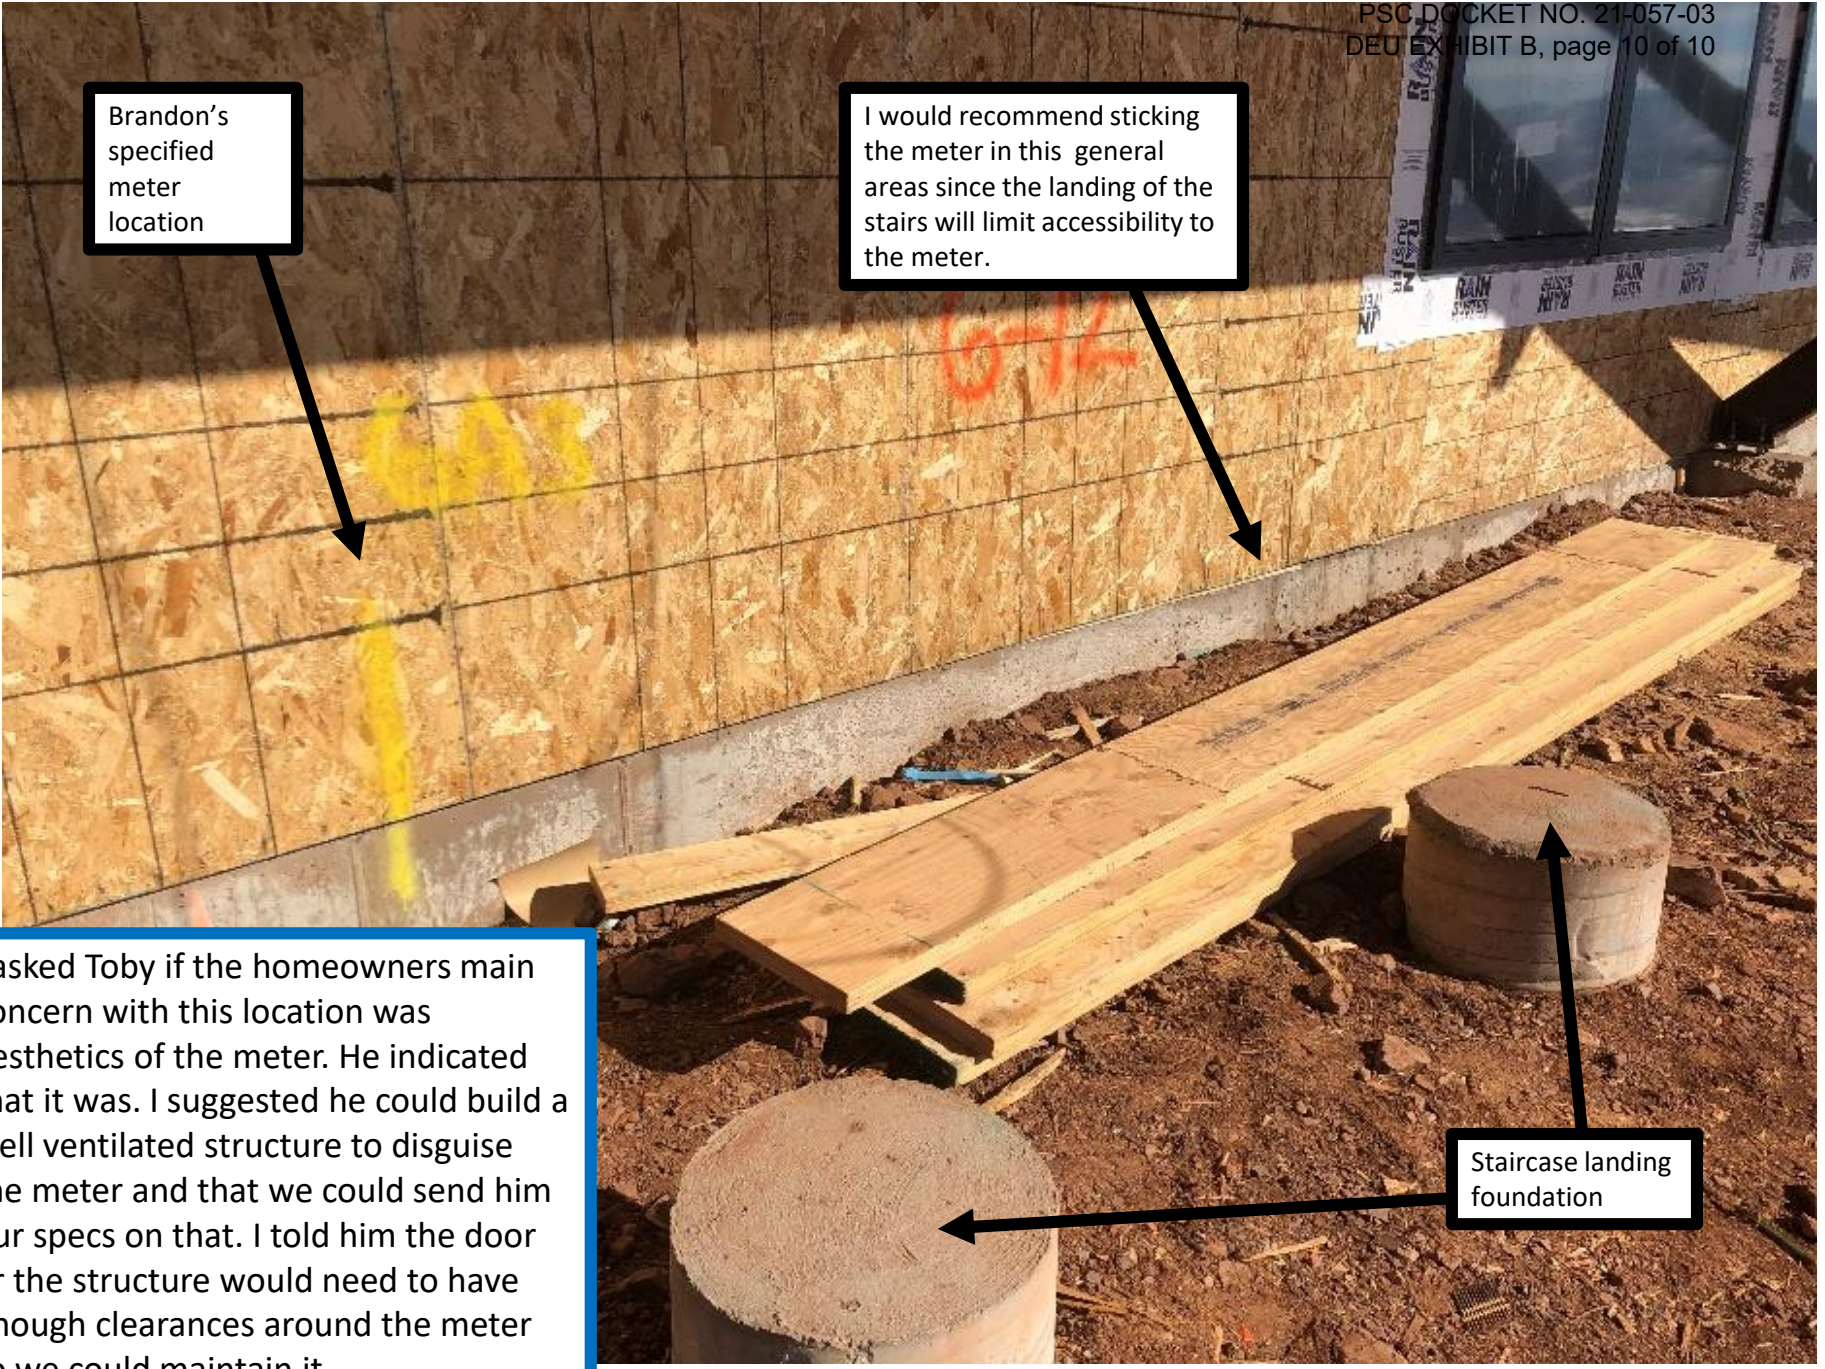
Brandon's
specified
meter
location

Staircase landing
foundation

I would recommend sticking
the meter in this general
area since the landing of the
stairs will limit accessibility
to the meter.

I asked Toby if the homeowners main concern with this location was aesthetics of the meter. He indicated that it was. I suggested he could build a well ventilated structure to disguise the meter and that we could send him our specs on that. I told him the door or the structure would need to have enough clearances around the meter so we could maintain it.
