Wildland Fire Protection Plan 2020-2022
Dixie Power
July 1, 2020

Introduction to Dixie Power	3
a. Description of areas within the service territory of the electric cooperative that may be subject to a heightened risk of wildland fire	4
Escalante Valley (Beryl) Area Substations and Feeders	6
Dixie and Arizona Area Substations and Feeders	8

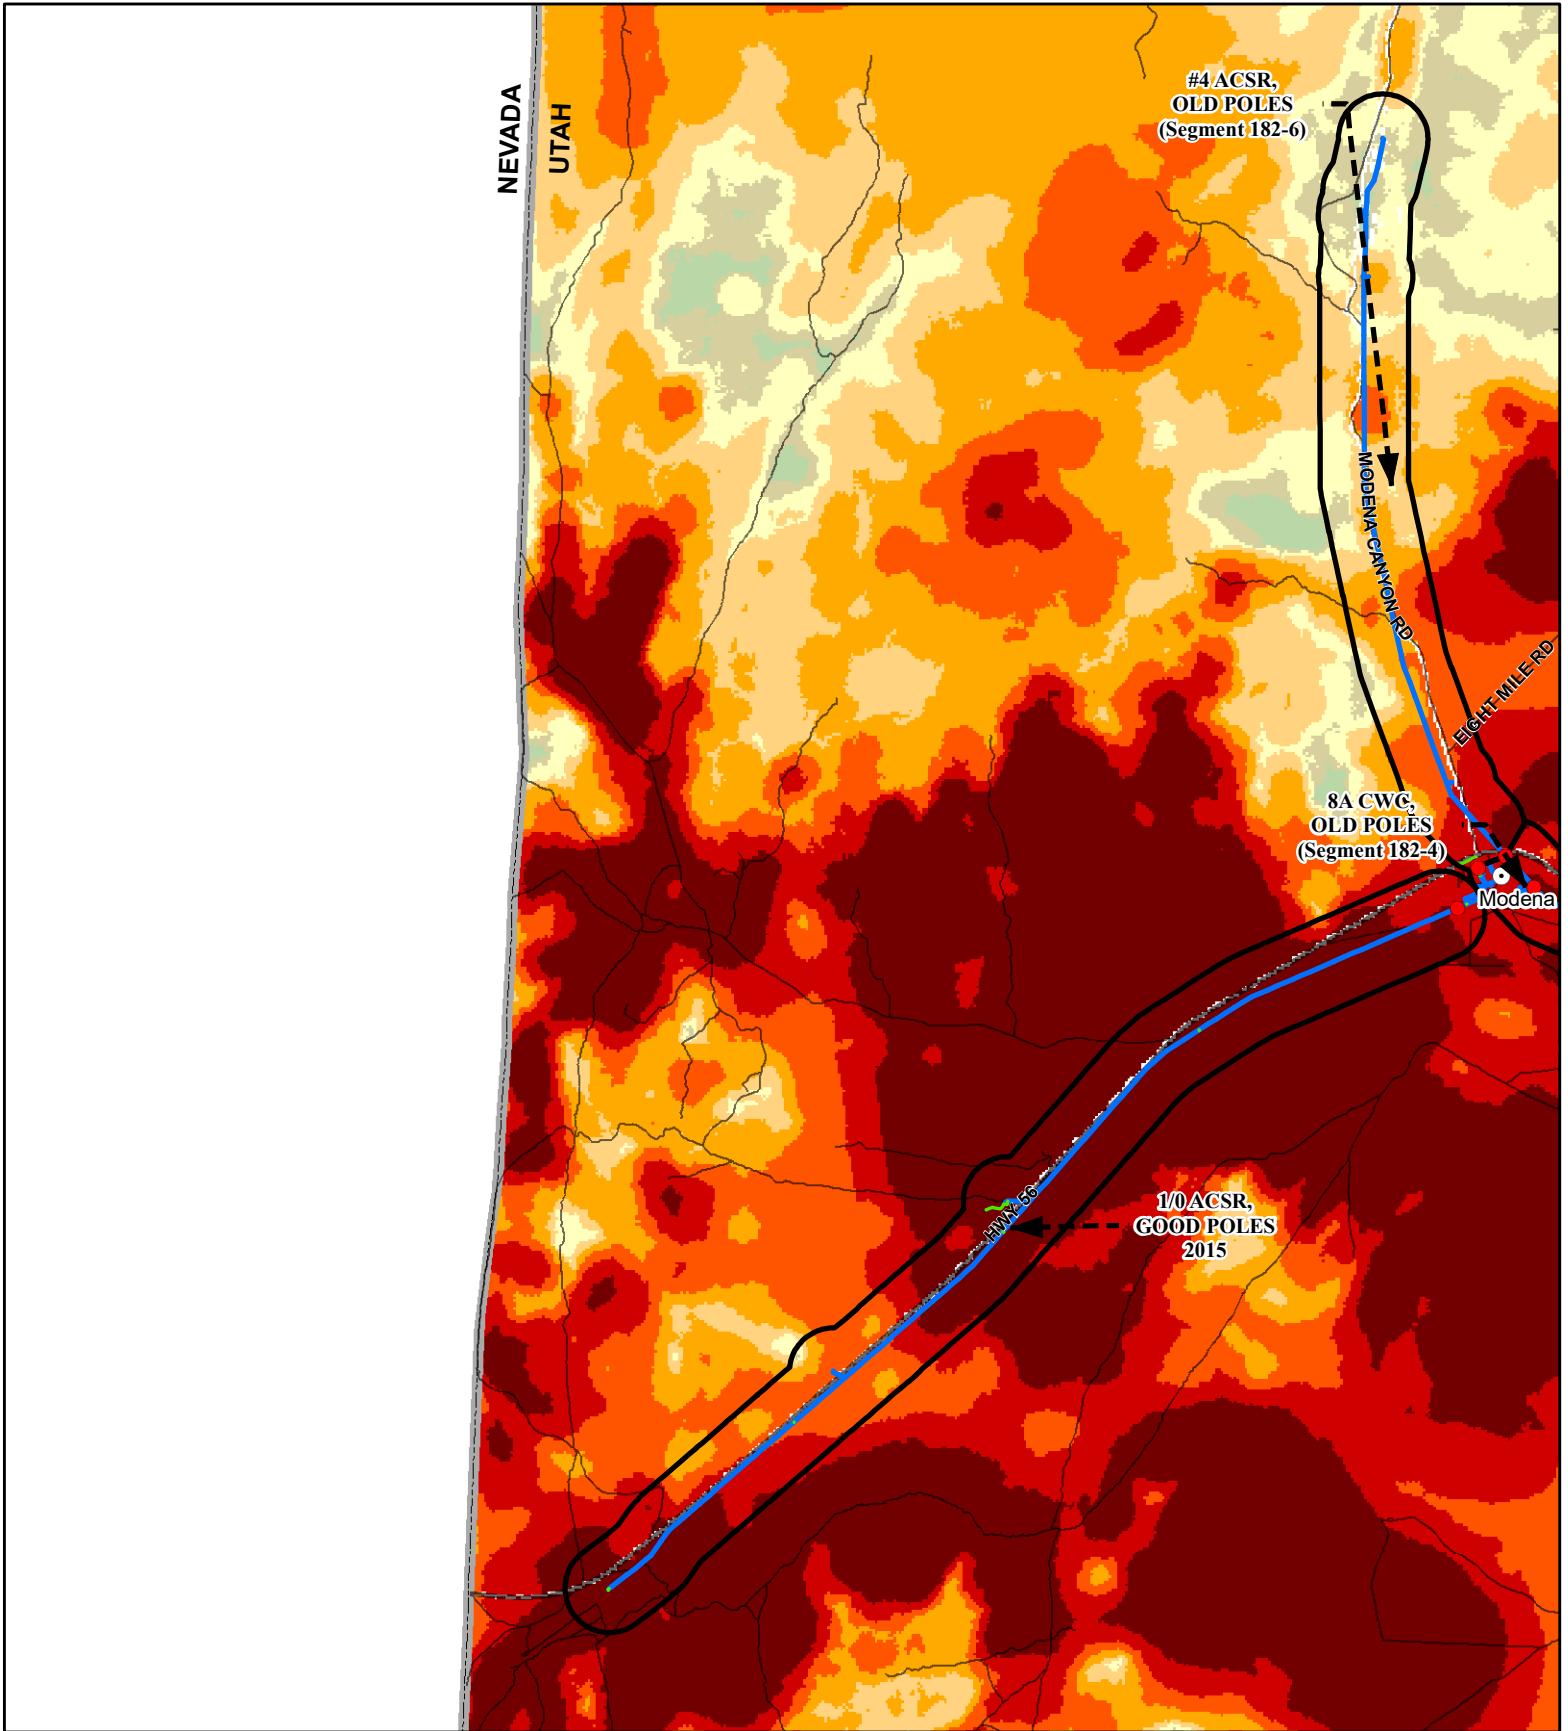
FIRE THREAT INDEX - BERYL AREA PAGE B1

- Fuse
- Overhead Powerline
- Underground Powerline
- State Boundary
- Line Comment

The resulting composite maps for all the powerlines owned and operated by Dixie Power are found in Appendix C (Fire Threat Index Areas) and Appendix D (Fire Risk Index Areas.) The overhead powerlines are drawn in blue in the composite maps and the underground powerlines are drawn in green. The areas of high fire threat index and high fire risk index are colored in red and orange, so the areas of interest are where the blue lines cross the orange and red areas. The overhead lines are a greater potential threat in a wildfire situation than underground lines because bare overhead wires are largely supported in open air on wooden poles and could be exposed to fire and lightning; underground lines are practically uninvolved in a wildfire situation because they’re buried four feet under the surface level of the ground.

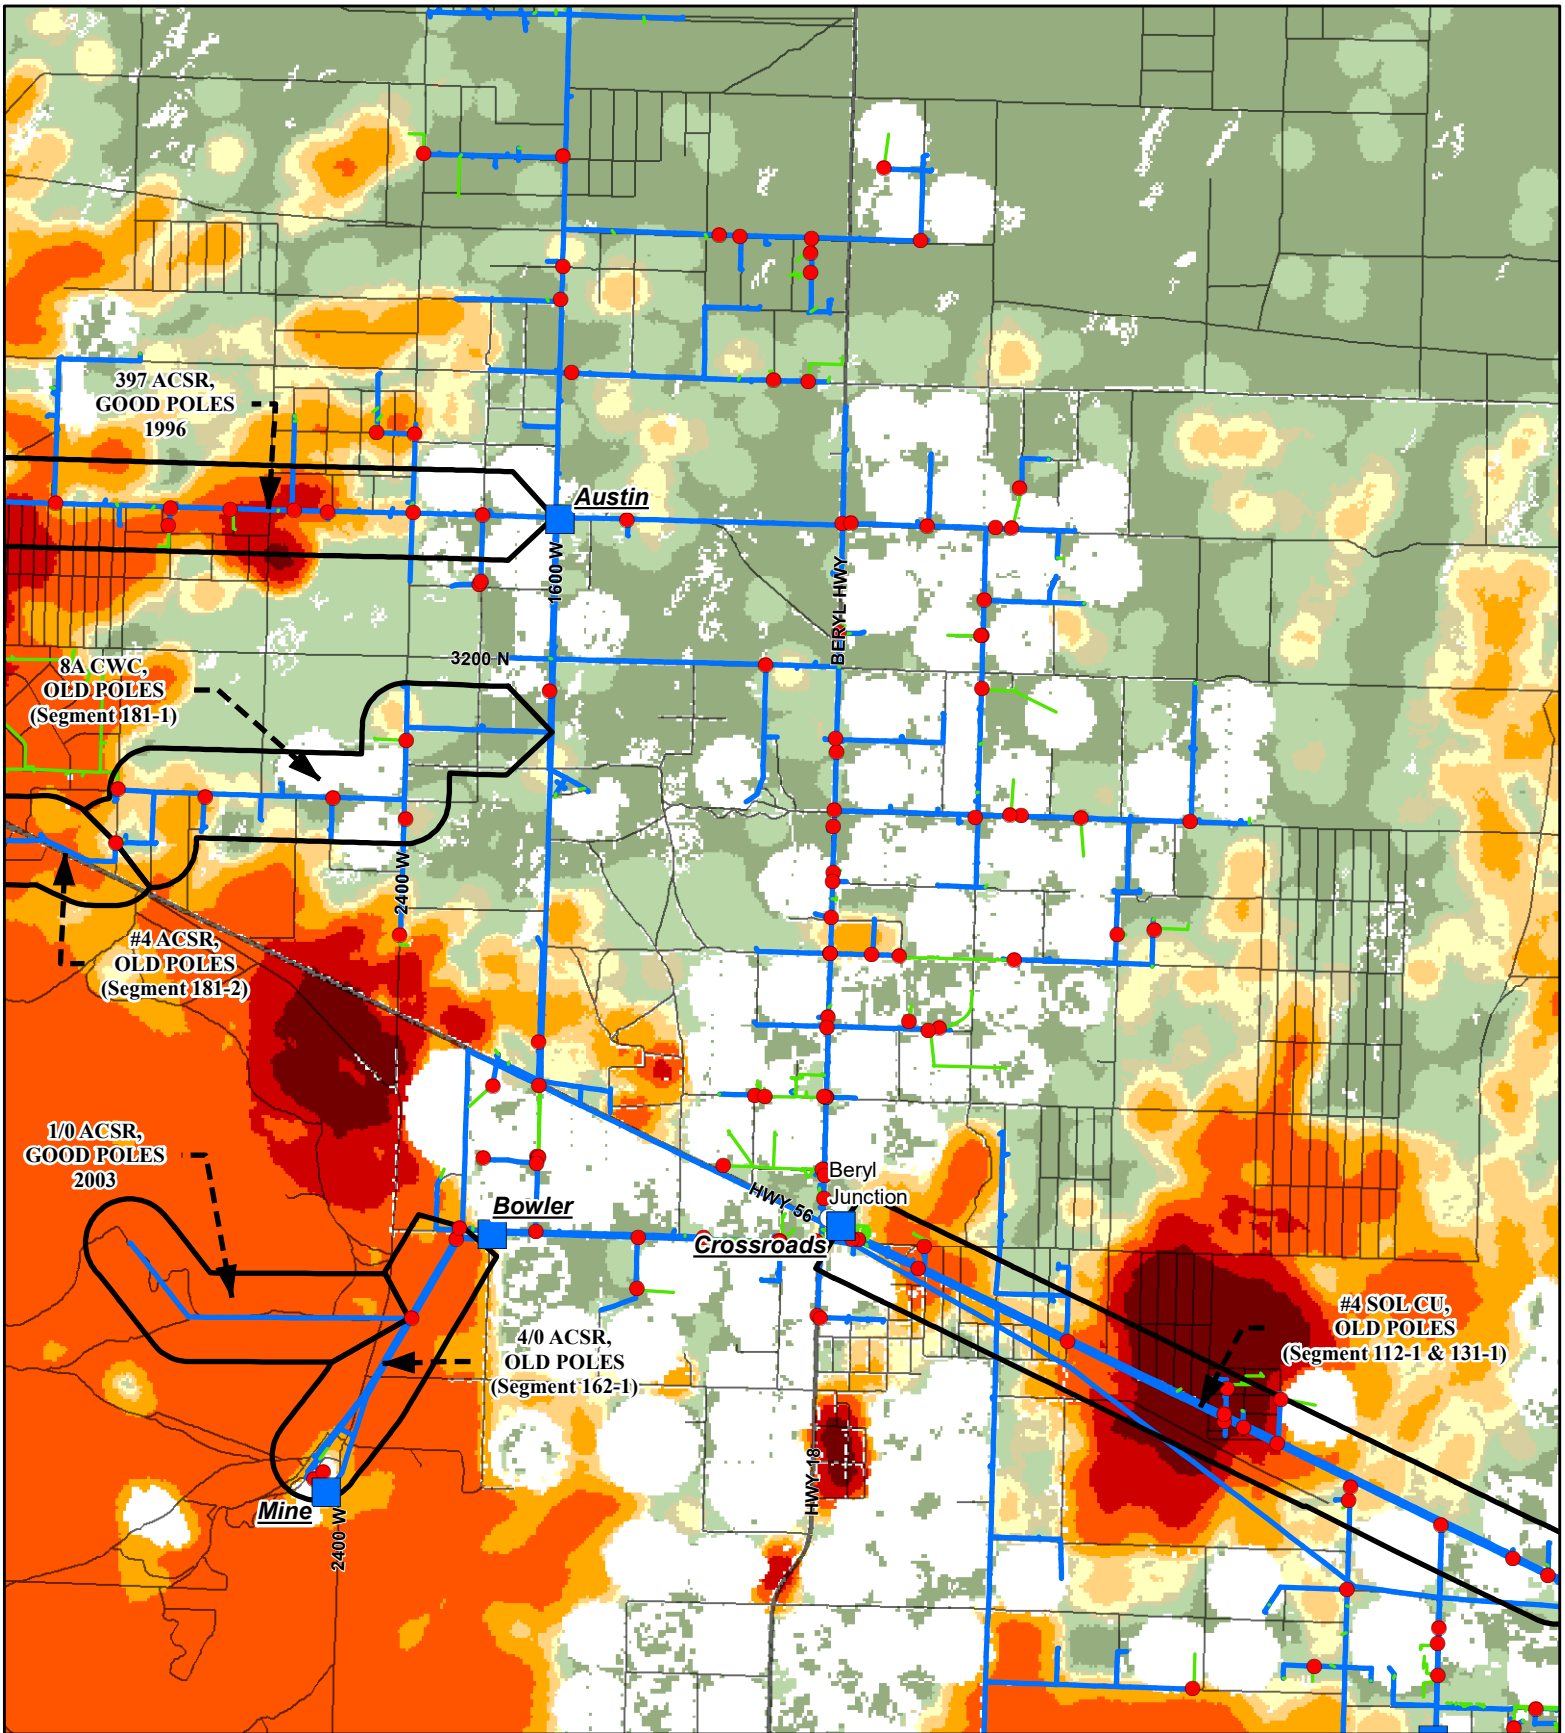
FIRE THREAT INDEX - BERYL AREA PAGE B5

- Substation
- Fuse
- Overhead Powerline
- Underground Powerline
- Line Comment

Escalante Valley (Beryl) Area Substations and Feeders			
Substation	Feeder	Description	Analysis
Austin Sub (Beryl Area Map B5)	181	OH South To Hwy 56 (Beryl Area Map B5 and B2)	This feeder serves mostly irrigated, cultivated land (marked in green on the maps) and so poses very negligible fire risk. The one area of concern includes the two segments on the southwest portion of this feeder where the OH line leaves irrigated land, near Highway 56 (see map B5 & B2.) The first 5.2-mile segment (181-1) of three-phase line has old poles and old conductor and so is scheduled for replacement in 2025. The second segment (181-2) is approximately 2 miles long with some three and single-phase line with old poles and conductor and is scheduled to be replaced in 2026.
	182	OH West to Modena (Beryl Area Map B5, B2, and B1)	This feeder crosses a lot of area with red and orange risk level and so requires a fair amount of detailed evaluation. The first segment of this feeder, going west, (map B5) has good, new poles with good ACSR conductor. Continuing west on this feeder (map B2) there are segments with old poles and old conductor that are slated for rebuild on the dates indicated in the following list for each segment: <ul style="list-style-type: none"> - 182-1: 3.5 miles in 2032 - 182-2: 4.1 miles in 2031 - 182-3: 1.75 miles in 2027 - 182-4: 3 miles in 2028 - 182-5: 8.1 miles in 2030 - 182-6: 13.3 miles in 2029 Continuing south west past the town of Modena (map B1) there is a segment of line that is new, with new poles and conductor (2015) and so is considered to be of low threat for starting a wildfire.

wildland fire risk. And, at the north western edge of the feeder, along Highway 56, (map B5) it crosses a red zone, and since this 6-mile segment (131-1) has old poles and old conductor it is scheduled to be replaced in 2024.
	132	Underbuild North to Hwy 56 (Beryl Area Map B7 and B5)	This feeder serves mostly irrigated, cultivated land (marked in green on the maps) and so poses very negligible fire risk.
	134	UG East (Beryl Area Map B7)	Entirely underground feeder
Bowler Sub (Beryl Area Map B5)	162	34.5kV South to Mine Sub (Beryl Area Map B5)	This 2-mile 34.5kV transmission line (segment 162-1) goes south to the Mine Sub (map B5,) crosses an orange zone, has old poles and is scheduled for replacement in 2034.
	163	34.5kV North to Austin Sub (Beryl Area Map B5)	This 34.5kV transmission line goes north to the Austin Sub, crosses mostly irrigated, cultivated land (marked in green on the maps) and so poses very negligible fire risk.

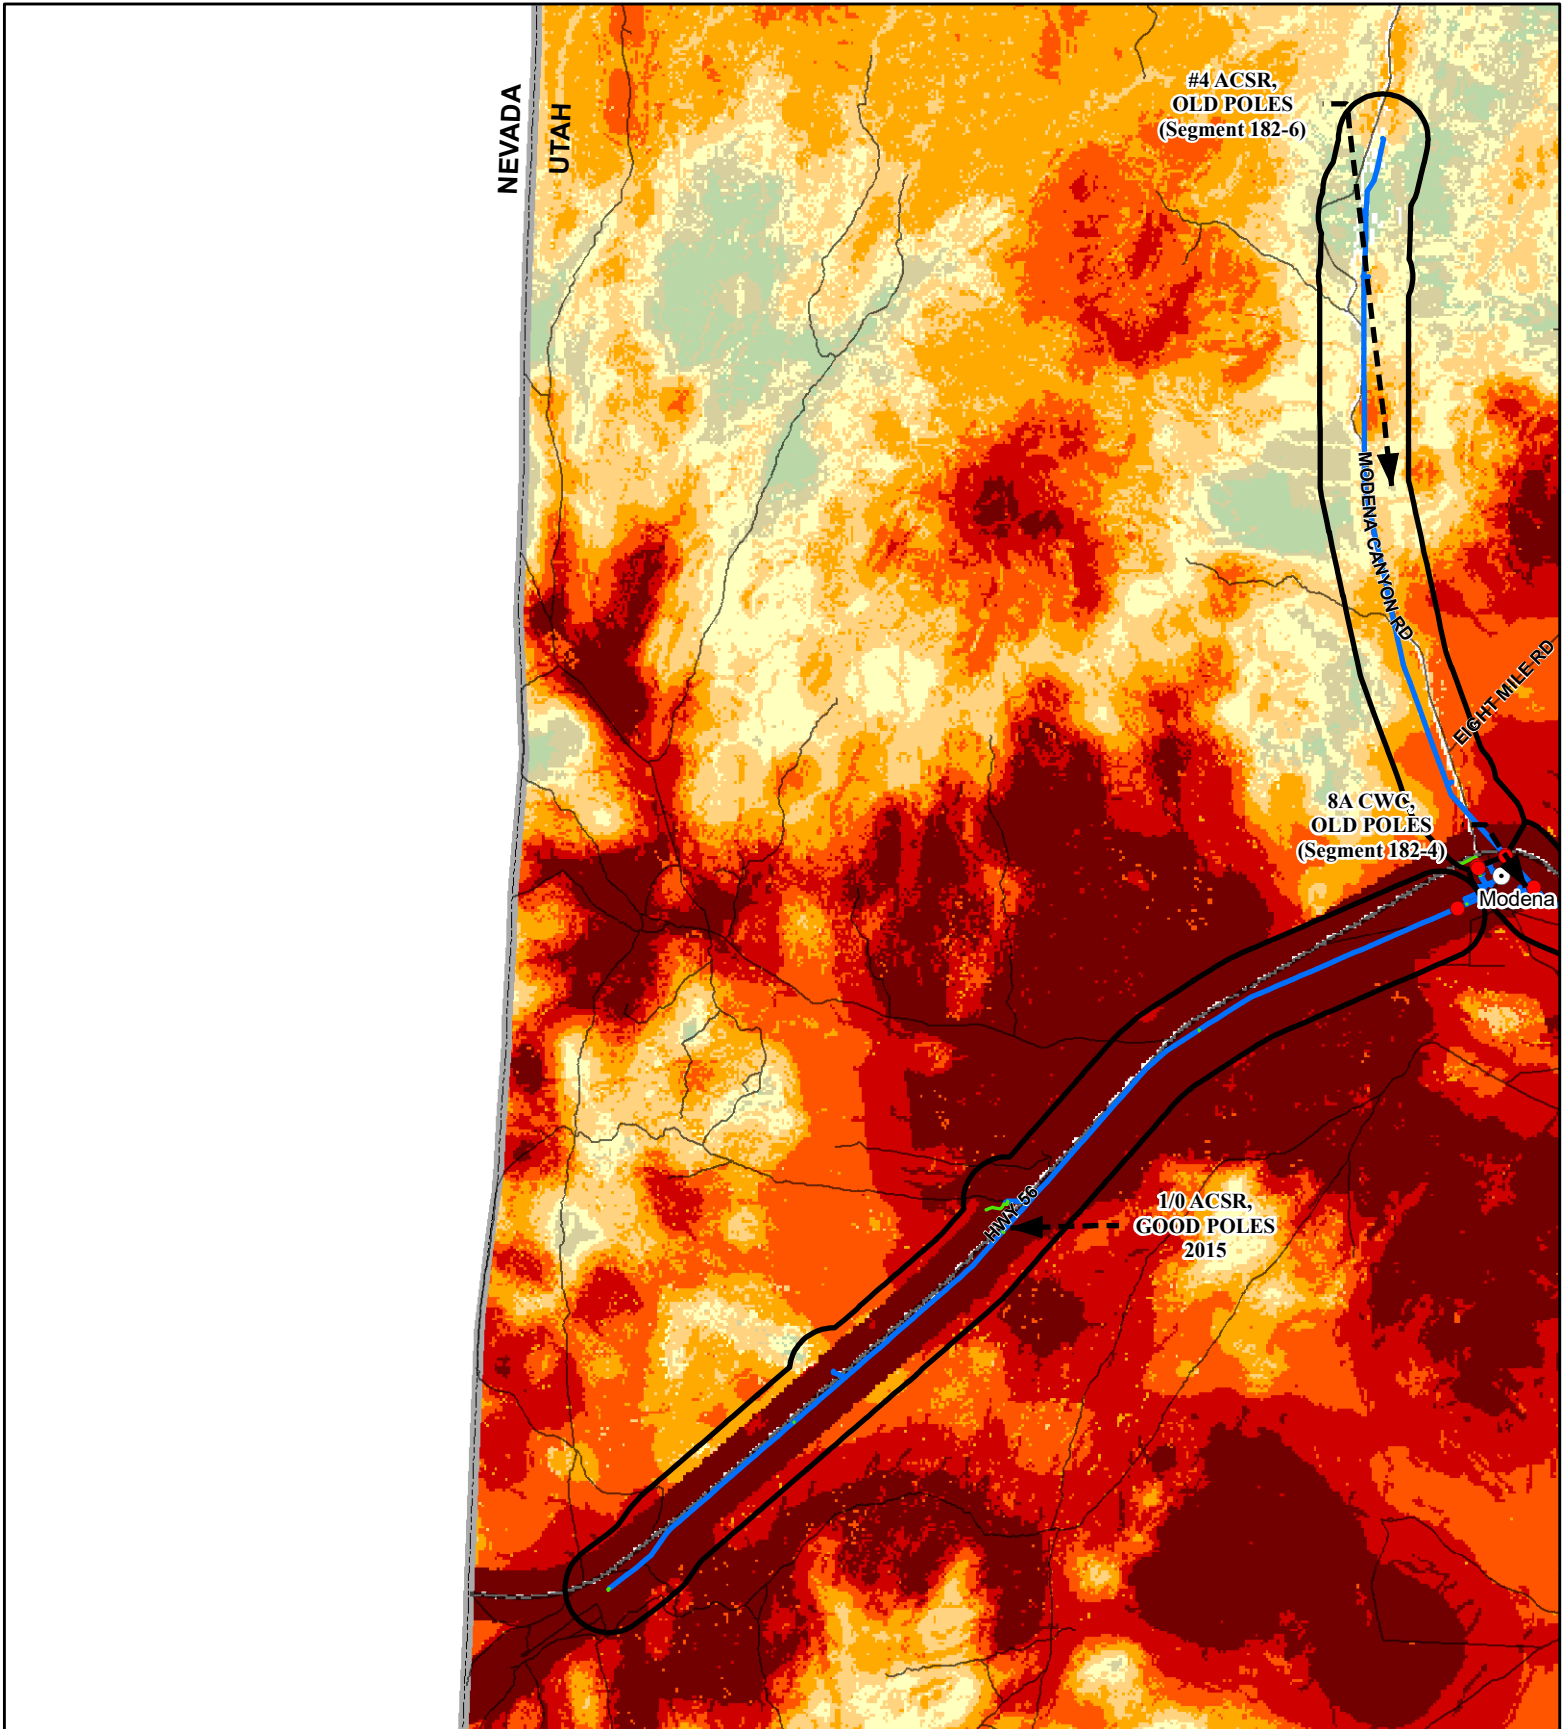
FIRE RISK INDEX - BERYL AREA PAGE B1

#4 ACSR,
OLD POLES
(Segment 182-6)

In addition to regular tree trimming and ROW clearing by a licensed, qualified, contractor, Dixie Power sends out individual linemen to each line fuse pole in known high-risk/dried grass locations (see the red dots on the Fire Risk maps in Appendix D) to clear out the brush or any other potential fire hazard manually. Note: this does not include transformer fuses on overhead lines, which are very small and are of a different characteristic, which expel significantly less hot gas, and therefore are much less likely to be involved in any wildland fire events. This specific and targeted round of clearing is done each year in late April/early May, depending on the weather and precipitation. For a detailed explanation of how expulsion fuses function, see Expulsion Fuse in Appendix A.
