**Re: Docket 23-035-05 – Rocky Mountain Power’s Power Quality Report for 2022**

# 2022 Utah Power Quality Report

Voltage Sag Analysis for Utah's Transmission System

PacifiCorp Power Quality Engineering  
1-31-2023

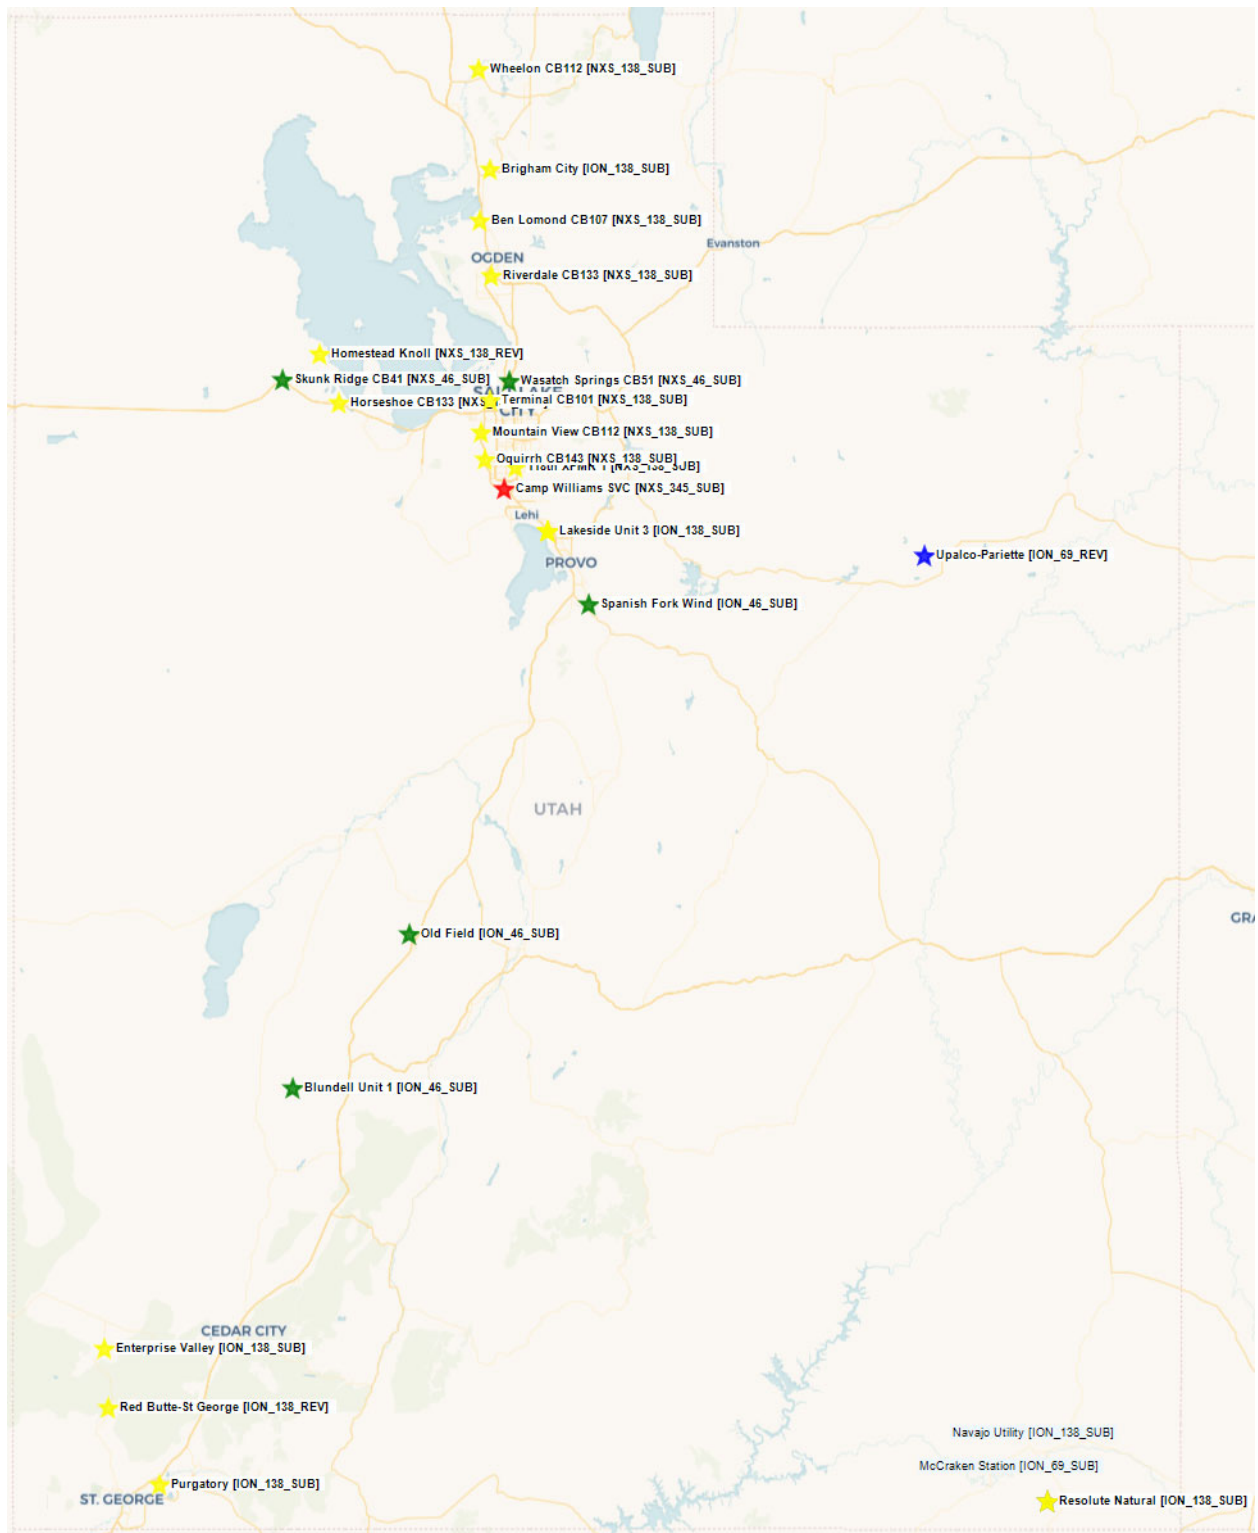
Figure 1 Power quality monitor locations for the state of Utah.

The power quality monitors on the transmission network are plotted in Figure 1:

- 34.5 kV < Green Marker < 69 kV
- 69 kV <= Blue Marker < 138 kV
- 138 kV <= Yellow Marker < 345 kV
- 345 kV <= Red Marker < 750 kV
