WILDLAND FIRE PROTECTION PLAN

Dixie Power

DATE: September 2023

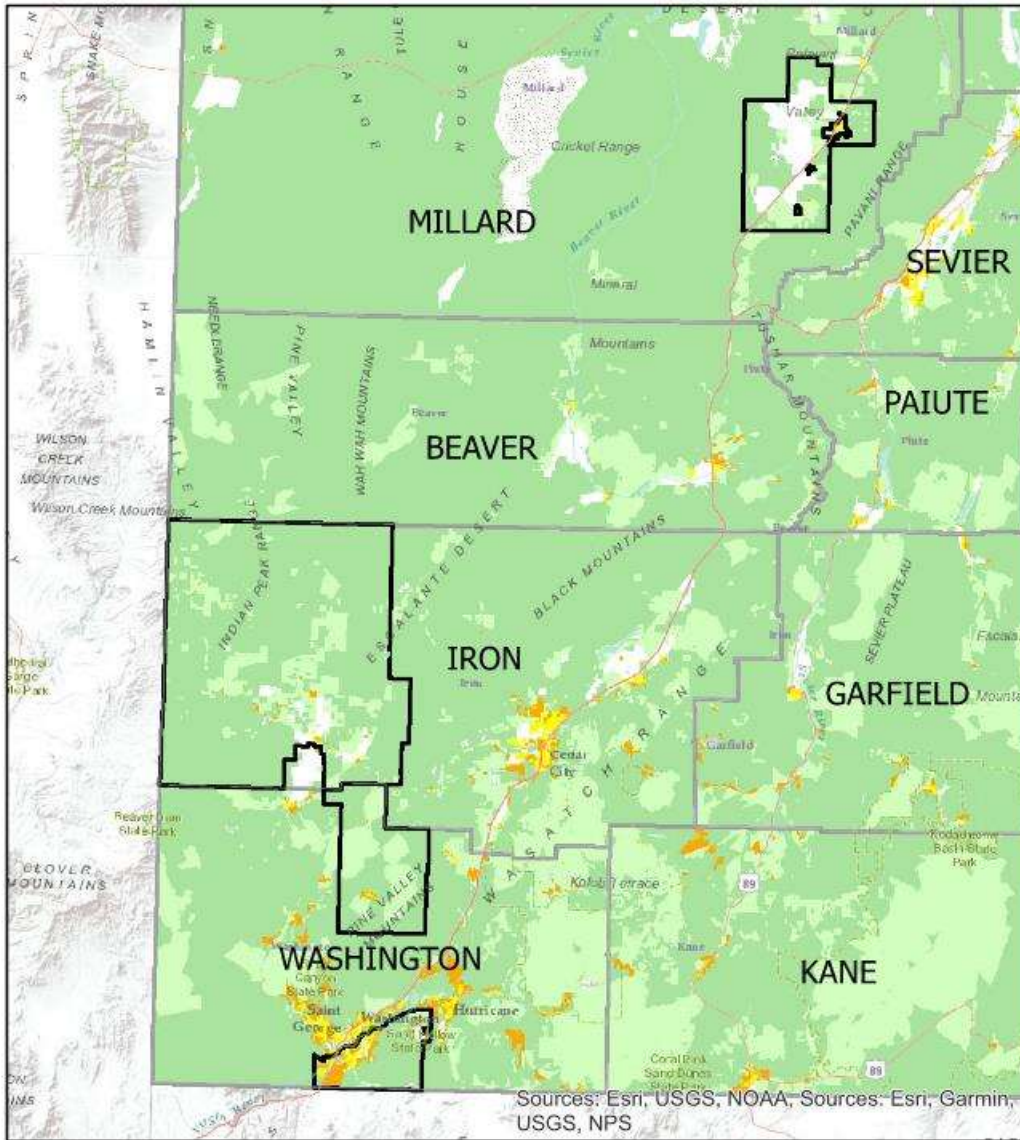
Figure 3. Wildland Urban Interface

The WUI is composed of both interface and intermix communities. The distinction between these is based on the characteristics and distribution of houses and wildland vegetation across the landscape. Intermix WUI refers to areas where housing and wildland vegetation intermingle, while interface WUI refers to areas where housing is in the vicinity of a large area of dense wildland vegetation. Figure 2 illustrates the distribution of WUI areas in the service area.

Wildland Urban Interface Map

Figure 3. Wildland Urban Interface.....26

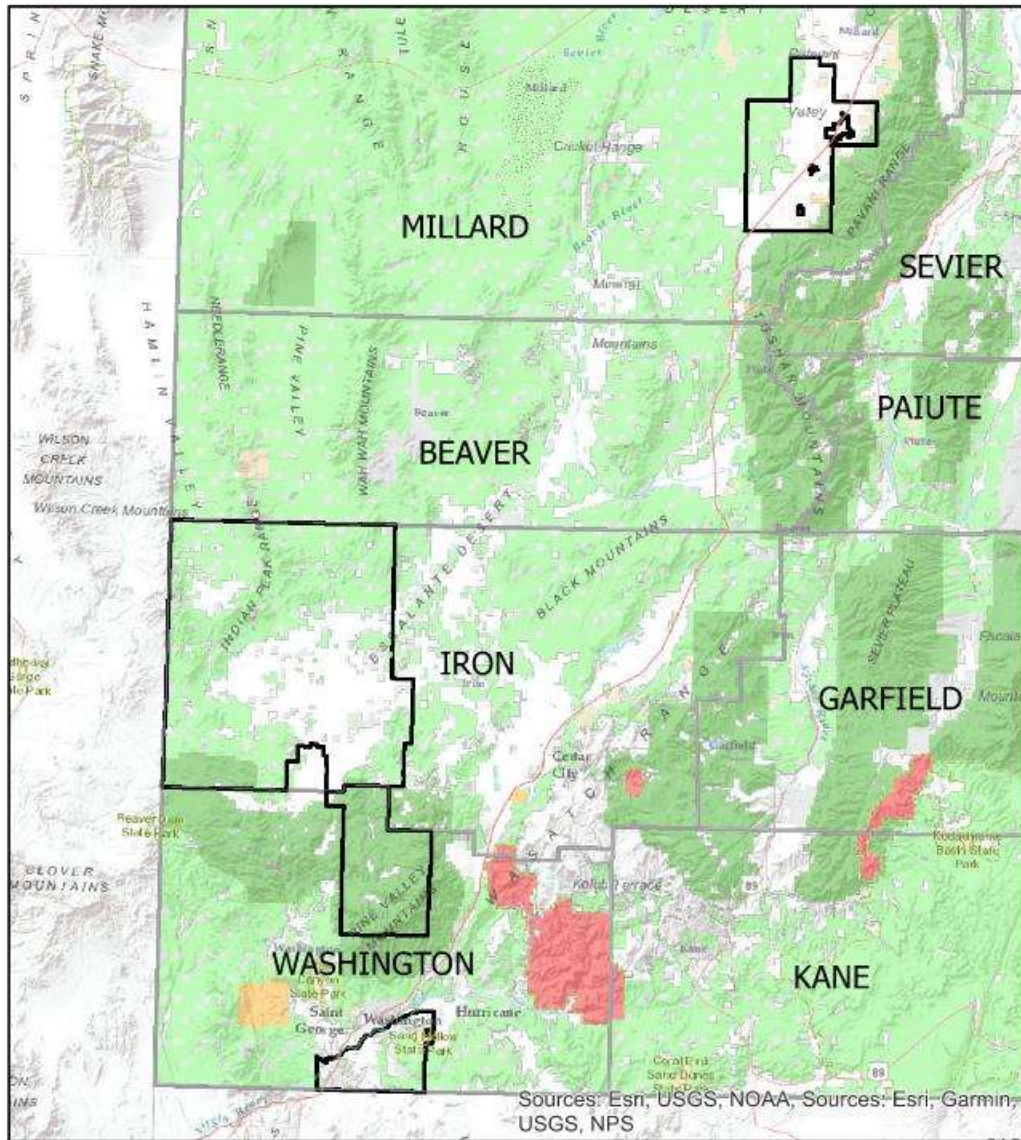
Figure 5. General Land Ownership

In the map shown below, in **Figure 5. General Land Ownership**, the light green areas illustrate the amount of property in all three counties, Millard, Iron, and Washington, that is owned and operated by the U.S. Bureau of Land Management (BLM) or approximately 63% of the total. The area shaded in tan in the Millard County area, northeast of the town of Kanosh, is tribal reservation land, owned and operated by the local Tribal Council, or about 0.1%. The darker green area in the northern part of Washington County, in the Pine Valley area, is land owned and operated by the US Forest Service, about 25%. The yellow-shaded area in the Dixie Area of Washington County is the Sand Hollow State Park, about 1%. The gray areas, predominantly in the Dixie area, is owned by the State Institutional Trust Lands (SITLA), or about 11%. All of the remaining area on the map, the white area, is privately owned, or about 55%. In all of these jurisdictions Dixie Power coordinates with the property owner and operator in all cases of obtaining and maintaining powerline easements and rights-of-way.

General Land Ownership Map

Figure 5. General Land Ownership46

To assure continuously cleared rights-of-way Dixie Power requires access to rights-of-way from all landowners and land managers, including public and private (see Map of Land Ownership in Figure 5, below.) Both safety and reliability suffer when Dixie Power is unable to access their powerlines due to access closed by landowners and land managers, and so Dixie continually requests the required access to all their powerlines. Dixie Power contracts with a certified tree trimming contractor who follows a set cycle of the overhead lines to ensure that all trees are the prescribed distance away from the powerlines (see prescribed distances detailed in Appendix F.) Additionally, if any of the cooperative line or ROW inspectors, or any member of the public, report that a segment of powerline has encroaching trees, a service order is created and a corresponding work order is issued to the tree trimming contractor in addition to their normal trimming cycle. Vegetation management is a permanent and ever-expanding part of every annual budget.

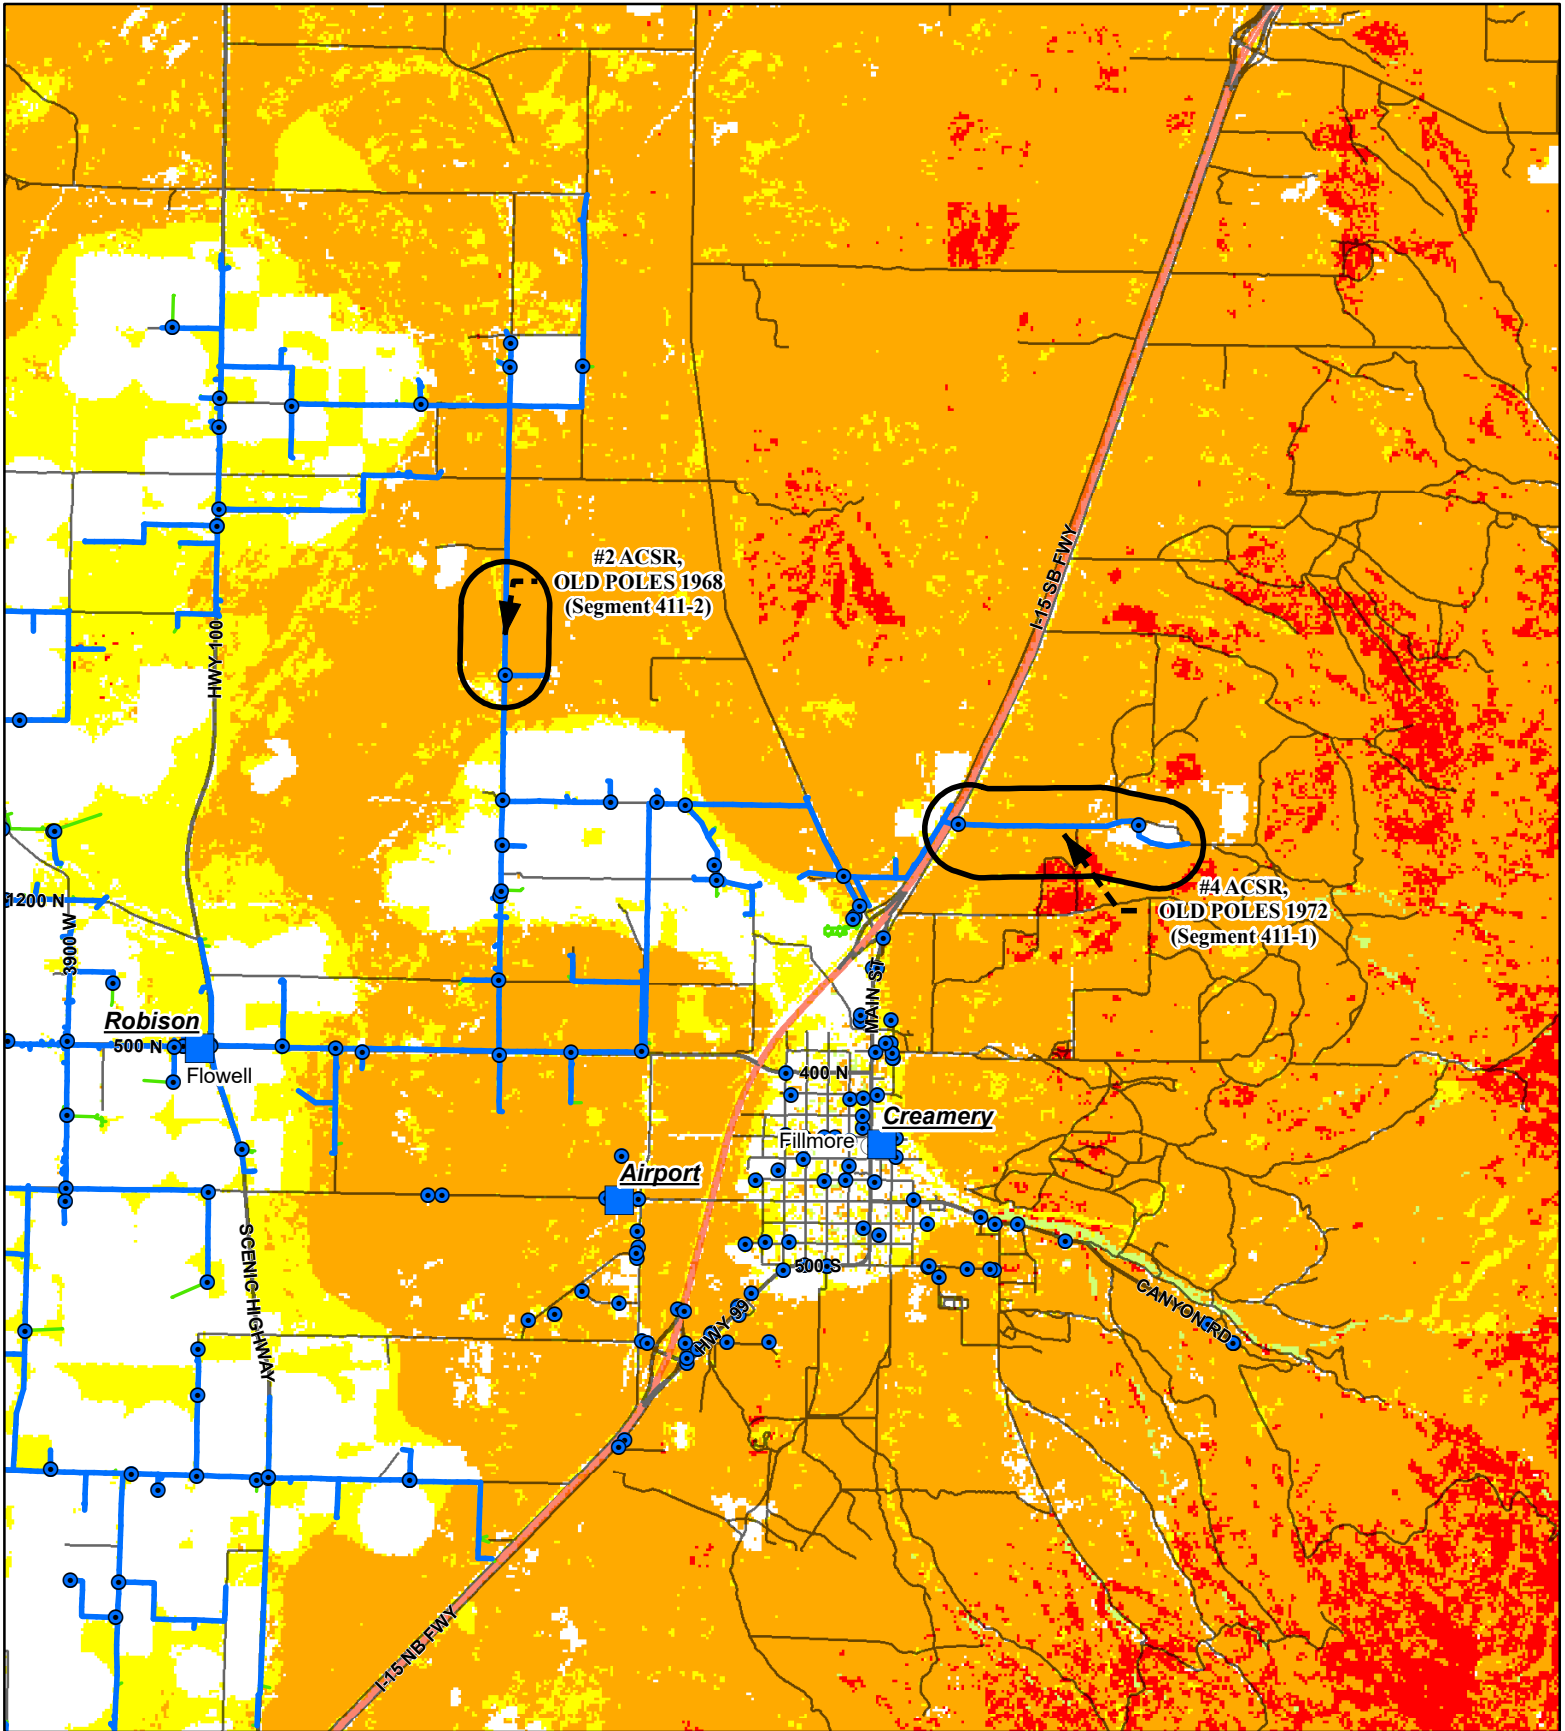
WILDFIRE HAZARD POTENTIAL - FLOWELL AREA PAGE F2

- Fuse
- Substation
- Overhead Powerline
- Underground Powerline
- Line Comment
- Very High
- High
- Moderate
- Low
- Very Low
- Minimal Direct Wildfire Impacts

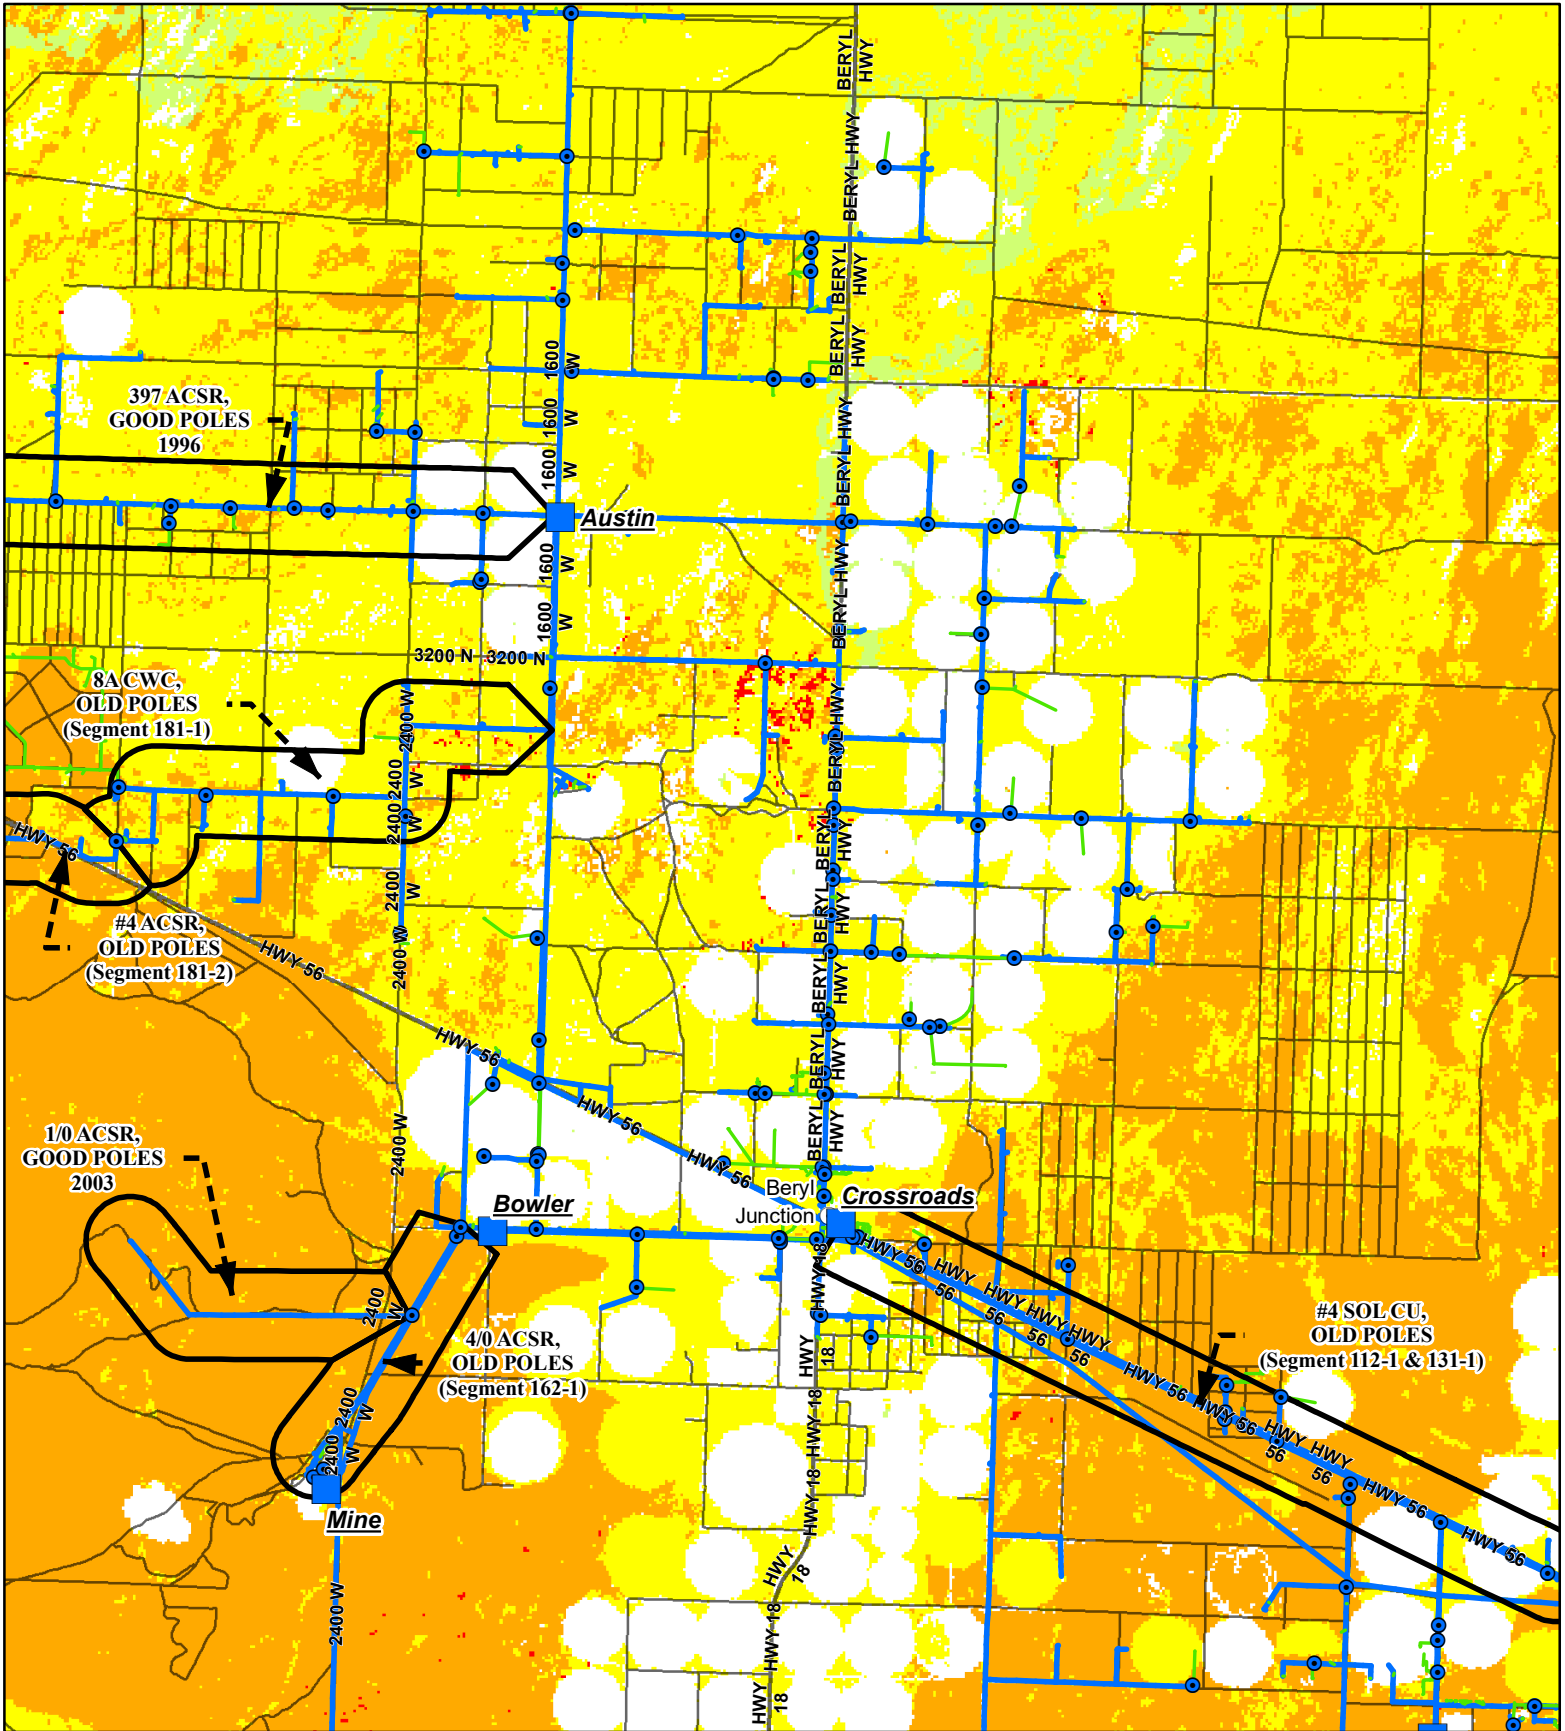
WILDFIRE HAZARD POTENTIAL - BERYL AREA PAGE B5

- Substation
- Line Comment
- Minimal Direct Wildfire Impacts
- Fuse
- Very High
- High
- Moderate
- Low
- Overhead Powerline
- Underground Powerline

Escalante Valley (Beryl) Area Substations and Feeders			
Substation	Feeder	Description	Analysis
Austin Sub (Beryl Area Map B5)	181	OH South To Hwy 56 (Beryl Area Map B5 and B2)	This feeder serves mostly irrigated, cultivated land and so poses very negligible fire risk. The one area of concern includes the two segments on the southwest portion of this feeder where the OH line leaves irrigated land, near Highway 56 (see map B5 & B2.) The first 5.2-mile segment (181-1) of three-phase line has old poles and old conductor and so is scheduled for replacement in 2026. The second segment (181-2) is approximately 2 miles long with some three and single-phase line with old poles and conductor and is scheduled to be replaced in 2027.
	182	OH West to Modena (Beryl Area Map B5, B2, and B1)	This feeder crosses a lot of area with orange risk level and so requires a fair amount of detailed evaluation. The first segment of this feeder, going west, (map B5) has good, new poles with good ACSR conductor. Continuing west on this feeder (map B2) there are segments with old poles and old conductor that are slated for rebuild on the dates indicated in the following list for each segment: <ul style="list-style-type: none"> - 182-1: 3.5 miles in 2032 - 182-2: 4.1 miles in 2031 - 182-3: 1.75 miles in 2028 - 182-4: 3 miles in 2029 - 182-5: 8.1 miles in 2030 - 182-6: 5.5 miles in 2024 Continuing southwest past the town of Modena (map B1) there is a segment of line that is new, with new poles and conductor (2015) and so is considered to be of low threat for starting a wildfire.

has old poles and old conductor it is scheduled to be replaced in 2025.
	132	Underbuild North to Hwy 56 (Beryl Area Map B7 and B5)	This feeder serves mostly irrigated, cultivated land, and so poses very negligible fire risk.
	134	UG East (Beryl Area Map B7)	Entirely underground feeder
Bowler Sub (Beryl Area Map B5)	162	34.5kV South to Mine Sub (Beryl Area Map B5)	This 2-mile 34.5kV transmission line (segment 162-1) goes south to the Mine Sub (map B5,) crosses an orange zone, has old poles and is scheduled for replacement in 2034.
	163	34.5kV North to Austin Sub (Beryl Area Map B5)	This 34.5kV transmission line goes north to the Austin Sub, crosses mostly irrigated, cultivated land (marked in green on the maps) and so poses very negligible fire risk.
Crossroads Sub (Beryl Area Map B5)	142	OH East Hwy 56 (Beryl Area Map B5)	This feeder partly serves irrigated, cultivated land which poses very negligible fire risk.

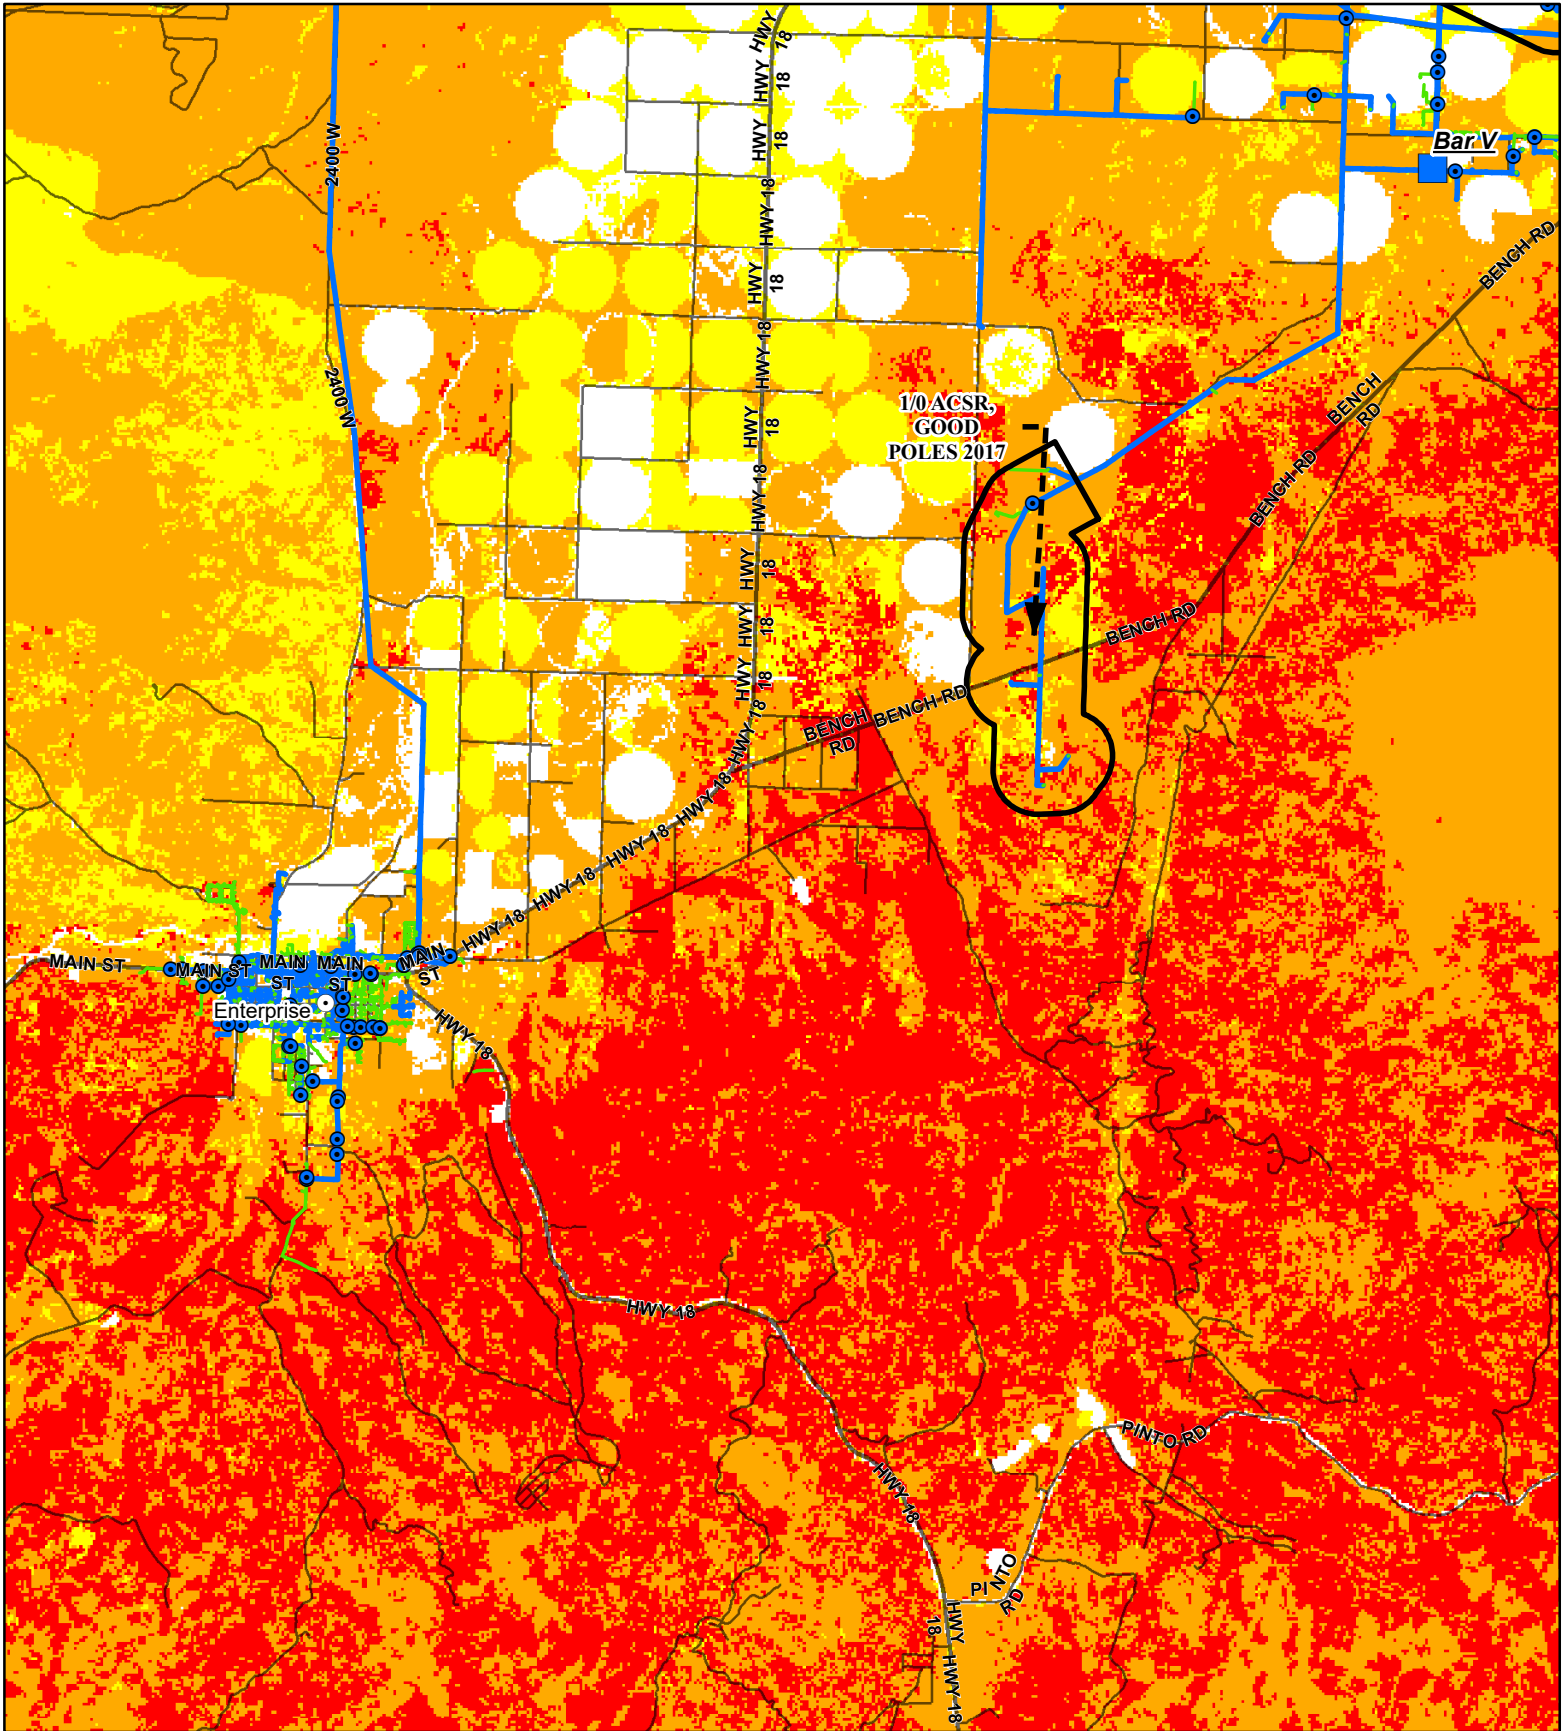
WILDFIRE HAZARD POTENTIAL - BERYL AREA PAGE B7

- Substation
- Fuse
- Overhead Powerline
- Underground Powerline
- Line Comment
- Very High
- High
- Moderate
- Low
- Minimal Direct Wildfire Impacts

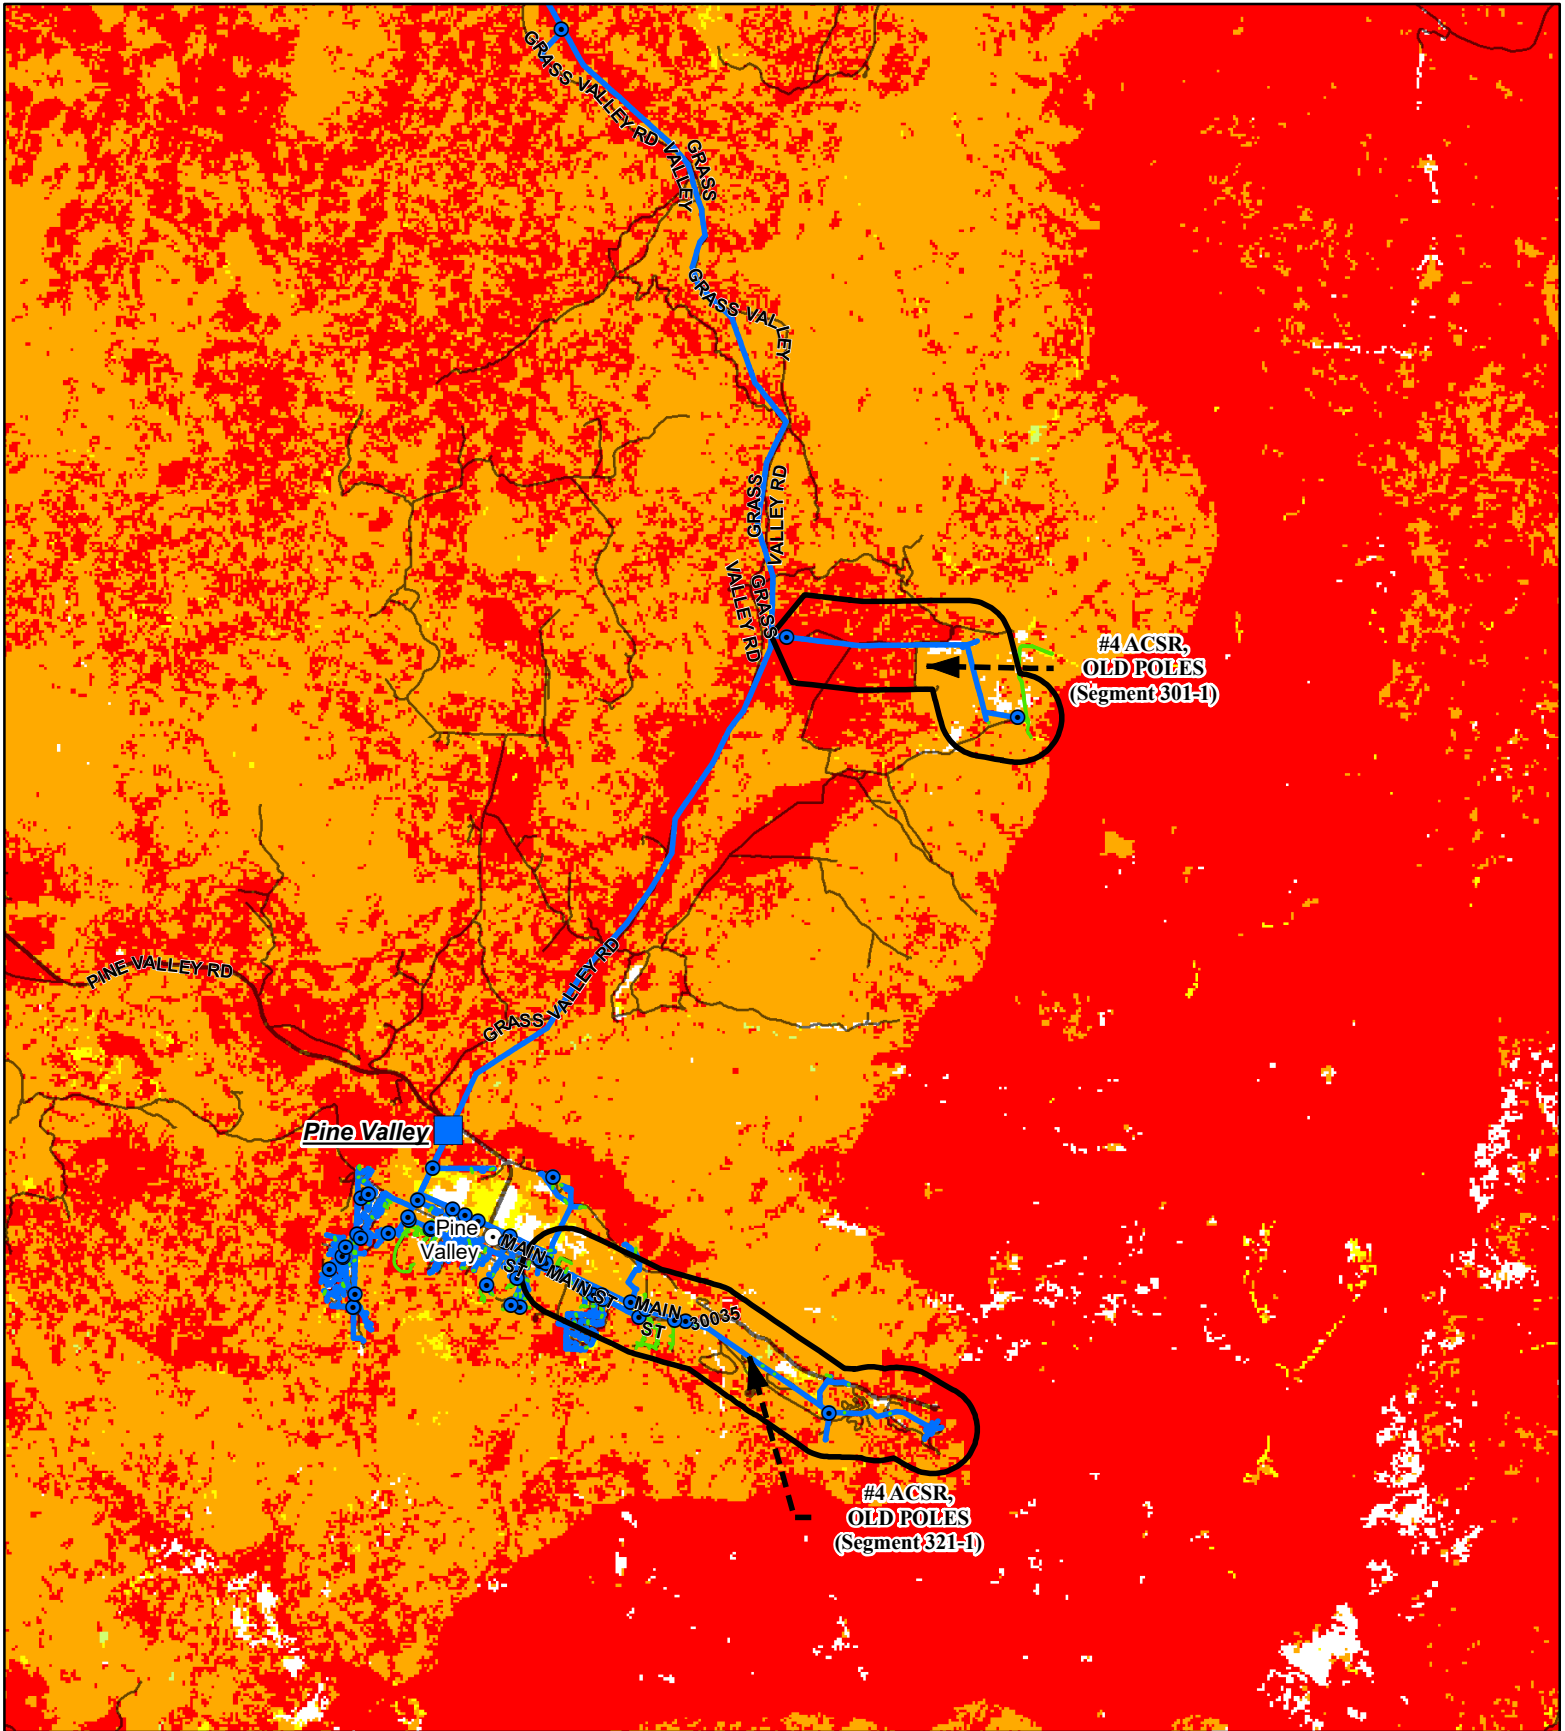
WILDFIRE HAZARD POTENTIAL - BERYL AREA PAGE B9

- Substation
- Fuse
- Overhead Powerline
- Underground Powerline
- Line Comment
- Very High
- High
- Moderate
- Low
- Minimal Direct Wildfire Impacts

125	OH Newcastle East (Beryl Area Map B6)	This feeder does not leave the substation. It is a backup to feeder 124.
Pine Valley Sub (Beryl Area Map B9)	321	OH South/Pine Valley Town (Beryl Area Map B9)	This feeder lies entirely within the town of Pine Valley (map B9) and so poses little risk of wildfire even though it is colored in red. Even so, the 3.1-mile segment (321-1) at the far east side of town had old poles and so was replaced in 2021.
Pinto (Beryl Area Map B8)	301	South to Pine Valley (Beryl Area Map B8 and B9)	This feeder crosses red and orange zones but has new poles and wire, except for a short 2.2-mile segment (301-1,) at the end of the Grass Valley tap to the east (map B9,) which has old poles and wire and so was replaced in 2022.

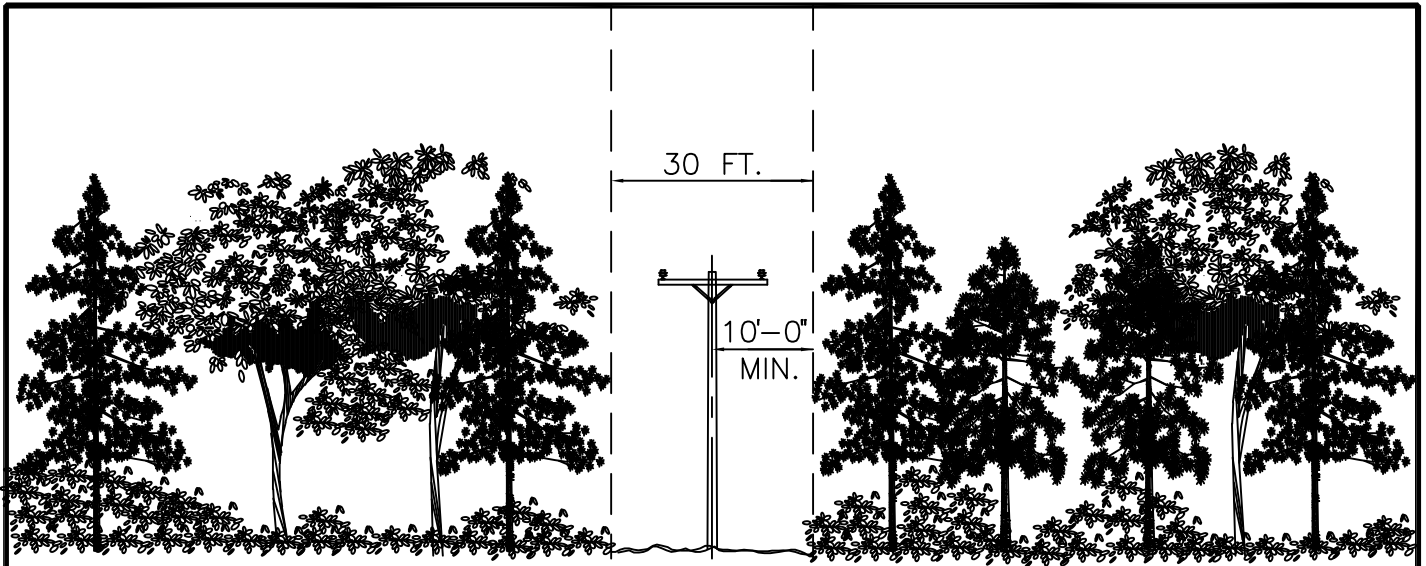
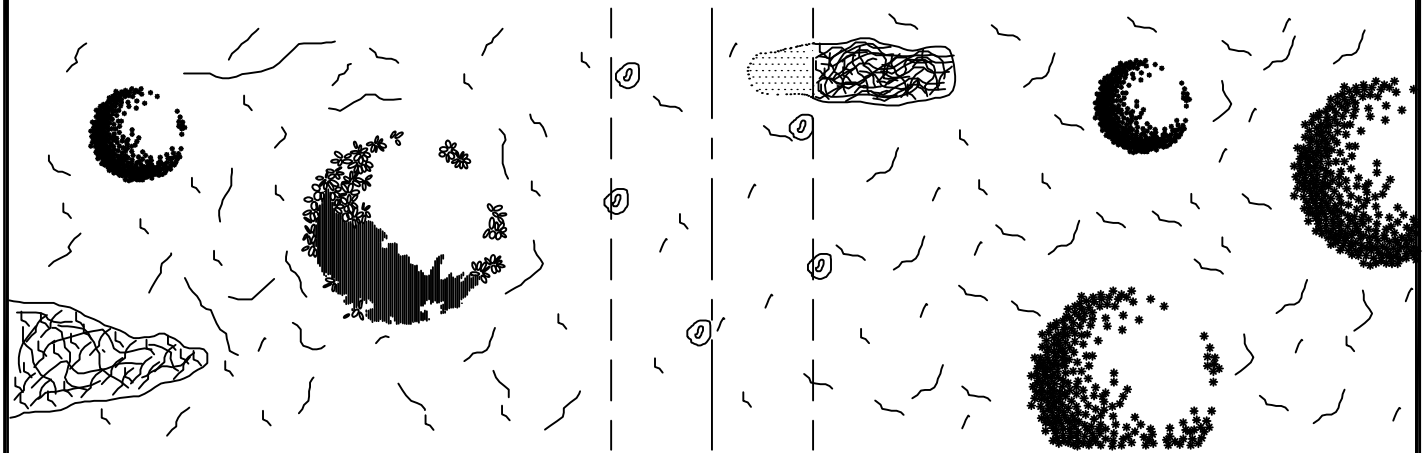
RUS Drawing M1.30G (R1)

ELEVATION

AFTER CLEARING

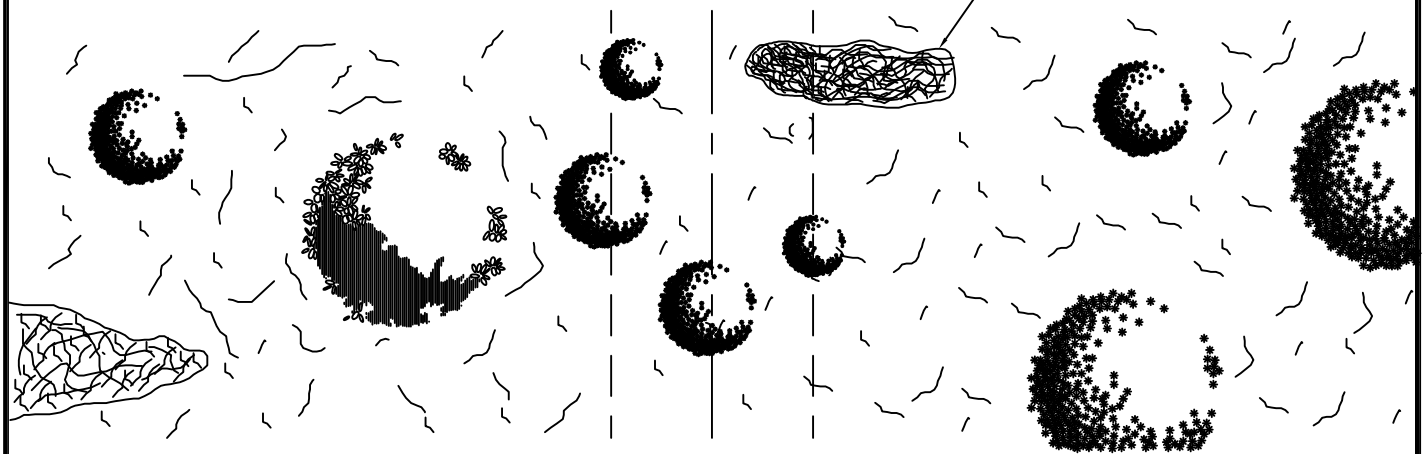
BEFORE CLEARING

1. Engineer shall designate all danger trees which are to be removed or topped. The unit for clearing danger trees is "TM-13."
2. The unit for clearing right-of-way of specified width is "TM-15" or "TM-15(1)."

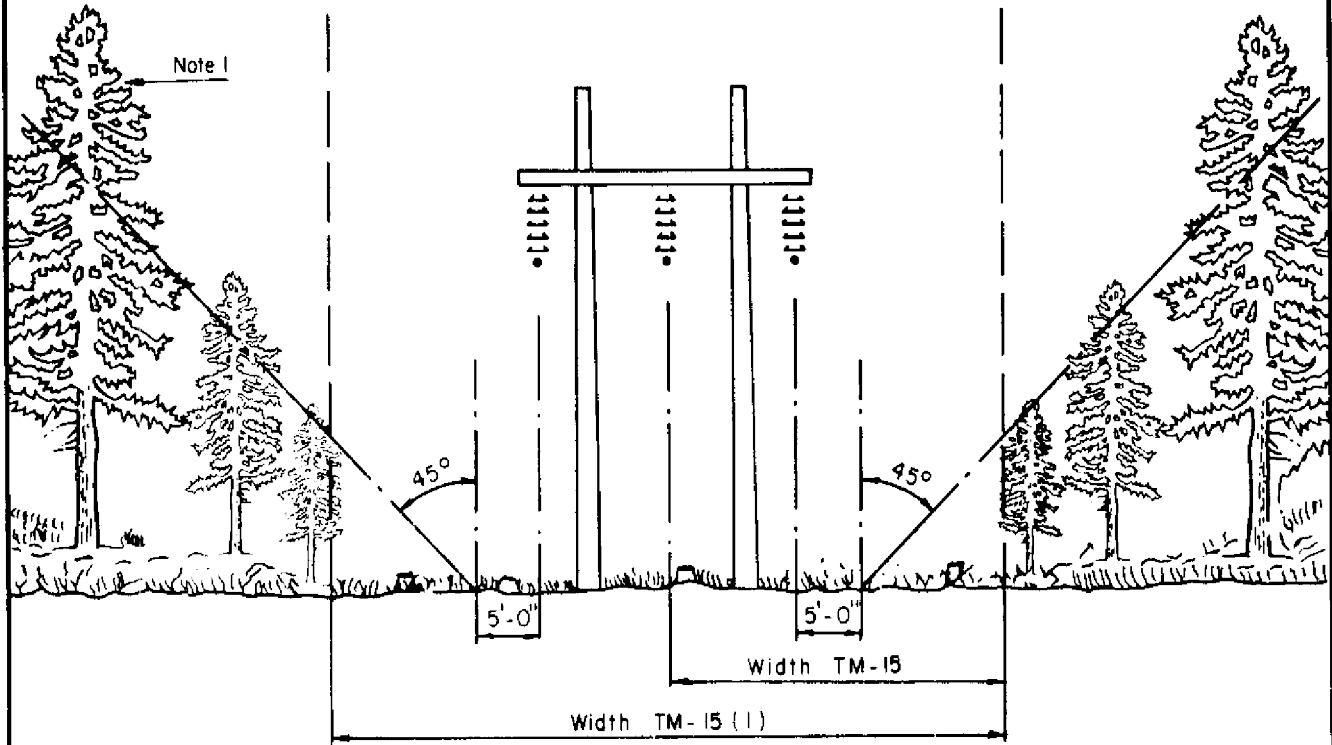
FEATHERED CLEARING

TRANSMISSION ROW CLEARING	
FEATHERED/CLEAR-CUT CLEARING
