Re: Docket 24-035-06 – Rocky Mountain Power’s Power Quality Report for 2023

Power Quality Introduction

Report Scope

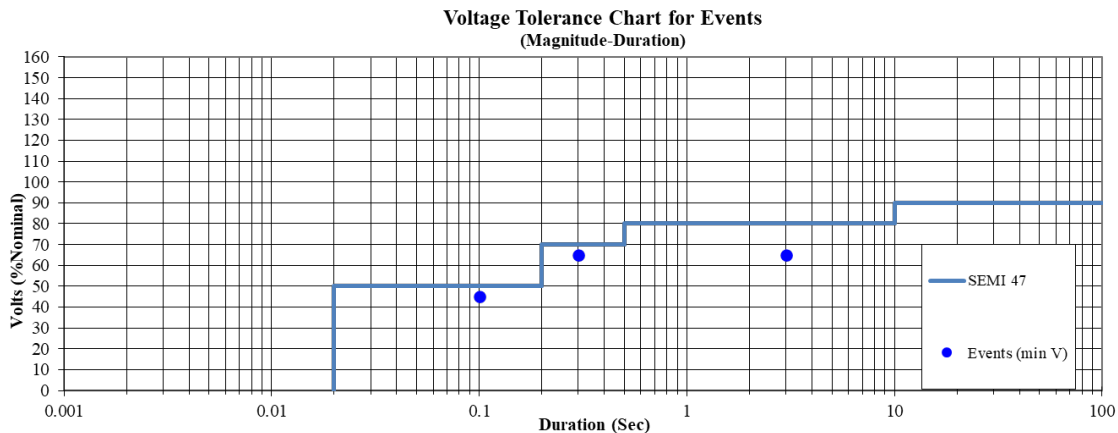
SEMI-F47 Curve – A voltage sag ride-through curve developed by the semiconductor manufacturing industry to ensure that control and manufacturing equipment would not require operator intervention in the event of a voltage sag. Implementation of the ride-through curve requirements to applicable control equipment ensures that equipment drop-off is not a result of control terminal sensitivity but determined by the equipment’s operational limitations and safety requirements of the attached load.

Customers are encouraged to ride through less severe voltage sags. The Company recommends customers utilize the SEMI-F47 curve as a guideline to determine the voltage sag ride-through parameters of their equipment. Events below the SEMI-F47 curve will likely cause customers' equipment to shut off, whereas customers are encouraged to design systems to ride through events occurring above the curve. Voltage sag events occurring below the SEMI-F47 curve during the data collection period are included in this report.

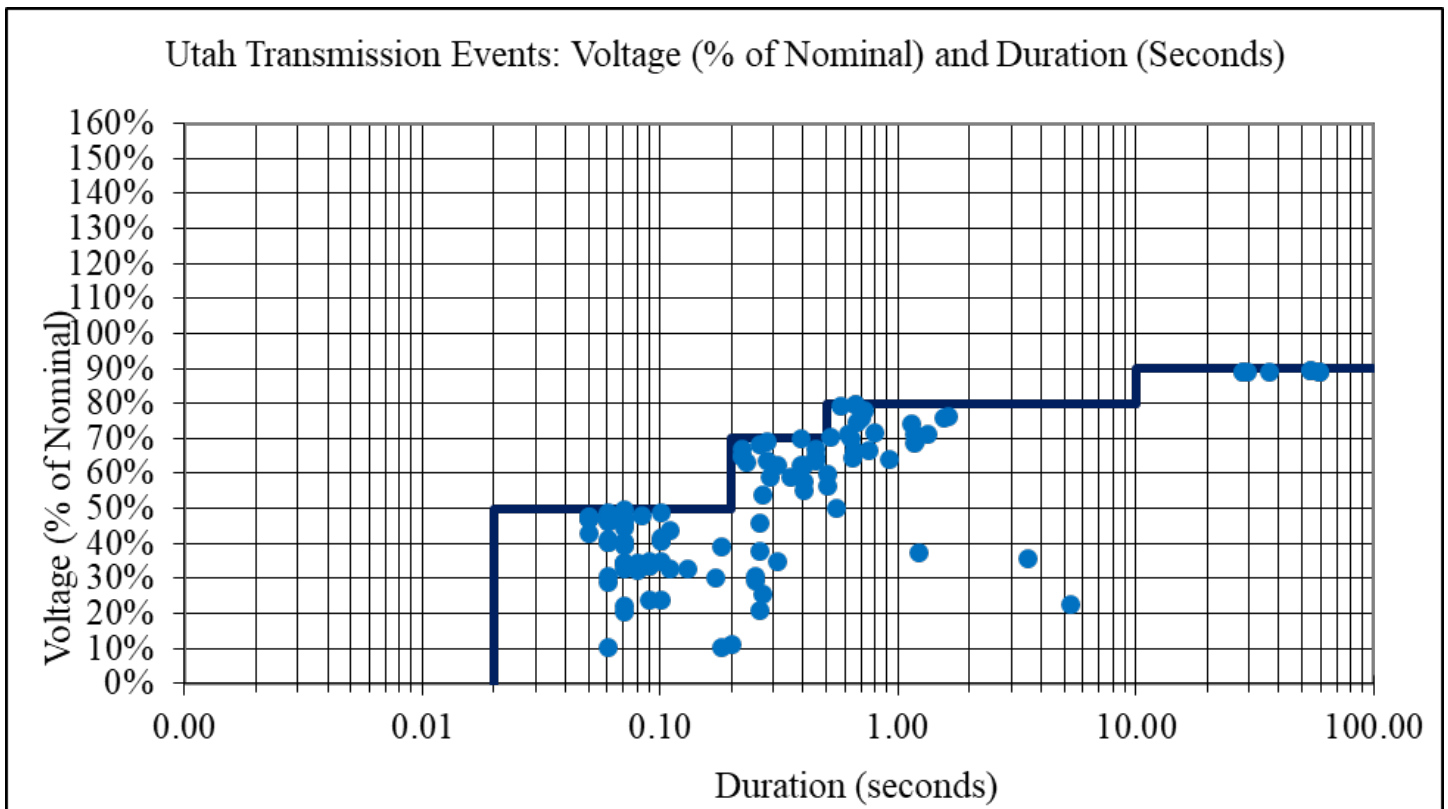
Figure 2 Utah Transmission SEMI-F47 Plot

The 2023 year included new monitoring locations that are located at transmission interconnections. Power quality monitors captured and increased number of shallower voltage sags with longer durations. For individual sites, the respective SEMI-F47 plot can be found in the Appendix -[SEMI-F47](#) Plots (see page 23).

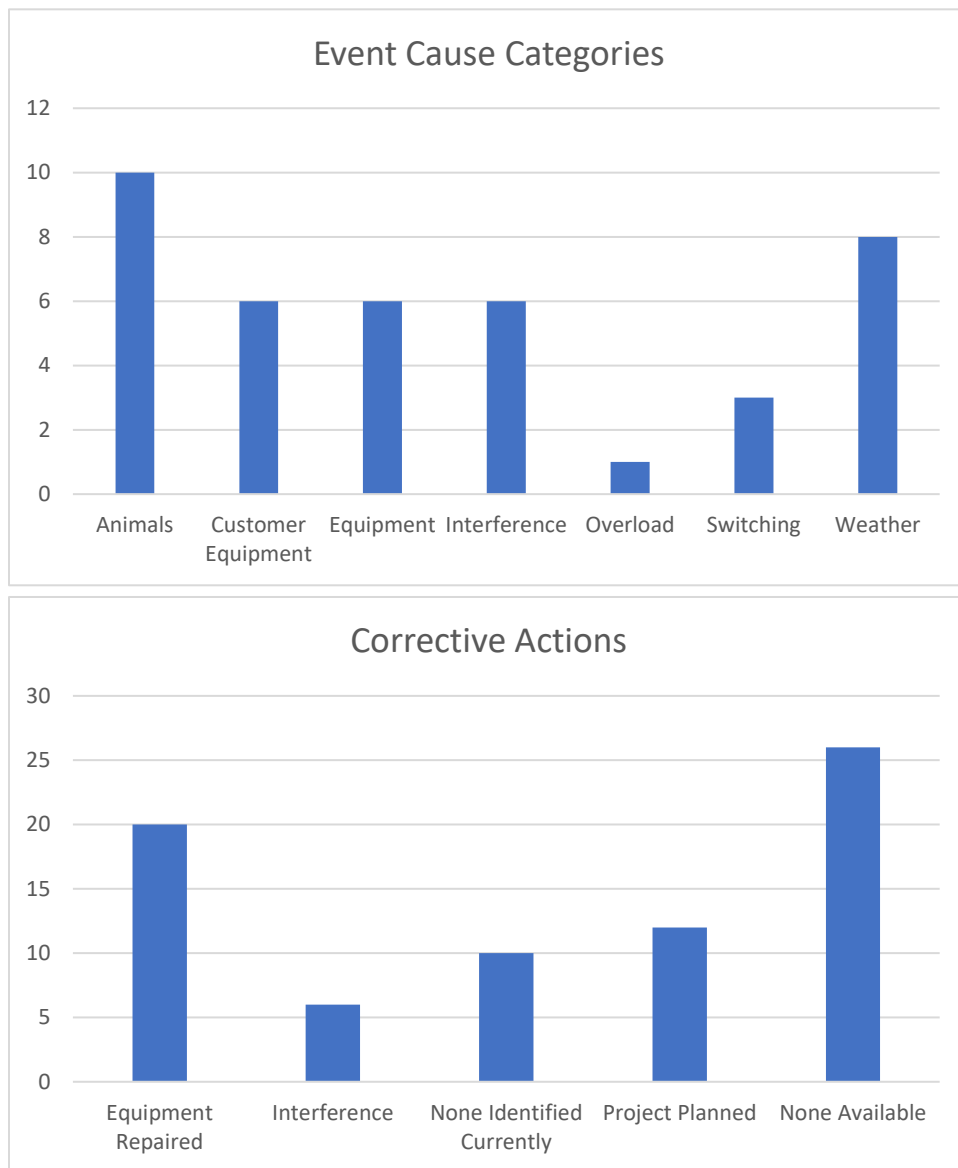
Figure 4 Event Cause Categories & Corrective Actions

Power quality events captured by the Company are typically associated with faults (short circuit) on the transmission network. Tracking events to identify patterns in system issues can provide preventative maintenance and system improvement recommendations. If a Company system fault occurred at the time of a recorded event, it is assigned a category and short description in Table 2. 33 “Other” events were also captured by monitors but removed from the table to improve other category readability. Other events are caused by an unknown or directly unidentifiable cause of a fault. Description and corrective actions taken for individual events are in the Appendix - [Event Information](#) (see page 17).
