Action Request Response

- **Date:** March 18, 2024
- **Re: Docket No. 24-035-06,** Rocky Mountain Power's Power Quality Report for the Period of January through December 2023

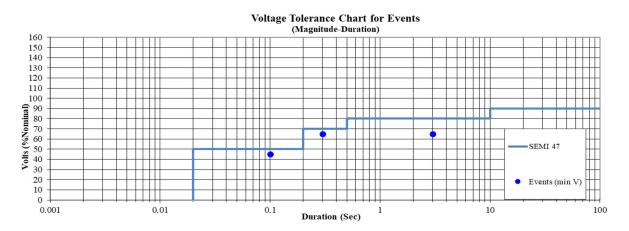
Illustration I (SEMI-F47 Curve Example)

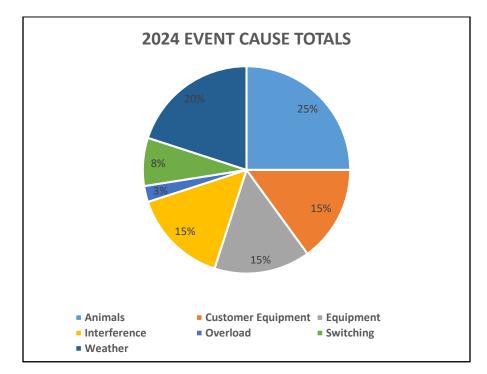
RMP compiles the meter data from the four reporting regions throughout Utah into major event causes. The Division notes that the event cause categories may differ slightly from year-to-year but still serves as an important year-over-year comparison of major events leading to power quality issues and remedies. Illustration II shows this reporting period's major event causes as a percentage of the total events.

RMP reports the 40 main event causes during 2023 of: 10 Animals, 6 Customer Equipment, 6 Utility Equipment, 6 Interference, 1 Overload, 3 Switching, and 8 Weather events.²³ The Division notes that the 40 major event causes reported this year are an improvement from last year's 45 major event causes.

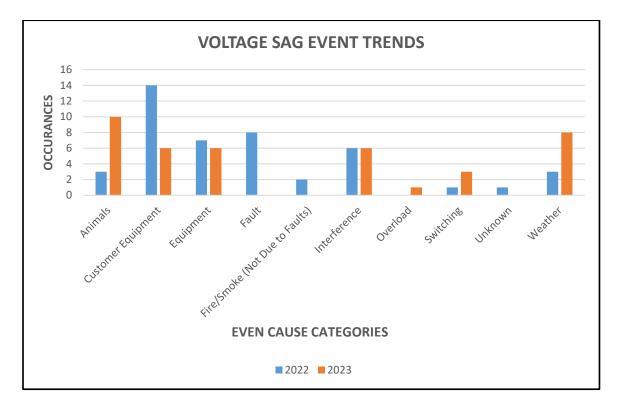
The Division concludes that tracking the major event causes year-over-year is important for interested parties to better understand the major event causes leading to poor power quality sag events. Illustration III provides a trend of 2022 and 2023 major event causes. While two years of data does not provide significant results, the Division hopes trending this data will provide a better understanding of power quality in the future.

Illustration III Voltage SAG Event Cause Trends

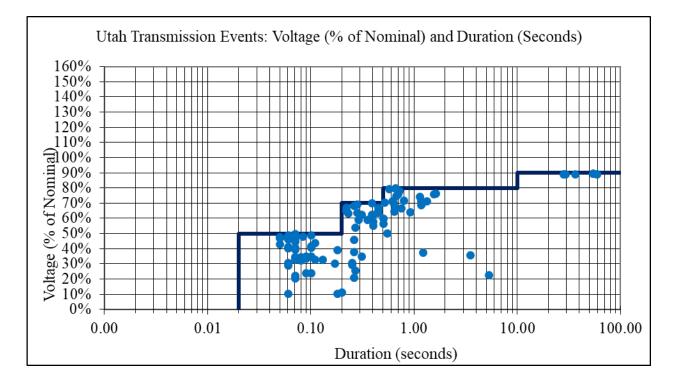
RMP does not report voltage spikes that would appear above the SEMI-F47 line. Voltage sags are generally more detrimental to power quality than spikes, however the Commission may wish to require reporting voltage spikes in future power quality reports to provide a more comprehensive view of variations that could affect customers' service and equipment. Illustration IV shows RMP's compiled 2023 SEMI-F47 sag events including the new meter stations and regions.²⁴

Illustration IV RMP SEMI-F47 2023 Curve

The Division has concerns with the number of events occurring below the SEMI-F47 line, especially events lasting between 1 and 10 seconds. The Division understands that voltage sags are inevitable given the many factors that are generally out of RMP's control. This year's report indicates animals and weather as the leading event cause contributors with customer, utility equipment failures, and interference remaining as large contributors to the event causes of power quality issues. Last year's report was substantially comprised of customer equipment event causes. However, this is RMP's second power quality report, and the Division has no baseline on which to evaluate its concerns or make recommendations on the current power quality metrics. The Division intends to monitor RMP's SEMI-F47 curves and the event causes in future years to develop a baseline before offering any recommendations.
