Re: Docket No. 24-035-09 – Rocky Mountain Power’s Power Quality Report for 2024

Rocky Mountain Power Proposal to Consolidate Reporting Requirements

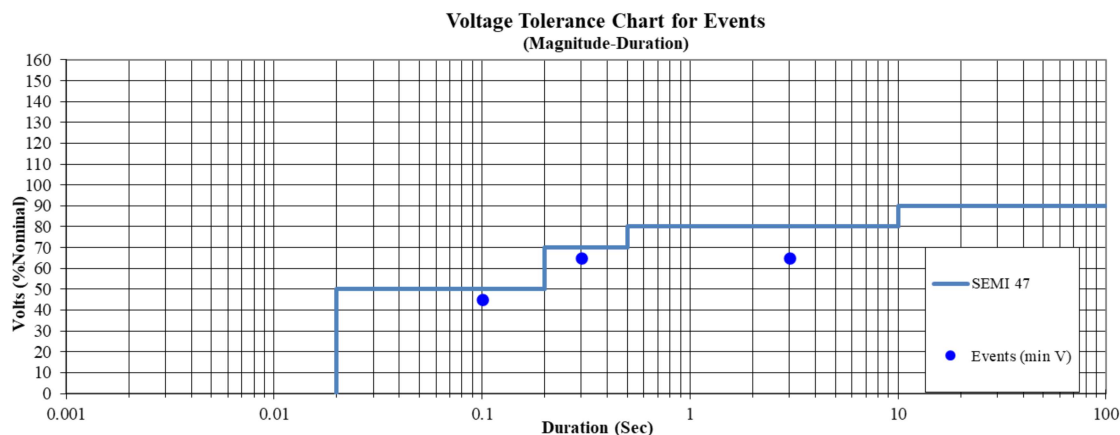
SEMI-F47 Curve – A voltage sag ride-through curve developed by the semiconductor manufacturing industry to ensure that control and manufacturing equipment would not require operator intervention in the event of a voltage sag. Implementation of the ride-through curve requirements to applicable control equipment ensures that equipment drop-off is not a result of control terminal sensitivity but determined by the equipment’s operational limitations and safety requirements of the attached load.

Customers are encouraged to develop systems to ride through less severe voltage sags. The Company recommends customers utilize the SEMI-F47 curve as a guideline to determine the voltage sag ride-through parameters of their equipment. Events below the SEMI-F47 curve will likely cause customers' equipment to shut off, whereas customers are encouraged to design systems to ride through events occurring above the curve. Voltage sag events occurring below the SEMI-F47 curve during the data collection period are included in this report.

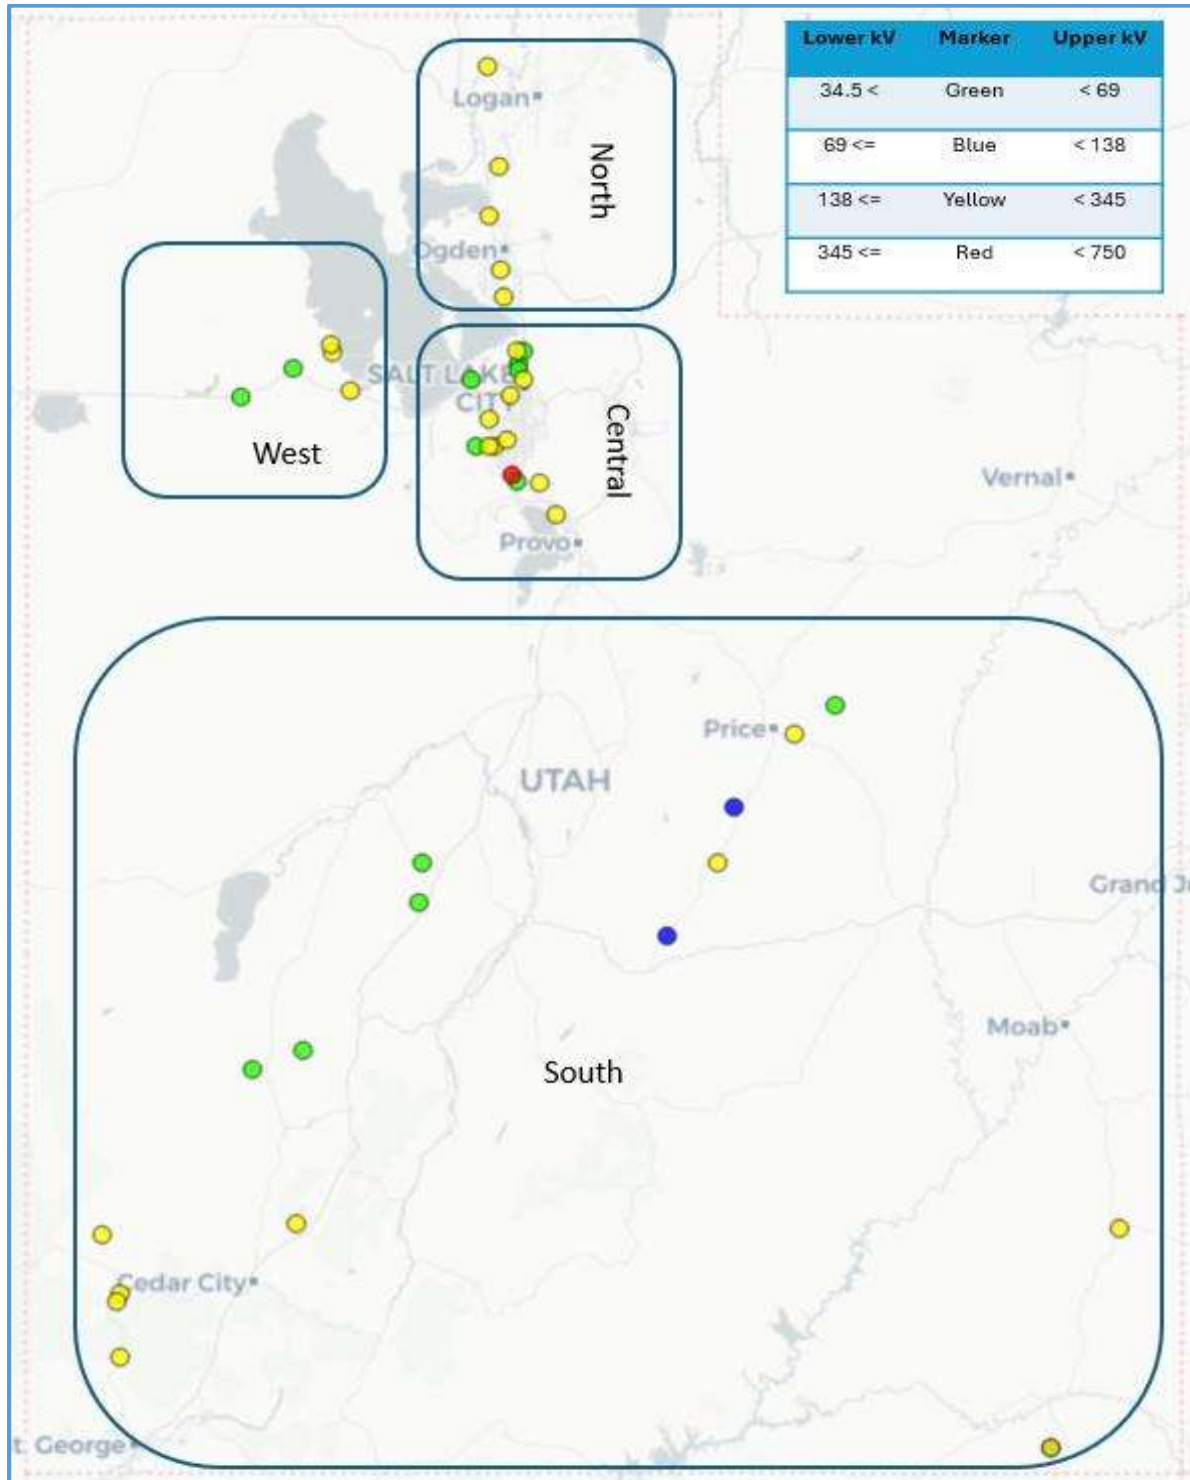
Figure 1: Monitoring Locations

Monitoring locations selected for this report are located at Company transmission substations. Monitor data availability at each location is not guaranteed as power quality monitors may have communication issues, hardware/software reset needs, or monitor failure. Voltage levels reported from Company monitors may vary from customer monitoring systems due to variables that include the distance of the fault from the customers' monitors as compared to the distance to the Company's monitors.

Regional maps can be found in the Appendix under Regional Site Maps (see page 13).

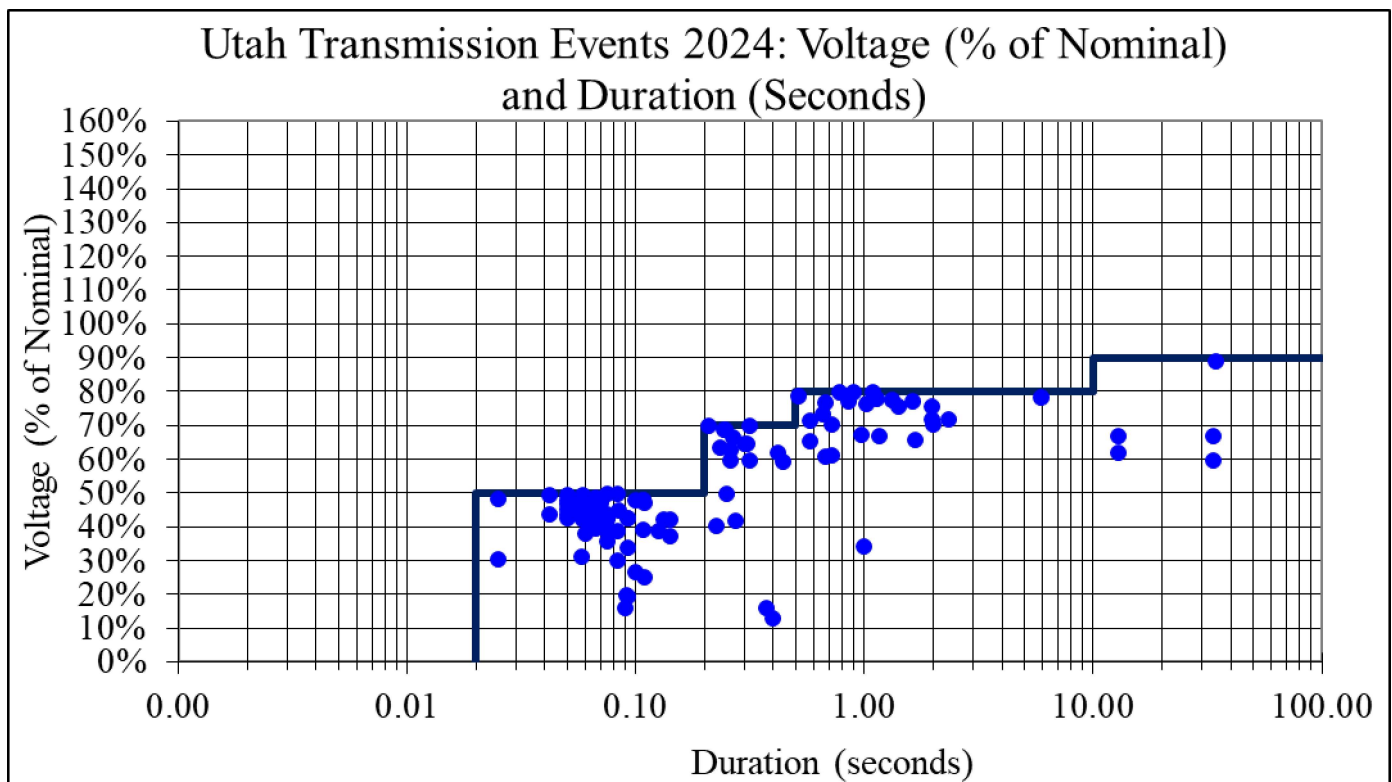
Figure 2: Utah Transmission SEMI-F47 Plot

The 2024 year included new monitoring locations that are located at transmission interconnections. Power quality monitors captured and increased number of shallower voltage sags with longer durations. For individual sites, the respective SEMI-F47 plot can be found in the Appendix –

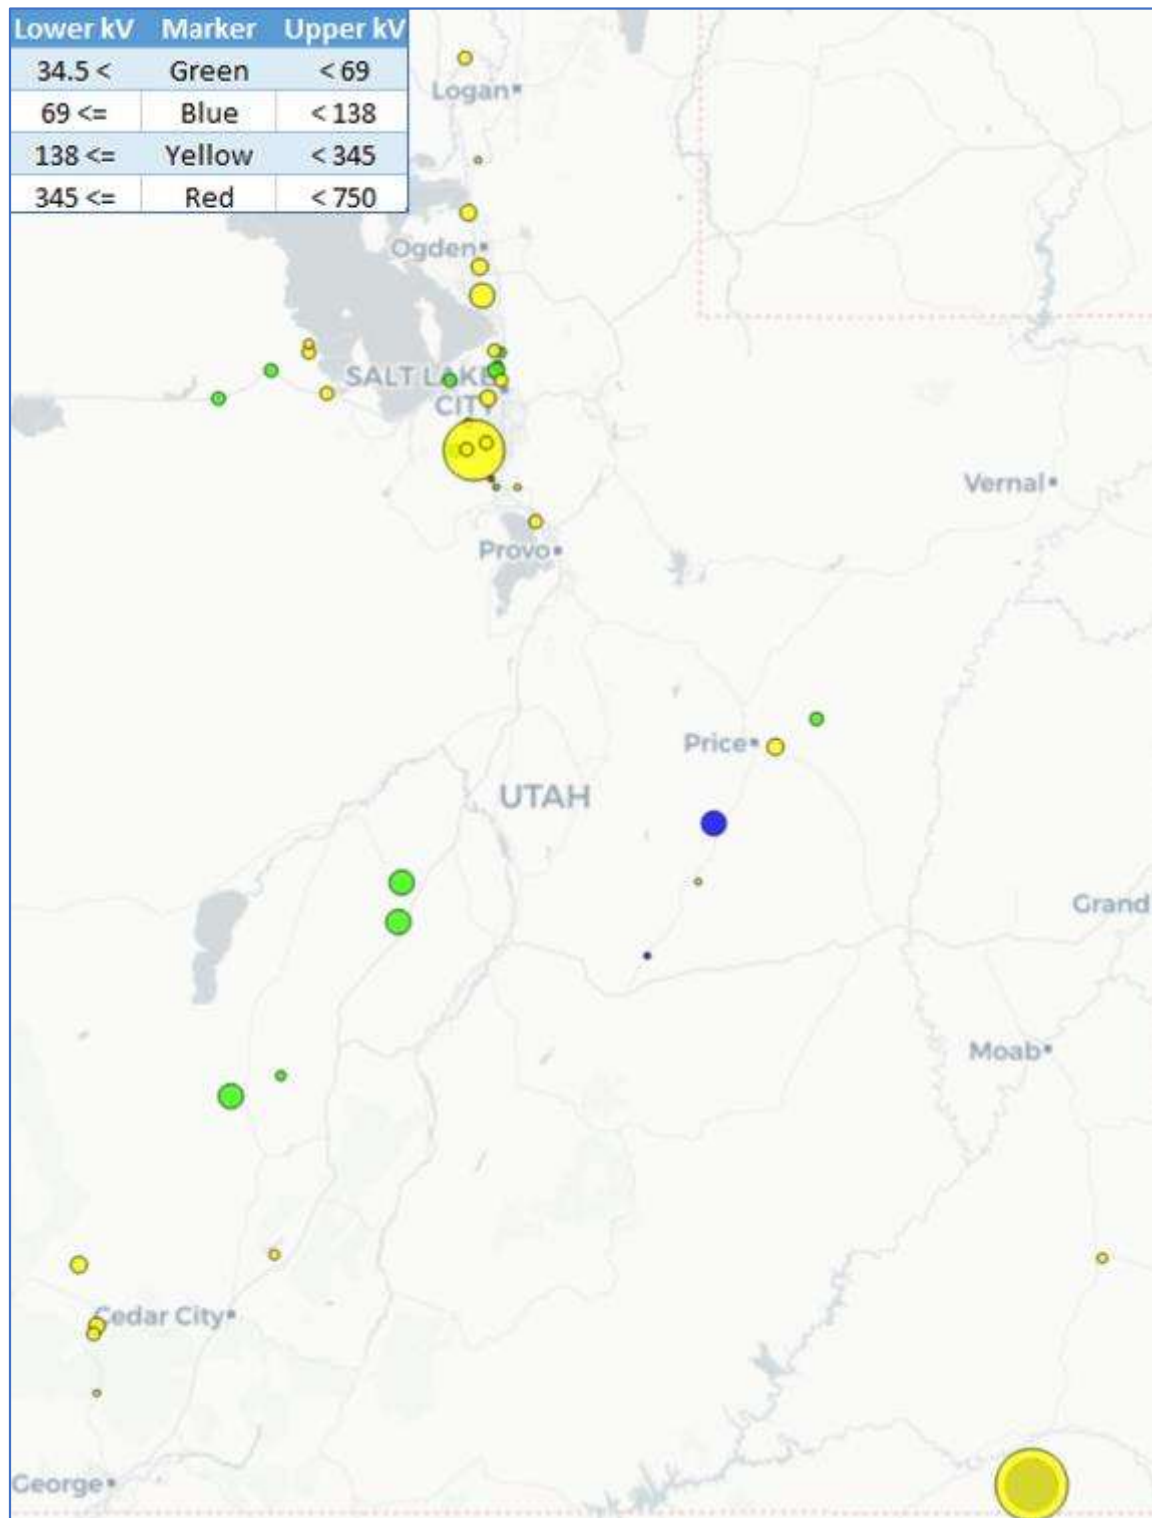
Figure 3: Voltage Sag Density Map

The Voltage Sag Density Map provides a hotspot view of voltage sags on the Utah transmission system.

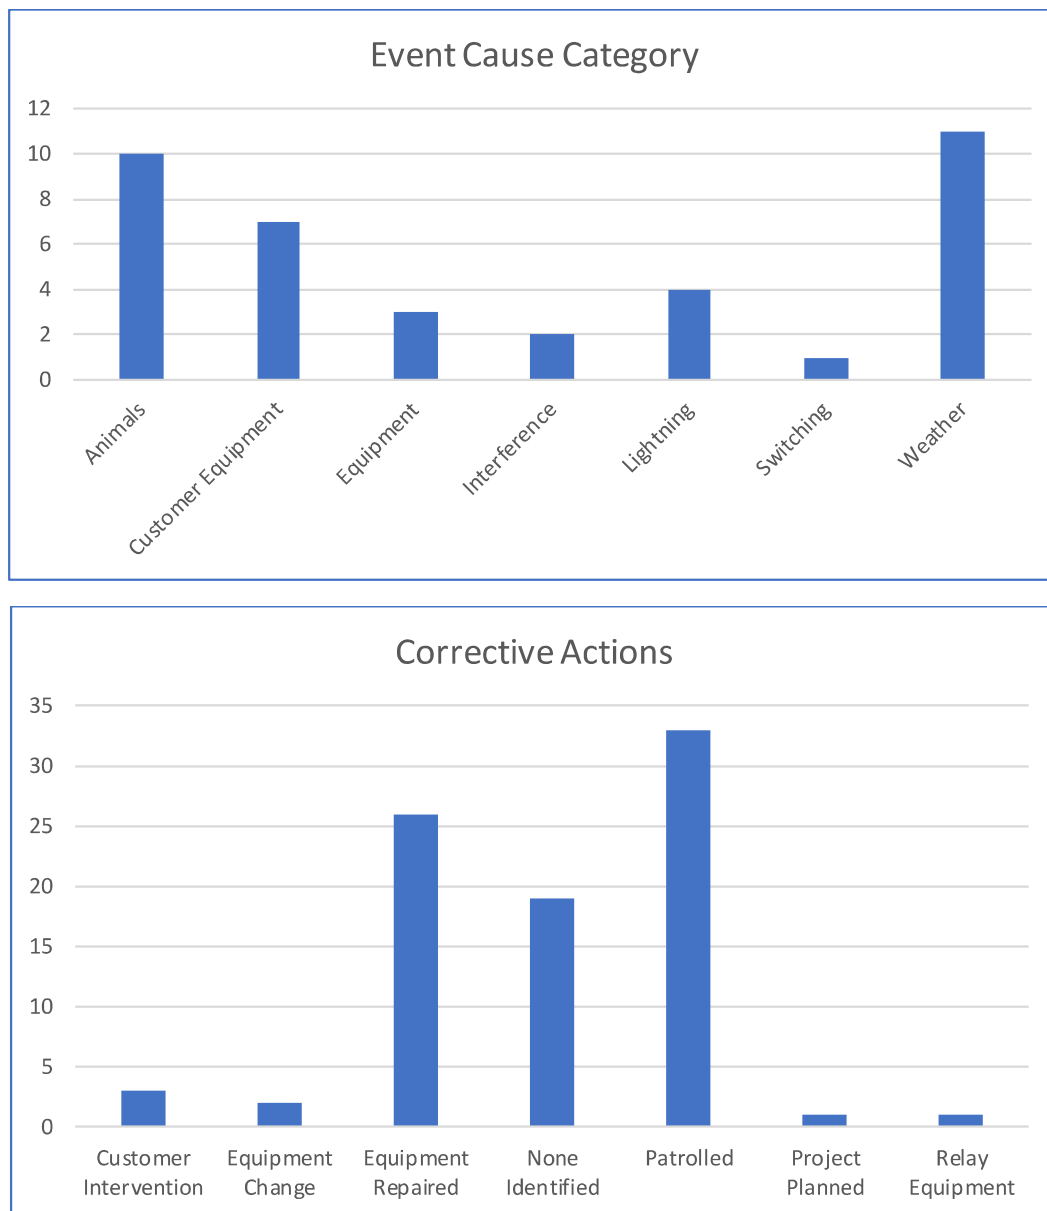
Figure 4: Event Cause Categories & Corrective Actions

Power quality events captured by the Company are typically associated with faults (short circuit) on the transmission network. Tracking events to identify patterns in system issues can provide preventative maintenance and system improvement recommendations. If a Company system fault occurred at the time of a recorded event, it is assigned a category and short description in Table 4. 49 “Fault” events were also captured by monitors but removed from the table to improve other category readability. Events that were caused by an unknown or directly unidentifiable cause and were confirmed to have fault current in relay records were given a cause category of Fault. Review the fault records description and corrective actions taken for individual events are in the Appendix - [Event Information](#) (see page 18).
