RE: **Docket No. 25-035-54**
Status Report of Rocky Mountain Power's Electrical Power Delivery Quality Plan.

In accordance with Administrative Rule R746-316-5, Rocky Mountain Power hereby submits this Status Report of its Electrical Power Delivery Quality Plan ("Report"). The Report attached herein contains a status update on the Company's approved Electrical Power Delivery Quality Plan as required by Utah Code §54-25 that was approved by the Public Service Commission of Utah in Docket No. 24-035-16. The reporting period is January through December 2024.

3 Equipment for Assessing Power Quality

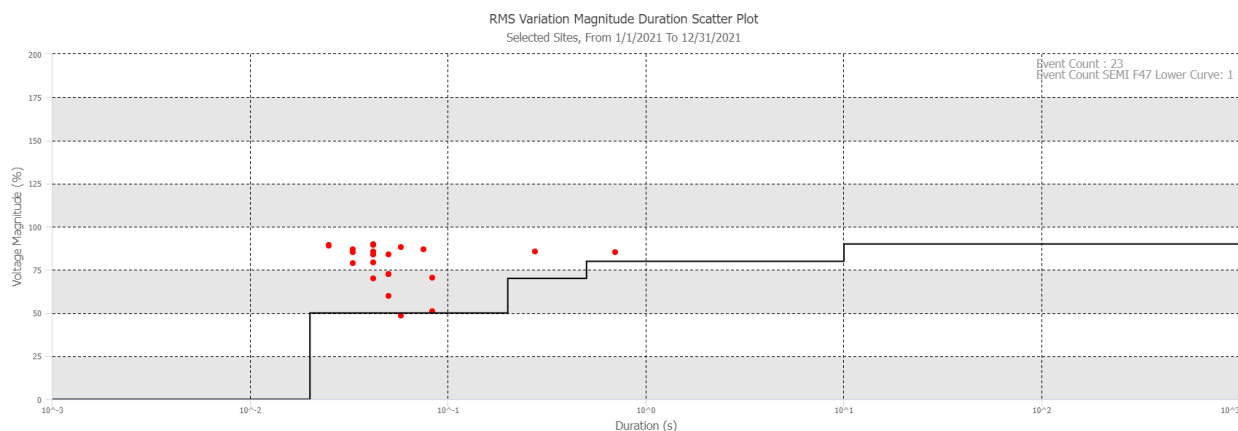
The Company encourages customers to implement appropriate voltage sag ride-through protocols to ensure that equipment interruptions occur because of a system design to meet safety and equipment protection guidelines. The hardening of control and LV systems can maximize the ride-through of a site. The Company recommends the use of SEMI-F47 ride-through analysis for low voltage control equipment in lieu of the CBEMA or ITIC. Below is an example SEMI-F47 plot showing multiple voltage sags, but only one occurring “below the line”. Below the line events will likely cause an issue for customers, but the expectation is for customers to be able to “ride through” events above the line.
