Our response in support of our request for review or re-hearing with the Public Service Commission

Our response to Rocky Mountain Power's response addressing safety risks regarding Rocky Mountain Power's exposed and improperly buried Rose Canyon Line Extension. Starting at a location at or near the end of the paved portion of the Rose Canyon road.

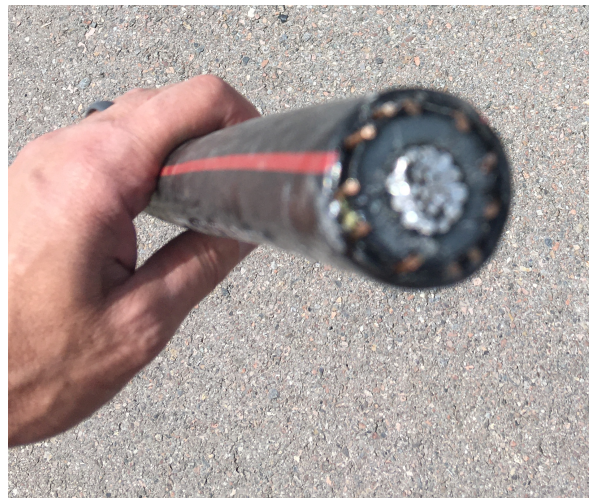
Docket 23-035-23 photograph taken on May 5, 2023 clearly shows this to be the case. Additionally it clearly shows that the exposed High voltage line has NO encasement in conduit.

High voltage cable not encased in conduit - like the one used in the Rose canyon line extension - the same cable pictured in the original complaint.

If ever a photograph was worth a thousand words, this is it! The photo clearly evidences that the high voltage power line is NOT encased in plastic conduit as falsely claimed by the power company. Therefore it clearly remains as an electrocution hazard and constitutes an imminent public safety emergency.

does not produce an electrocution risk to the public. It is CLEARLY OBVIOUS that the line is NOT encased in plastic conduit as falsely claimed in their response.

4. I would suggest burying the cable and conduit in the center of the road at a depth of 30" to 48" which should eliminate exposure of the cable.
